Pit, Below-Grade Tank, or Proposed Alternative Method Permit or Closure Plan Application

1.
Operator: BP America Production Company OGRID #: 778
Address: 200 Energy Court, Farmington, NM 87401
Facility or well name: Florance 24
API Number: 3004508119 OCD Permit Number:
U/L or Qtr/Qtr A Section 23 Township 29N Range 9W County: San Juan
Center of Proposed Design: Latitude 36.71635 Longitude -107.74387 NAD: ☐ 1927 ☒ 1983
Surface Owner: ☒ Federal ☐ State ☐ Private ☐ Tribal Trust or Indian Allotment

BELOW-GRADE TANK CLOSURE PLAN

Florance 24
API No. 3004508119
Unit Letter A, Section 23, T29N, R9W

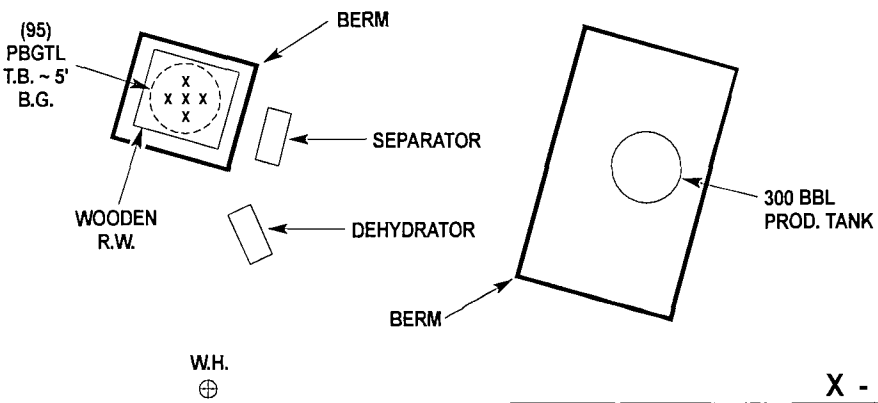
DISCOLORATION/STAINING OBSERVED: YES / NO EXPLANATION - @ 21 BGT BETWEEN 4' - 6' BELOW GRADE ONLY.

APPARENT EVIDENCE OF A RELEASE OBSERVED AND/OR OCCURRED: YES / NO EXPLANATION: @ 21 BGT ONLY AROUND SIDEWALLS.

OTHER: SOIL IMPACTS @ 21 BGT, VERY MINIMAL IN QUANTITY. RECOMMENDED EXCAVATING & THIN SPREADING ON WELL PAD. 21 BGT SIDEWALLS COVERED WITH SEDIMENT PROBABLY CAUSED BY WIND BLOWN DEPOSITION OR BY GRAVITATIONAL PROCESS AIDED BY PRECIPITATION.
