Remediation Plan

Righthand Canyon 35-1

UL-L, Sec. 35, T21S R24E

Proposal

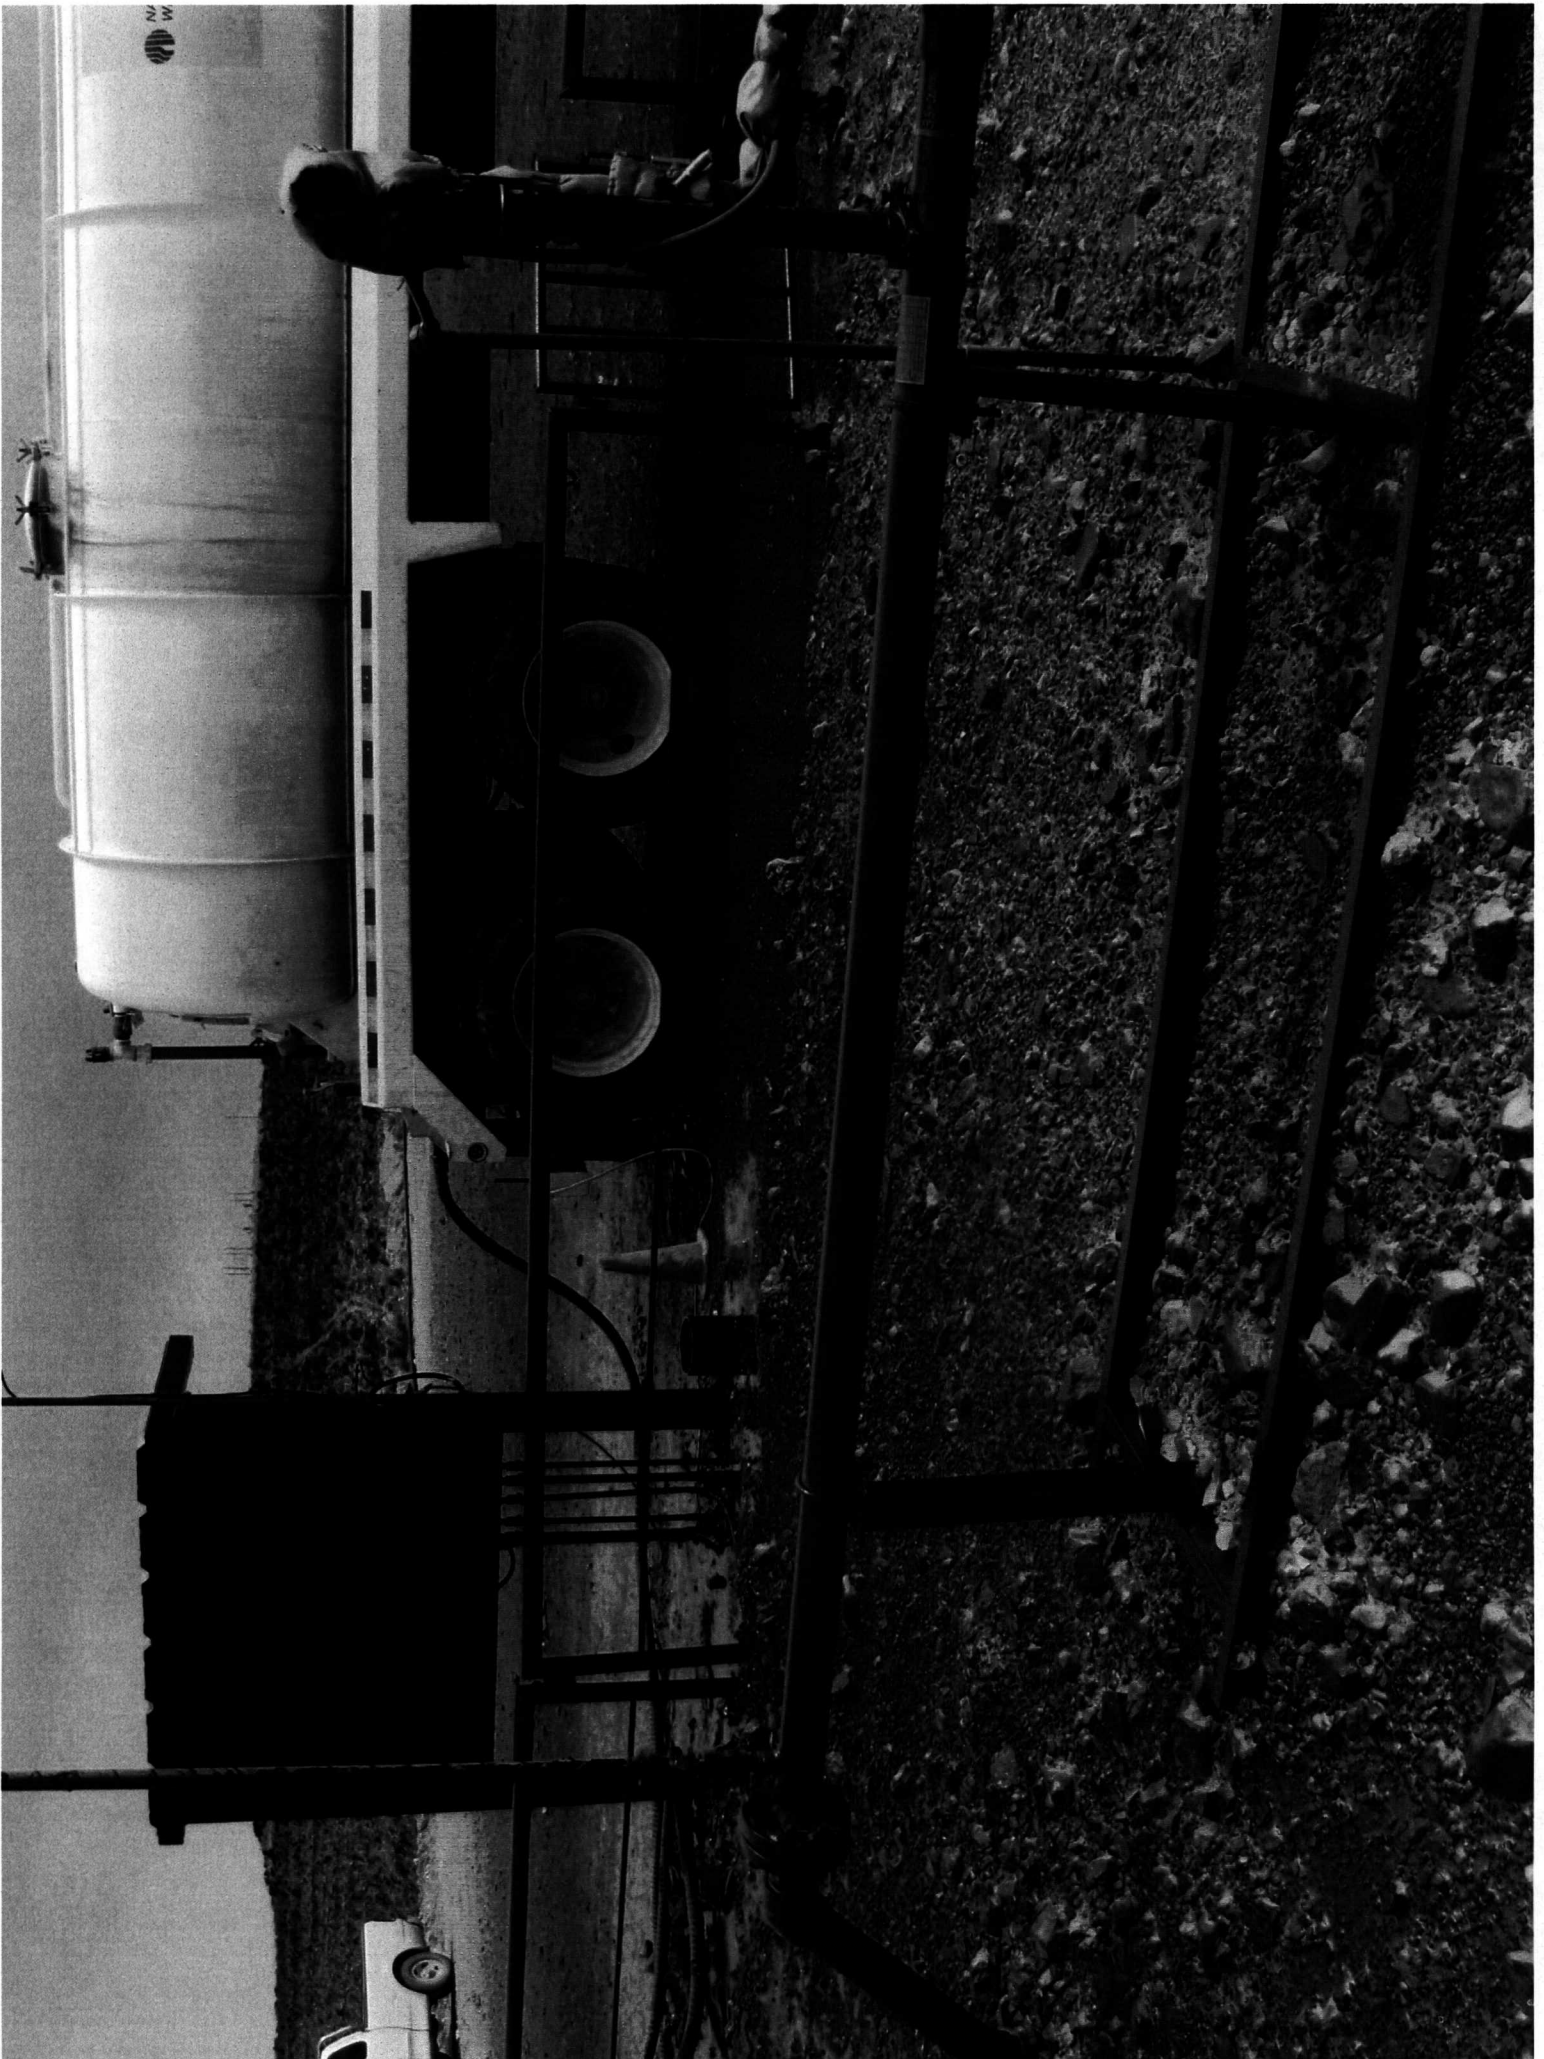
Project Correspondence Sheet

Date:	Time:	Project Manager:
Project Number:		
Project Name: <i>Right Hand Canyon 35-2</i>		
Topic:		
Notes:		
<p>The diagram is a hand-drawn sketch on a grid background. It depicts a 'Flow Path' that starts from the top, moves down, and then curves to the left. Along this path, there are five points labeled SP-3, SP-5, SP-4, SP-2, and SP-1. SP-3 is on the left side of the path, SP-5 is at the top, SP-4 is on the right side, SP-2 is on the left side, and SP-1 is in the center. A 'Spill Area' is indicated by a large, irregular oval shape that encompasses the lower part of the flow path and the area around SP-1 and SP-2. Within this spill area, there are two rectangular boxes labeled 'Separator'. To the right of the spill area, there is a vertical line labeled 'Gate'. A north arrow is drawn in the upper right quadrant, pointing towards the top right.</p>		
Document must be filed in Project File	Prepared by:	Page ____ of ____
