Pit, Below-Grade Tank, or Proposed Alternative Method Permit or Closure Plan Application

1.
Operator: BP America Production Company OGRID #: 778
Address: 200 Energy Court, Farmington, NM 87401
Facility or well name: Gallegos Canyon Unit 137E
API Number: 3004526194 OCD Permit Number:
U/L or Qtr/Qtr M Section 36 Township 28N Range 13W County: San Juan
Center of Proposed Design: Latitude 36.61467 Longitude -108.17693 NAD: ☐ 1927 ☒ 1983
Surface Owner: ☒ Federal ☐ State ☐ Private ☐ Tribal Trust or Indian Allotment

BELOW-GRADE TANK CLOSURE PLAN

Gallegos Canyon Unit 137E
API No. 3004526194
Unit Letter M, Section 36, T28N, R13W

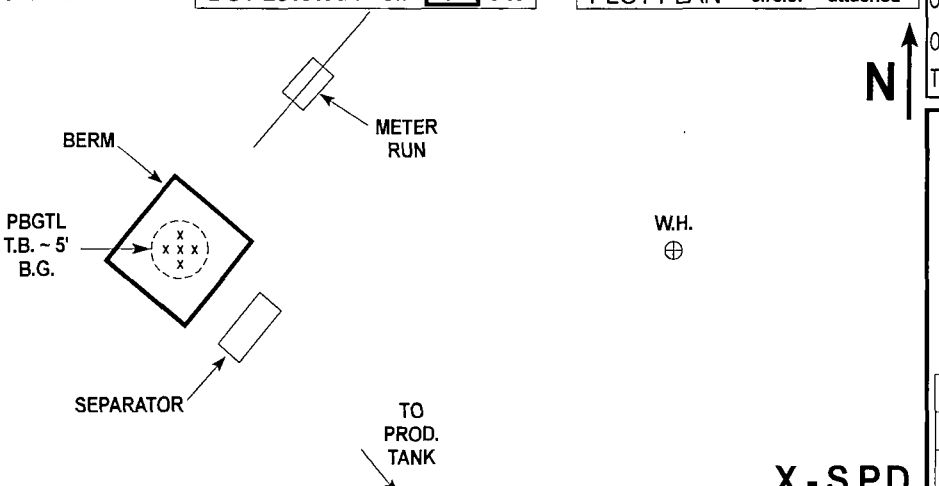
PLOT PLAN circle: attached

DISCOLORATION/STAINING OBSERVED: YES / NO EXPLANATION - FROM PREVIOUS CLOSURE ACTIVITY IN MARCH 2003 (LT. GRAY TO BLACK)

APPARENT EVIDENCE OF A RELEASE OBSERVED AND/OR OCCURRED : YES / NO EXPLANATION:

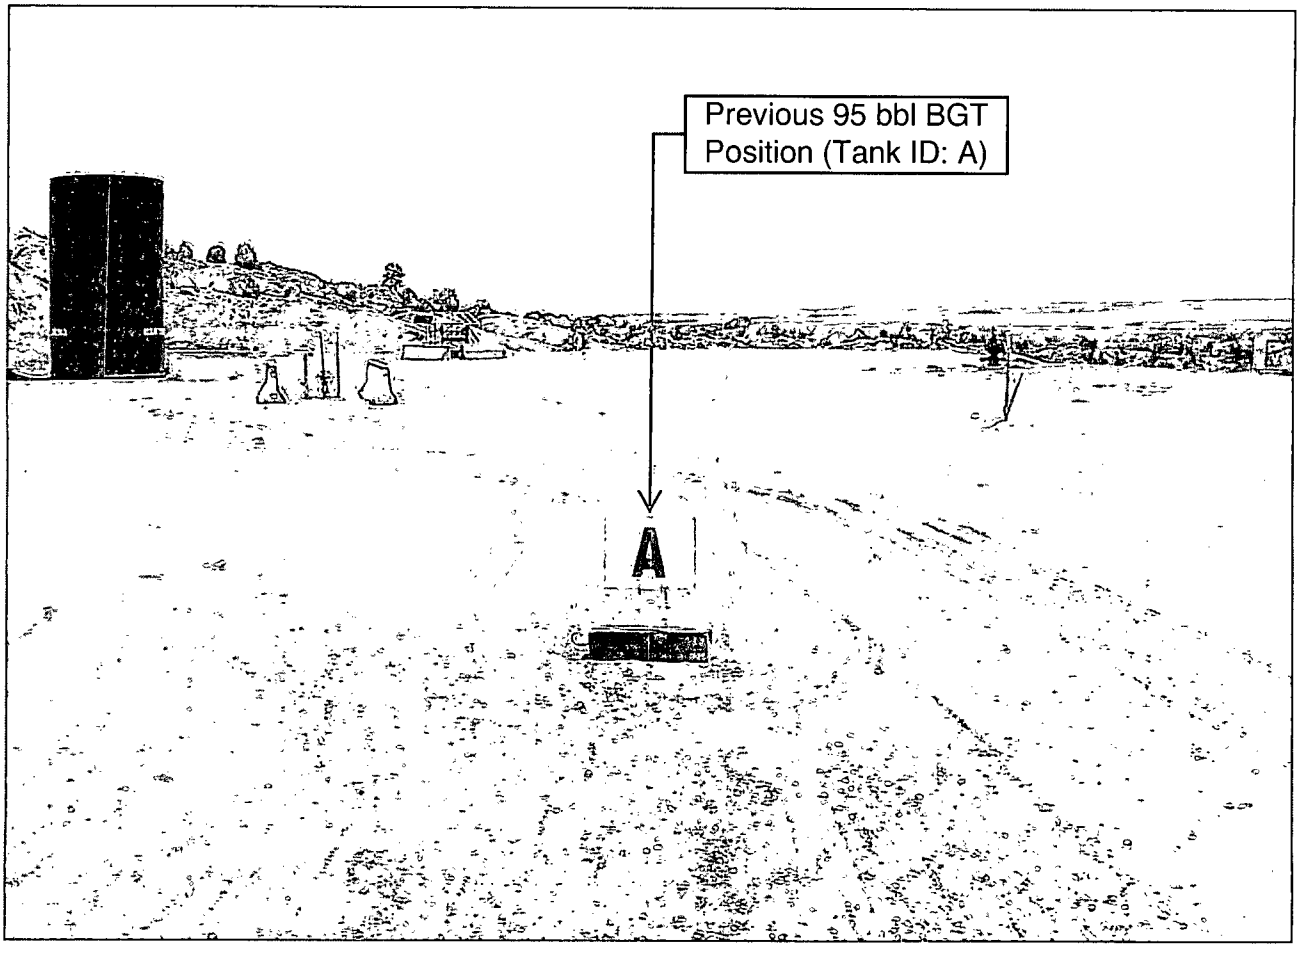
Previous 95 bbl BGT
Position (Tank ID: A)
A

9. If the sampling demonstrates that a release has not occurred or that any release does not exceed the concentrations specified above, then BP shall backfill the excavation, with compacted, non-waste containing, earthen material; construct a division-prescribed soil cover, re-contour and re-vegetate the location. The location will be reclaimed if it is not with in the active process area
The area under the BGT was backfilled with clean soil and is still within the active well area.
