WORKPLANS

E INFORMATIO		
REPO	RT TYPE:	: Invest	igation & Charac	cterization F	Plan
		Report	Date: September 20	0, 2007	
General Site Info			80		
Site:			Jnit Tract 11 Tank Batt	ery	
Company:		Celero Energy	y II LP		
Section, Townshi	ip and Range		Township 13S	Range 31E	
Unit Letter:		G			
Lease Number:					
County:		Chaves County			
GPS:		N33.16250°	W103.78889°		
Surface Owner:		State			
Mineral Owner:	!	State

Proximity Sketch of CAPROCK QUEEN UNIT MONITOR WELLS

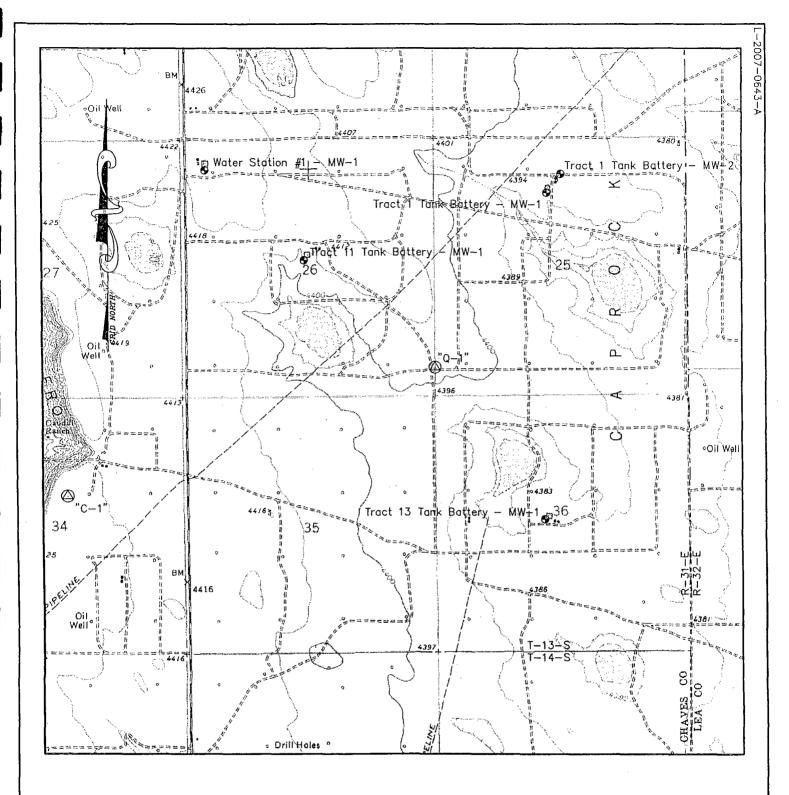
● - Denotes Monitor Well

Located in Sections 25, 26 and 36 Township 13 South, Range 31 East, N.M.P.M. Chaves County, New Mexico SECTION 26, TOWNSHIP 13 SOUTH, RANGE 31 EAST, N.M.P.M.

Neither the New Mexico State Engineer's Office database nor the USGS database show any wells in Section 26, Township 13 South, Range 31 East. The monitor well installed at this site had a depth to groundwater of 138'. A risk-based evaluation was performed for the Site in accordance with the New Mexico Oil Conservation Division (NMOCD) Guidelines for Remediation of Leaks, Spills and Releases, dated August 13, 1993. The guidelines require a risk-based evaluation of the site to determine recommended remedial action levels (RRAL) for benzene, toluene, ethylbenzene and xylene (collectively referred to as BTEX) and total petroleum hydrocarbons (TPH) in soil. The proposed RRAL for benzene was determined to be 10 parts per million (ppm) or milligrams per kilogram (mg/kg) and 50 ppm for total BTEX (sum of benzene, toluene, ethylbenzene, and xylene). Based upon the depth to groundwater, the proposed RRAL for TPH is 5,000 mg/kg.

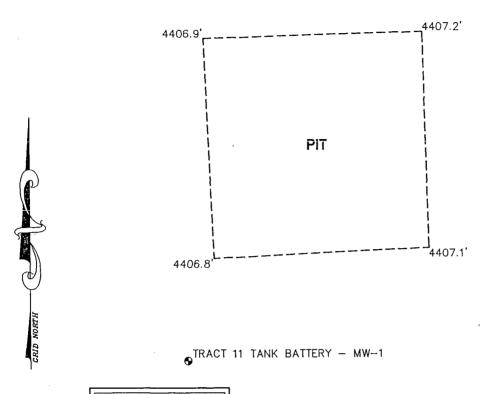
TANK BATTERY	11 - W-1					
NORTHING (Y)	EASTING (X)	LATITUDE	LONGITUDE	TOP OF CASING		ELEVATION NATURAL GROUND
786,730.7	665,646.0	33'09'41.73" N	103'47'31.38" W	4,407.42	4,404.28	4,404.0

Date Surveyed: June 11, 2007 Weather: Warm & Clear
