Pit, Below-Grade Tank, or Proposed Alternative Method Permit or Closure Plan Application

Facility or well name: Sellers Federal LS 2M JUN 09 2014

BELOW-GRADE TANK CLOSURE PLAN

Sellers Federal LS 2M BGT Tank B (18 bbl)
API No. 3004529080
Unit Letter O, Section 30, T30N, R10W

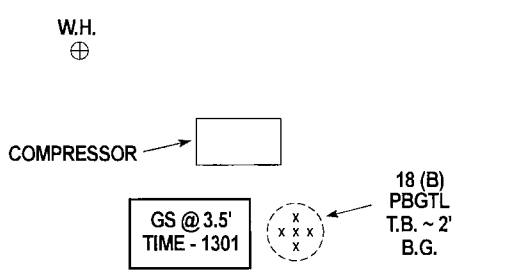
SITE SKETCH

DISCOLORATION/STAINING OBSERVED: YES / NO EXPLANATION - BENEATH 18 BGT & 95 BGT (2 - 4 INCHES IN THICKNESS).

APPARENT EVIDENCE OF A RELEASE OBSERVED AND/OR OCCURRED : YES / NO EXPLANATION : NOT FROM BGT LOST INTEGRITY; OVERFLOW(S)?

TANK ID: (D) - SIDEWALLS NOT VISIBLE.
