Pit, Below-Grade Tank, or
Proposed Alternative Method Permit or Closure Plan Application

Facility or well name: Riddle F LS 3A

BELOW-GRADE TANK CLOSURE PLAN

Riddle F LS 3A
API No. 3004523697
Unit Letter F, Section 20, T28N, R8W

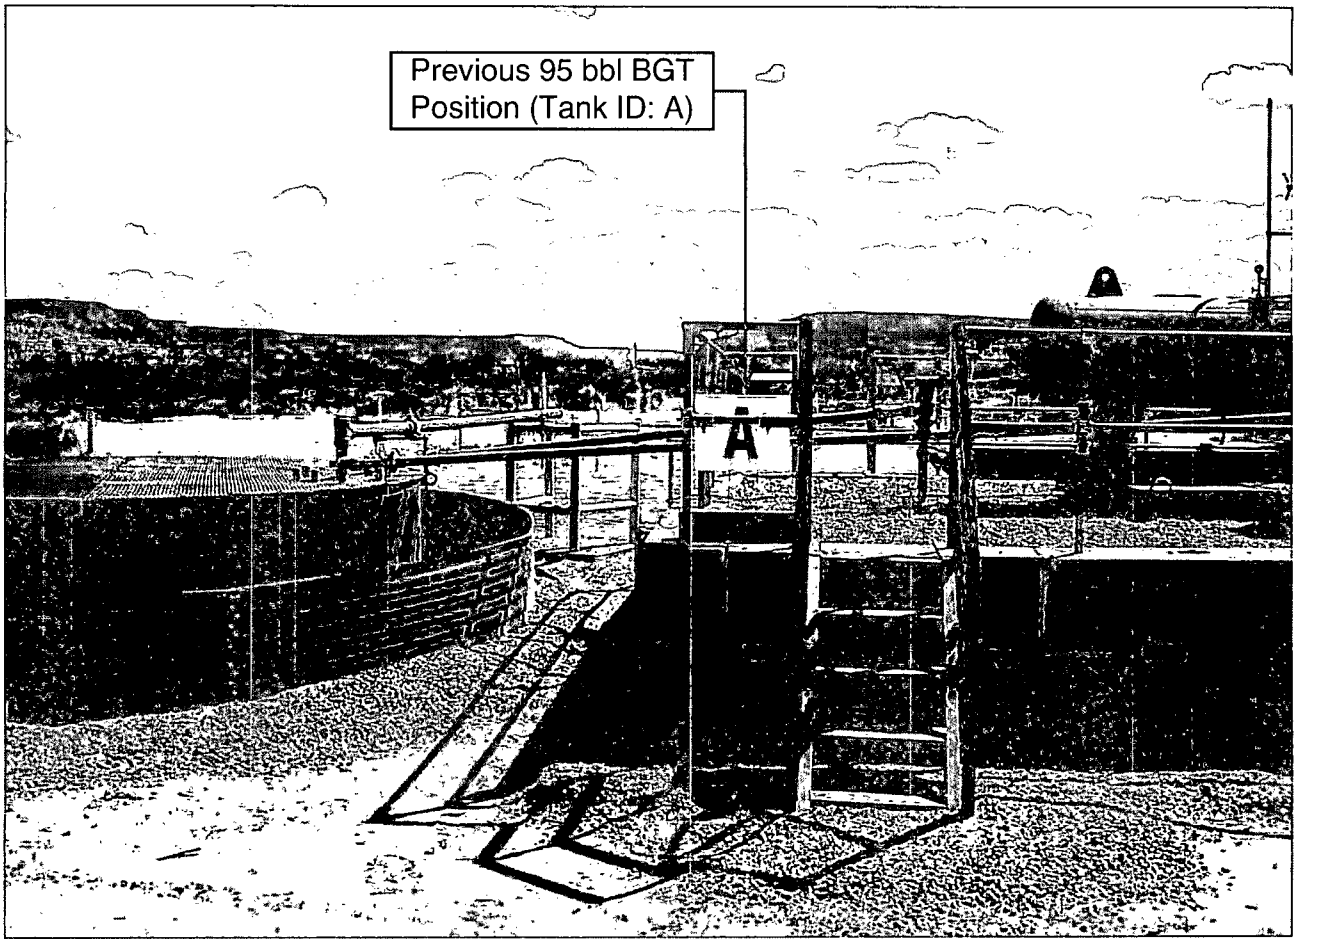
Previous 95 bbl BGT
Position (Tank ID: A)
A

9. If the sampling demonstrates that a release has not occurred or that any release does not exceed the concentrations specified above, then BP shall backfill the excavation, with compacted, non-waste containing, earthen material; construct a division-prescribed soil cover, re-contour and re-vegetate the location. The location will be reclaimed if it is not with in the active process area
The area under the BGT was backfilled with clean soil and is still within the active area.
