CORE DATA EXHIBITS

BEFORE THE
OIL CONSERVATION COMMISSION
Santa Fe, New Mexico
Case No. ^{8946 8950} ~~9113~~ ⁹¹¹⁴ Exhibit No. 2
Submitted by Mobil
Hearing Date 3-30-87

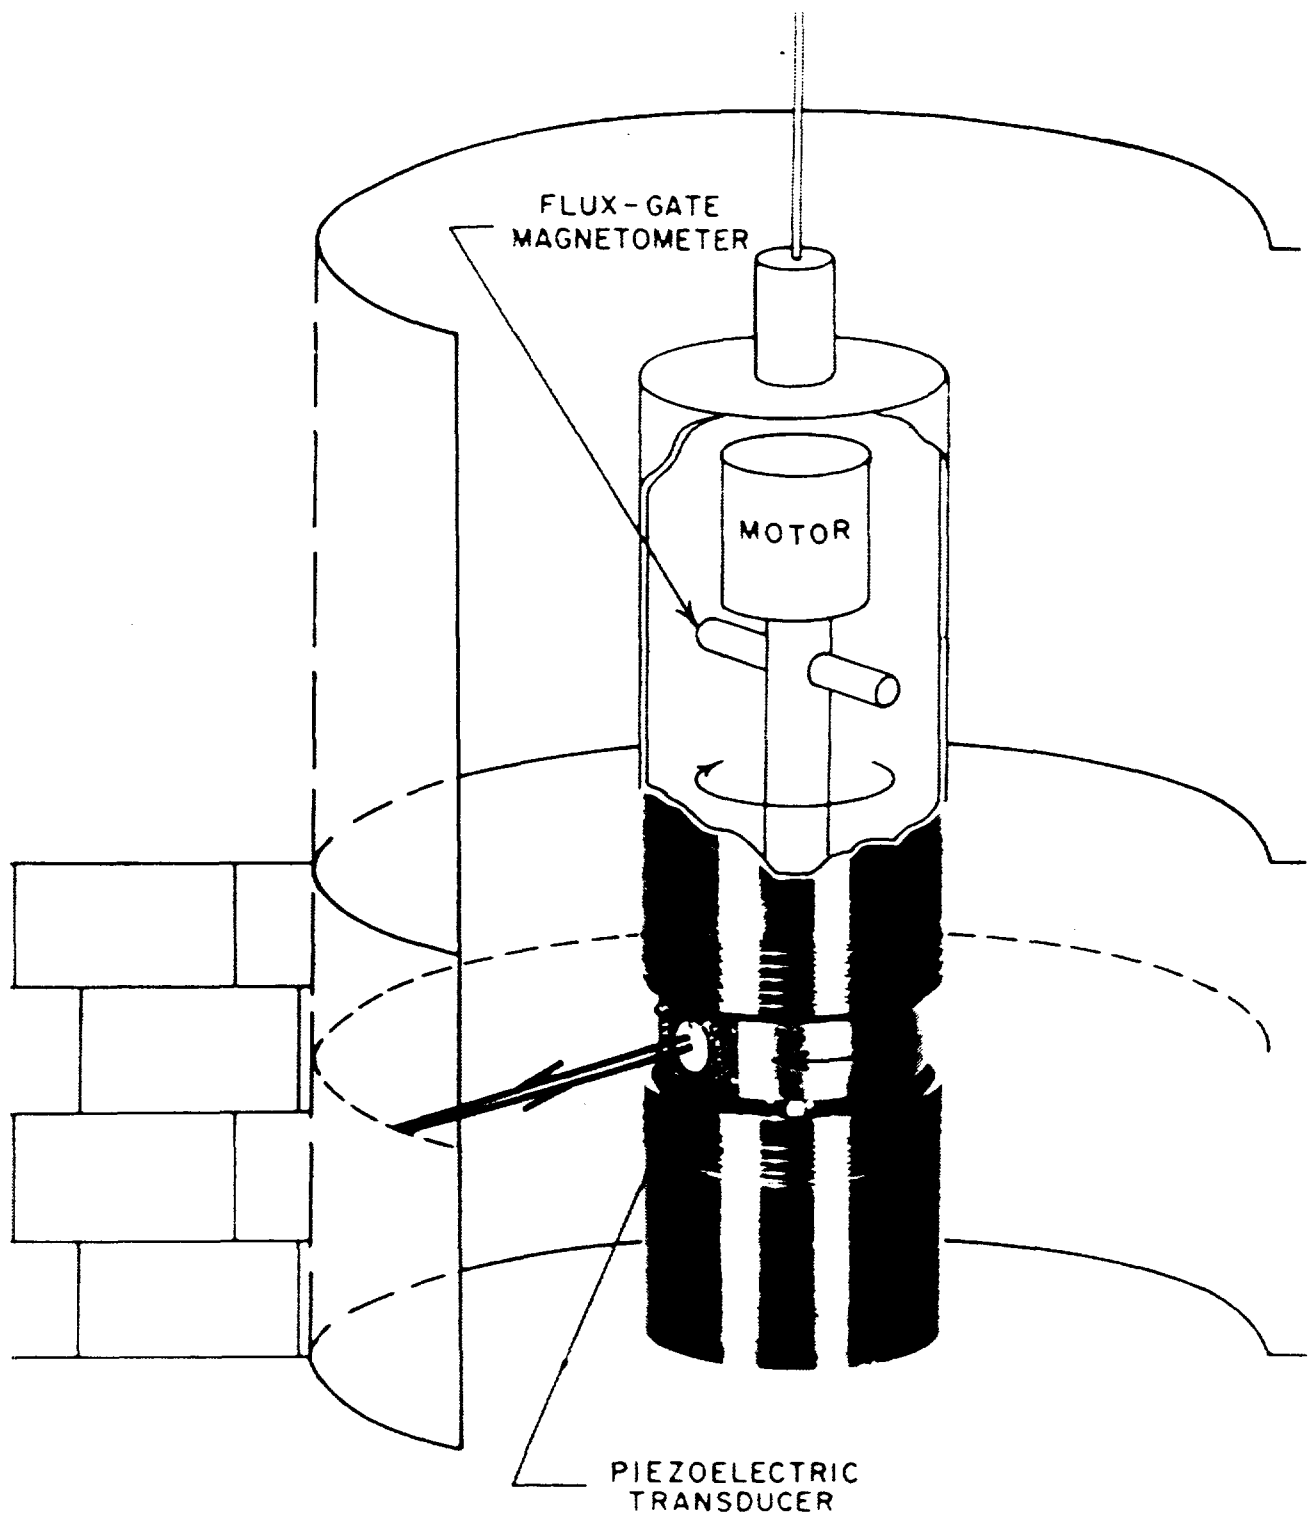
Fig. 1 Schematic of Basic Televiewer Elements (From; Zemanek, J., et. al., 1970, Formation Evaluation by Inspection with the Borehole Televiewer; Geophysics, v. 35, no. 2, p. 255, fig. 1.)

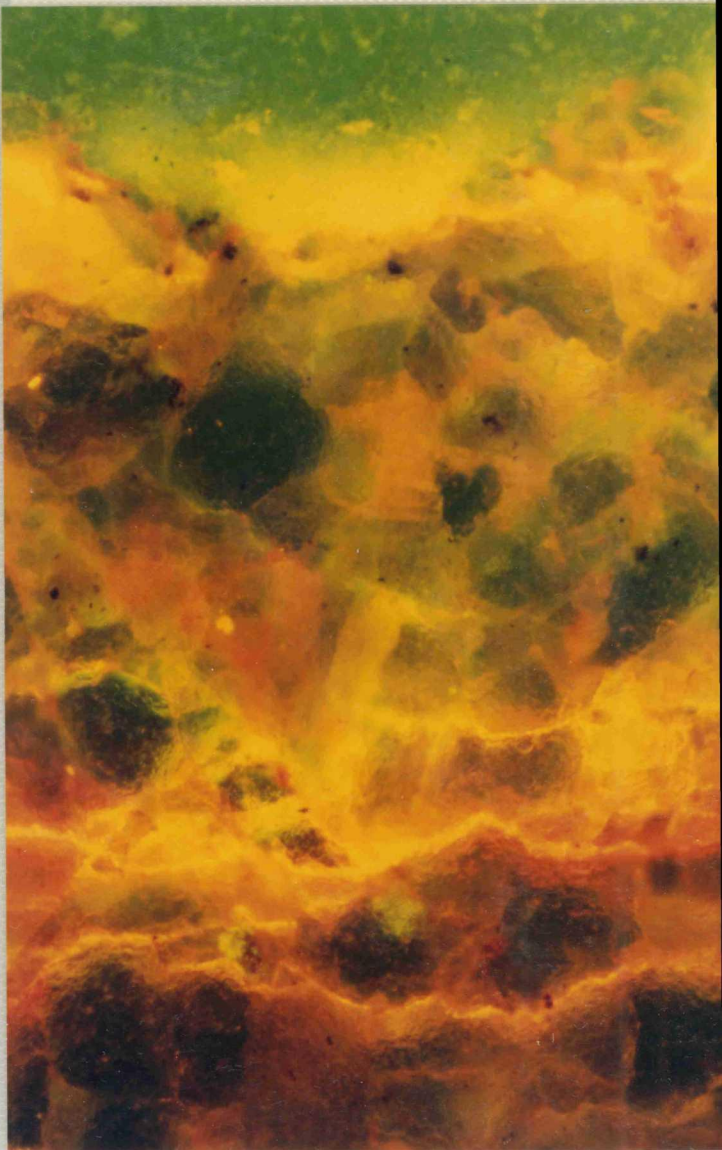
Photo 3A

- Mobil - Lindrith B Unit
No. 38 Core
- B Zone - 6709.4
- Fluorescence photomicro-
graph approx. 300X
- Major vertical fracture face (left)
and associated micro-fracturing
and intergranular porosity.

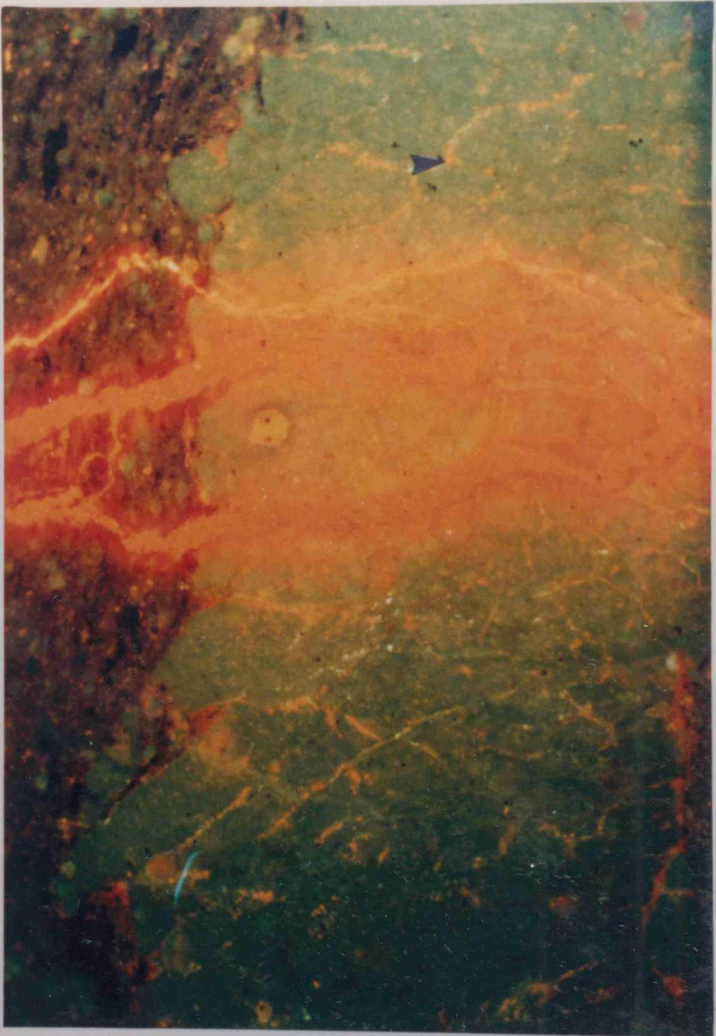
Photo 6

- Mallon Oil - Davis Fed. 3-15 core.
- B Zone - 7167' (7161 log depth)
- Terratek Sample 7167, photo C
- approx. 100X
- "Blue-violet fluorescence photomicrograph of vertical fracture porosity transecting both muddy and grain supported portions of laminated rock. Note minor amounts of porosity separating transported grains from calcareous cement (arrows)."

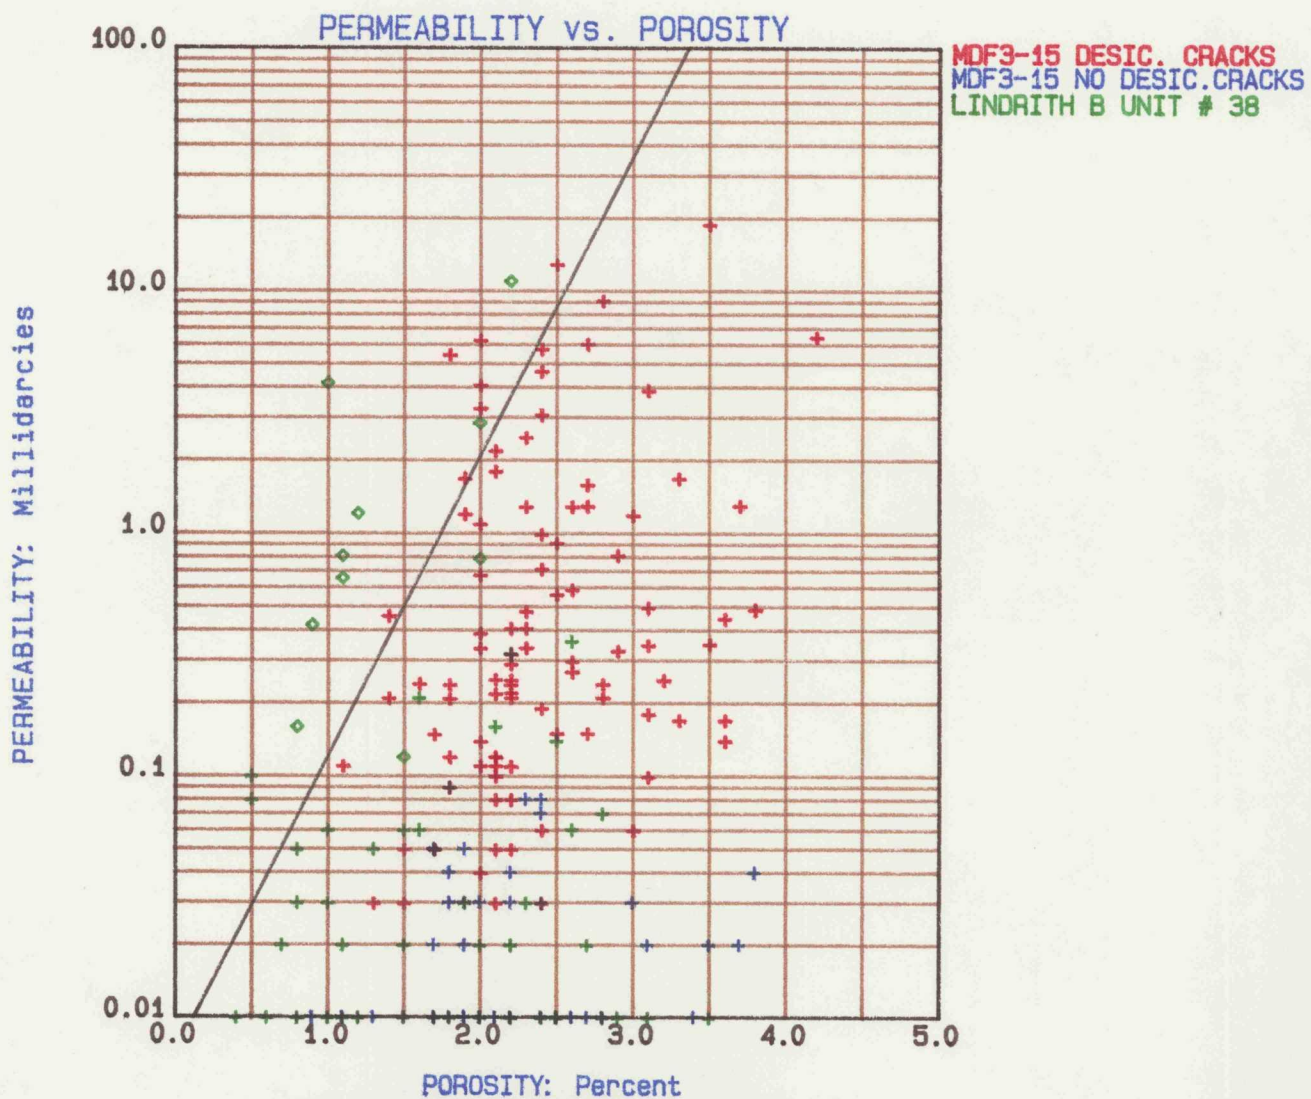
GAVILAN CORES GALLUP FORMATION
DIAMONDS = FRACTURE PERMEABILITY IN
LINDRITH B-38. LEFT OF LINE DENOTES
FRACTURE PERM AREA OF LINDRITH B-38 CORE
