Pit, Below-Grade Tank, or
12322 Proposed Alternative Method Permit or Closure Plan Application

1.
Operator: BP America Production Company OGRID #: 778
Address: 200 Energy Court, Farmington, NM 87401
Facility or well name: Sammons Gas Com C 1E
API Number: 3004524282 OCD Permit Number:
U/L or Qtr/Qtr P Section 7 Township 29N Range 9W County: San Juan
Center of Proposed Design: Latitude 36.73315 Longitude -107.81370 NAD: ☐1927 ☒1983 Surface
Owner: ☐ Federal ☐ State ☒ Private ☐ Tribal Trust or Indian Allotment

BELOW-GRADE TANK CLOSURE PLAN

Sammons Gas Com C 1E
API No. 3004524282
Unit Letter P, Section 7, T29N, R9W

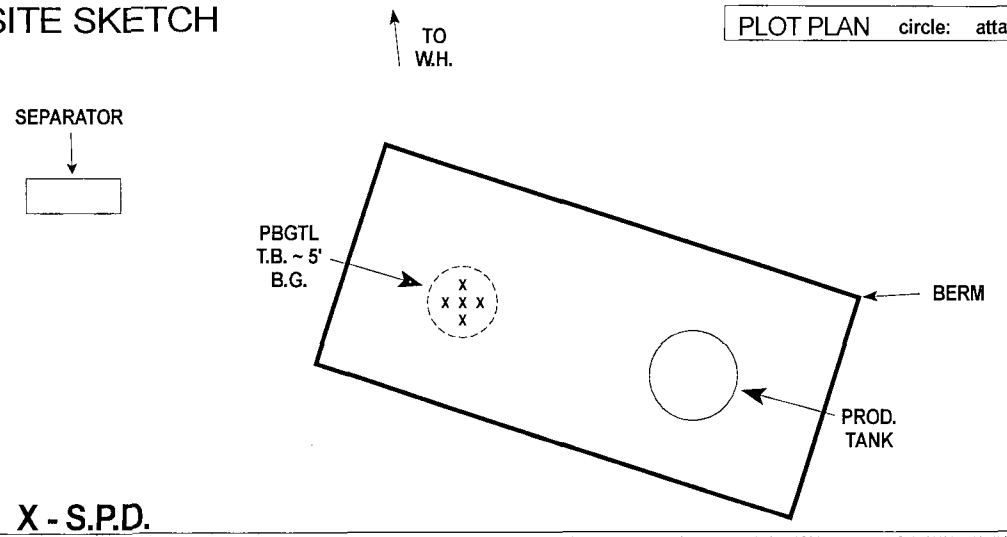
SITE SKETCH

DISCOLORATION/STAINING OBSERVED: YES / [NO] EXPLANATION -

APPARENT EVIDENCE OF A RELEASE OBSERVED AND/OR OCCURRED : YES / [NO] EXPLANATION :

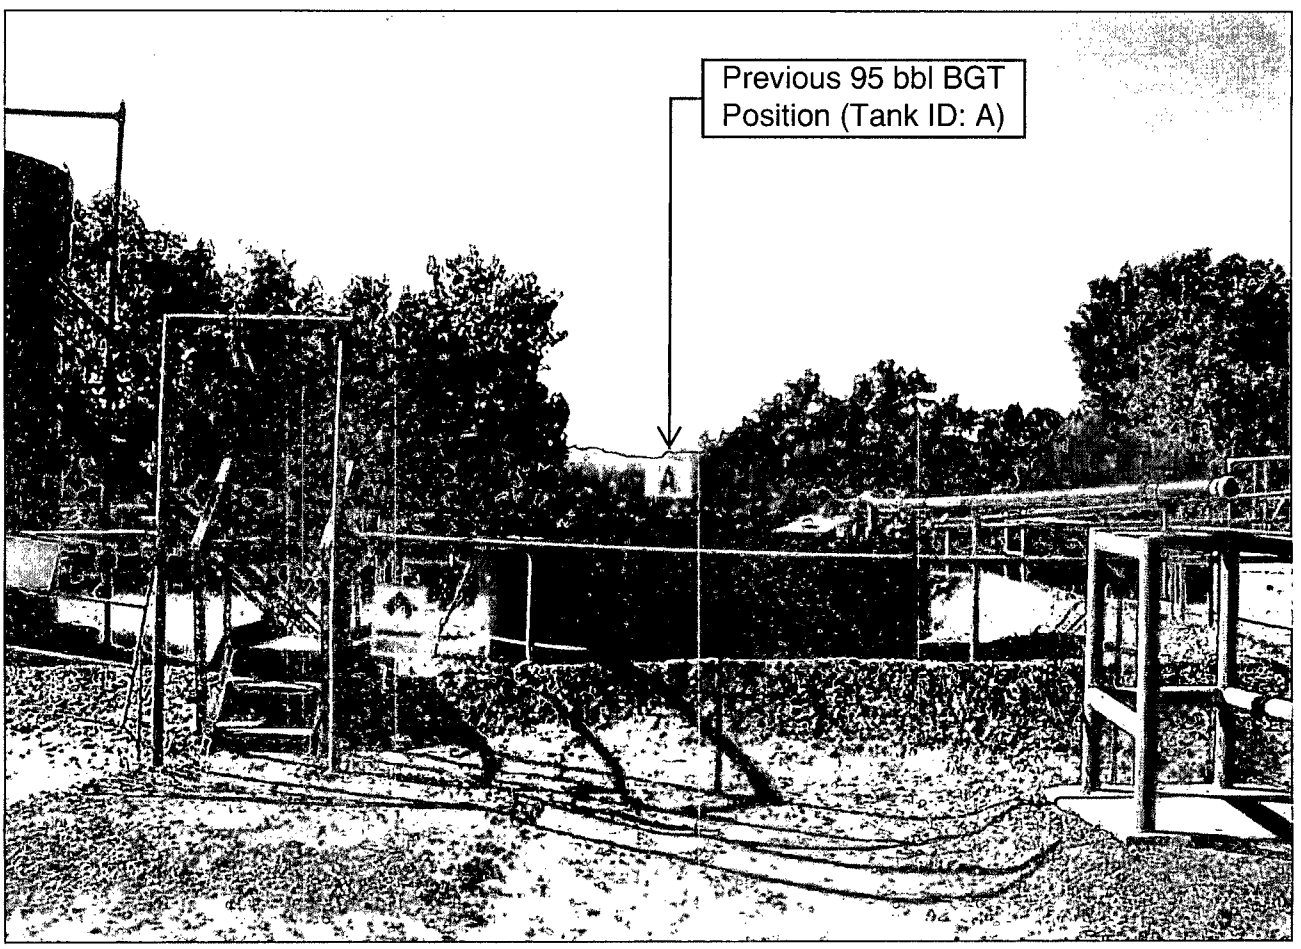
Previous 95 bbl BGT
Position (Tank ID: A)
A

9. If the sampling demonstrates that a release has not occurred or that any release does not exceed the concentrations specified above, then BP shall backfill the excavation, with compacted, non-waste containing, earthen material; construct a division-prescribed soil cover, re-contour and re-vegetate the location. The location will be reclaimed if it is not with in the active process area
The area under the BGT was backfilled with clean soil and is still within the active well area.
