## Ojo Chiso Federal No. 003

### **WORK PLAN**

Unit Letter M, Section 26, Township 22 South, Range 34 East

RE: BTA Oil Producers, LLC - Ojo Chiso Federal #003 - Remediation Work Plan

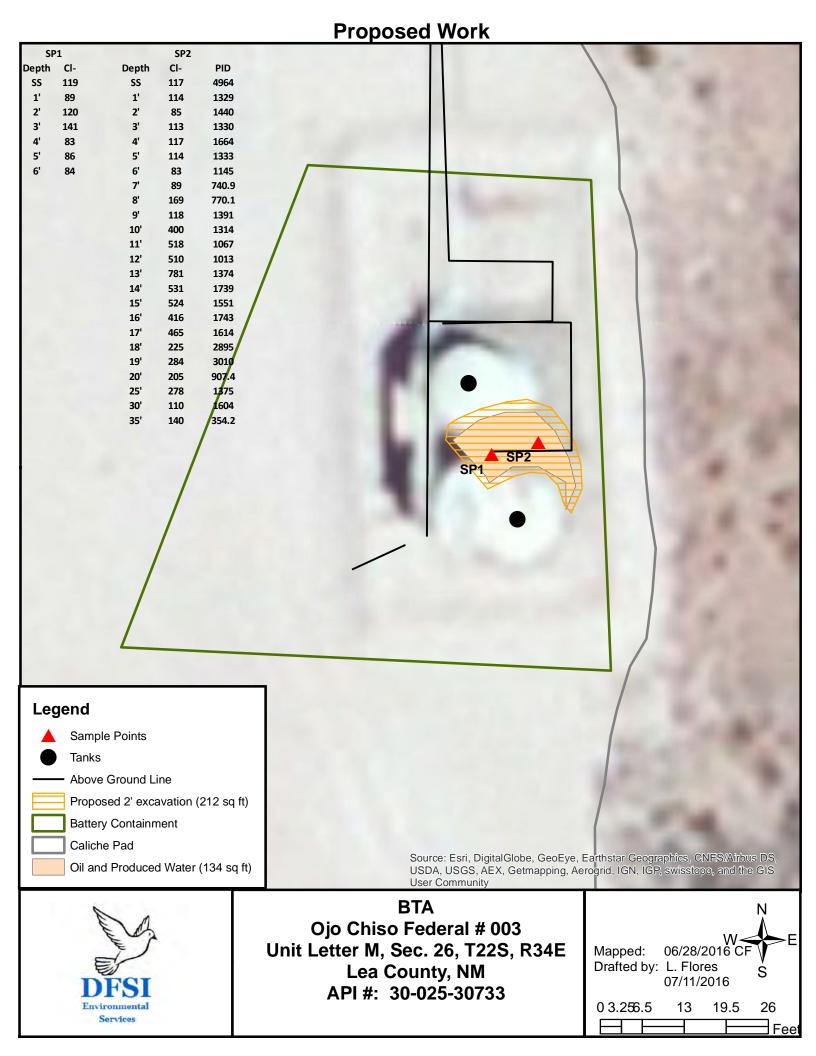
Soil Delineation SP1 SP2 Depth PID CI-Depth CI-4964 119 117 SS SS 1' 1' 1329 89 114 2' 120 85 1440 3' 141 113 1330 4' 1664 83 4' 117 114 5' 86 5' 1333 6' 84 83 1145 740.9 89 169 770.1 118 1391 10' 400 1314 11' 518 1067 12' 510 1013 13' 781 1374 14' 531 1739 15' 524 1551 16' 416 1743 465 17' 1614 225 2895 18' 19' 284 3010 20' 205 907.4 25' 278 1375 110 1604 30' 35' 140 354.2 SP2 Legend Sample Points Tanks Above Ground Line **Battery Containment** Caliche Pad Source: Esri, DigitalGlobe, GeoEye, Earthstar Geographics, CNES/Airbus DS, Oil and Produced Water (134 sq ft) USDA, USGS, AEX, Getmapping, Aerogrid, IGN, IGP, swisstopo, and the GIS **User Community BTA** Ojo Chiso Federal # 003 W**<** 06/28/2016 CF Unit Letter M, Sec. 26, T22S, R34E Mapped: Drafted by: L. Flores Lea County, NM 07/11/2016 API #: 30-025-30733 0 3.256.5 13 19.5 26 Services F<u>ee</u>

On June 28, 2016 DFSI personnel were on site to obtain samples within the leak area (Figure 1). Two samples were obtained and field sampled for chloride levels, as well as BTEX. The BTEX samples were performed using a Mini Rae Photoionization Detector (PID).

In order to maintain tank integrity, the release area around SP1 and SP2 will be excavated to a depth of 2' bgs. The excavation will be backfill with clean, imported soil to ground surface and contoured to the surrounding area. Seeding of the site is not warranted. Due to safety hazards, the battery will be addressed at time of abandonment.
