**Re: Delineation Plan for Paladin Energy Corporation, East Caprock SWD and Posey A 5 Spill, Unit O (SW/4, SE/4), Section 11, Township 12 South, Range 32 East, Lea County, New Mexico**

This plan is submitted to the New Mexico Oil Conservation Division (OCD) District 1 for delineating the vertical and lateral extent of spills at the Paladin Energy Corporation (Paladin) East Caprock salt water disposal (SWD) and Posey A 5 tank battery (Site). The Site is located in Unit O (SW/4, SE/4), Section 11, Township 12 South, Range 32 East in Lea County, New Mexico. On March 28, 2017, Paladin received notice from OCD that a field inspector visited the Site on February 23, 2017, and observed spills around equipment and tanks at the East Caprock SWD and at the separator located near the southeast corner of the Posey A 5 battery (API No. 30-025-00102). The spill at the East Caprock SWD was caused by a leak at the injection pump that flowed east and north around the tanks. The leak at the Posey A 5 battery was caused by a hole in the separator. The spill at the Posey A 5 battery flowed south along the east side of the lease road for about 300 feet. The geodetic position is 33° 17' 22.811" North a

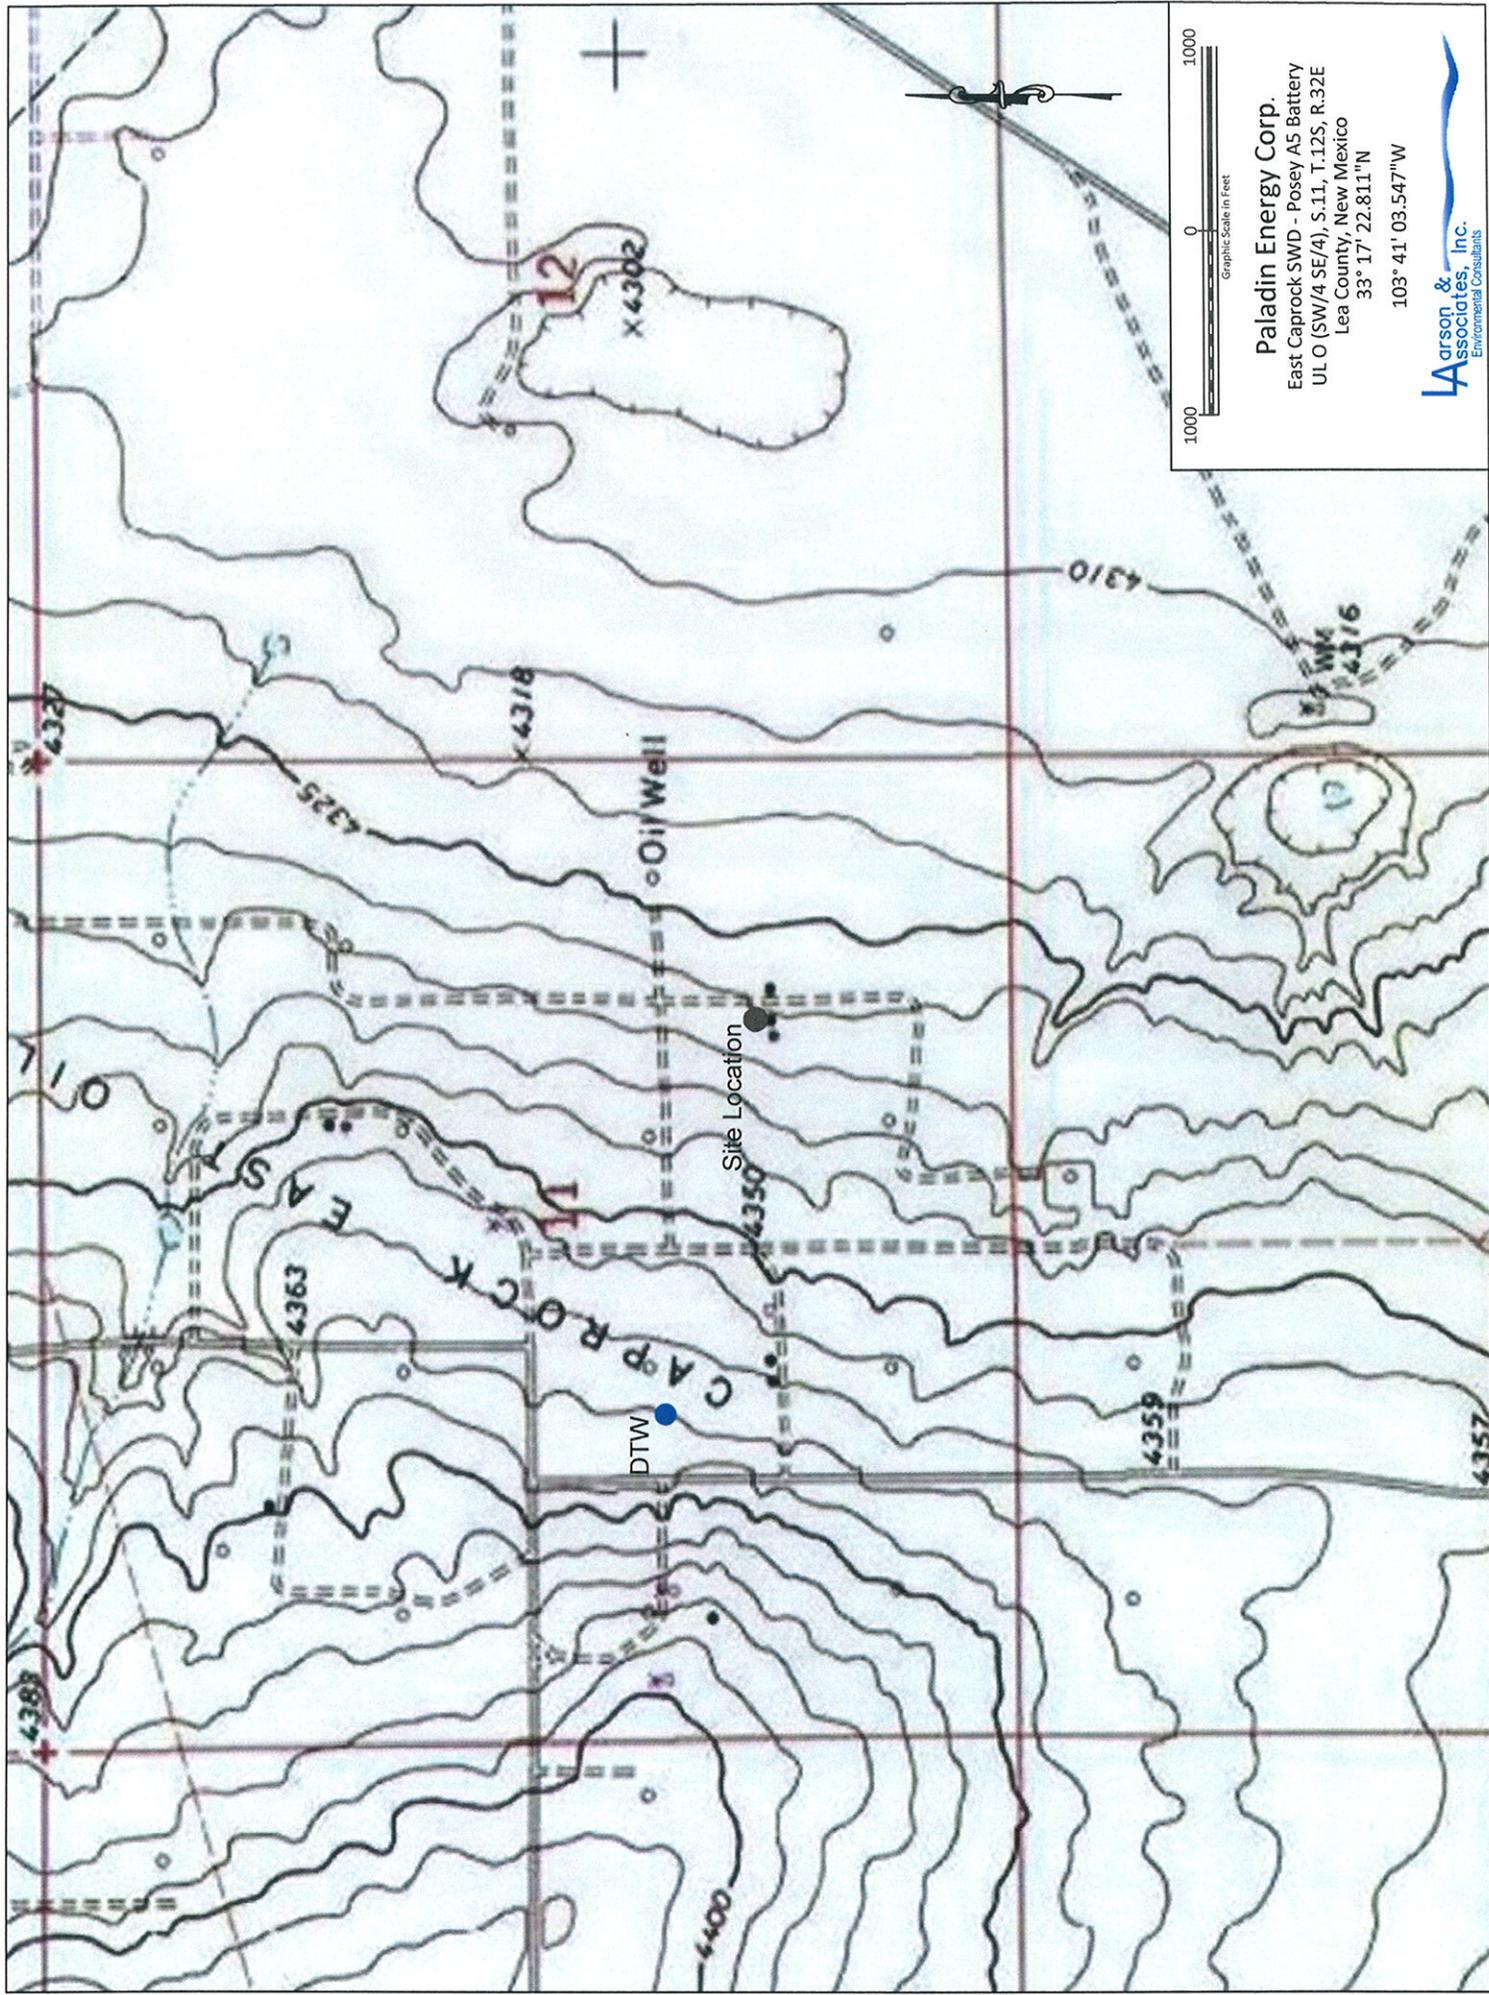
Figure 1 - Topographic Map

Paladin Energy Corp.  
 East Caprock SWD - Posey A5 Battery  
 UL O (SW/4 SE/4), S.11, T.12S, R.32E  
 Lea County, New Mexico  
 33° 17' 22.811"N  
 103° 41' 03.547"W

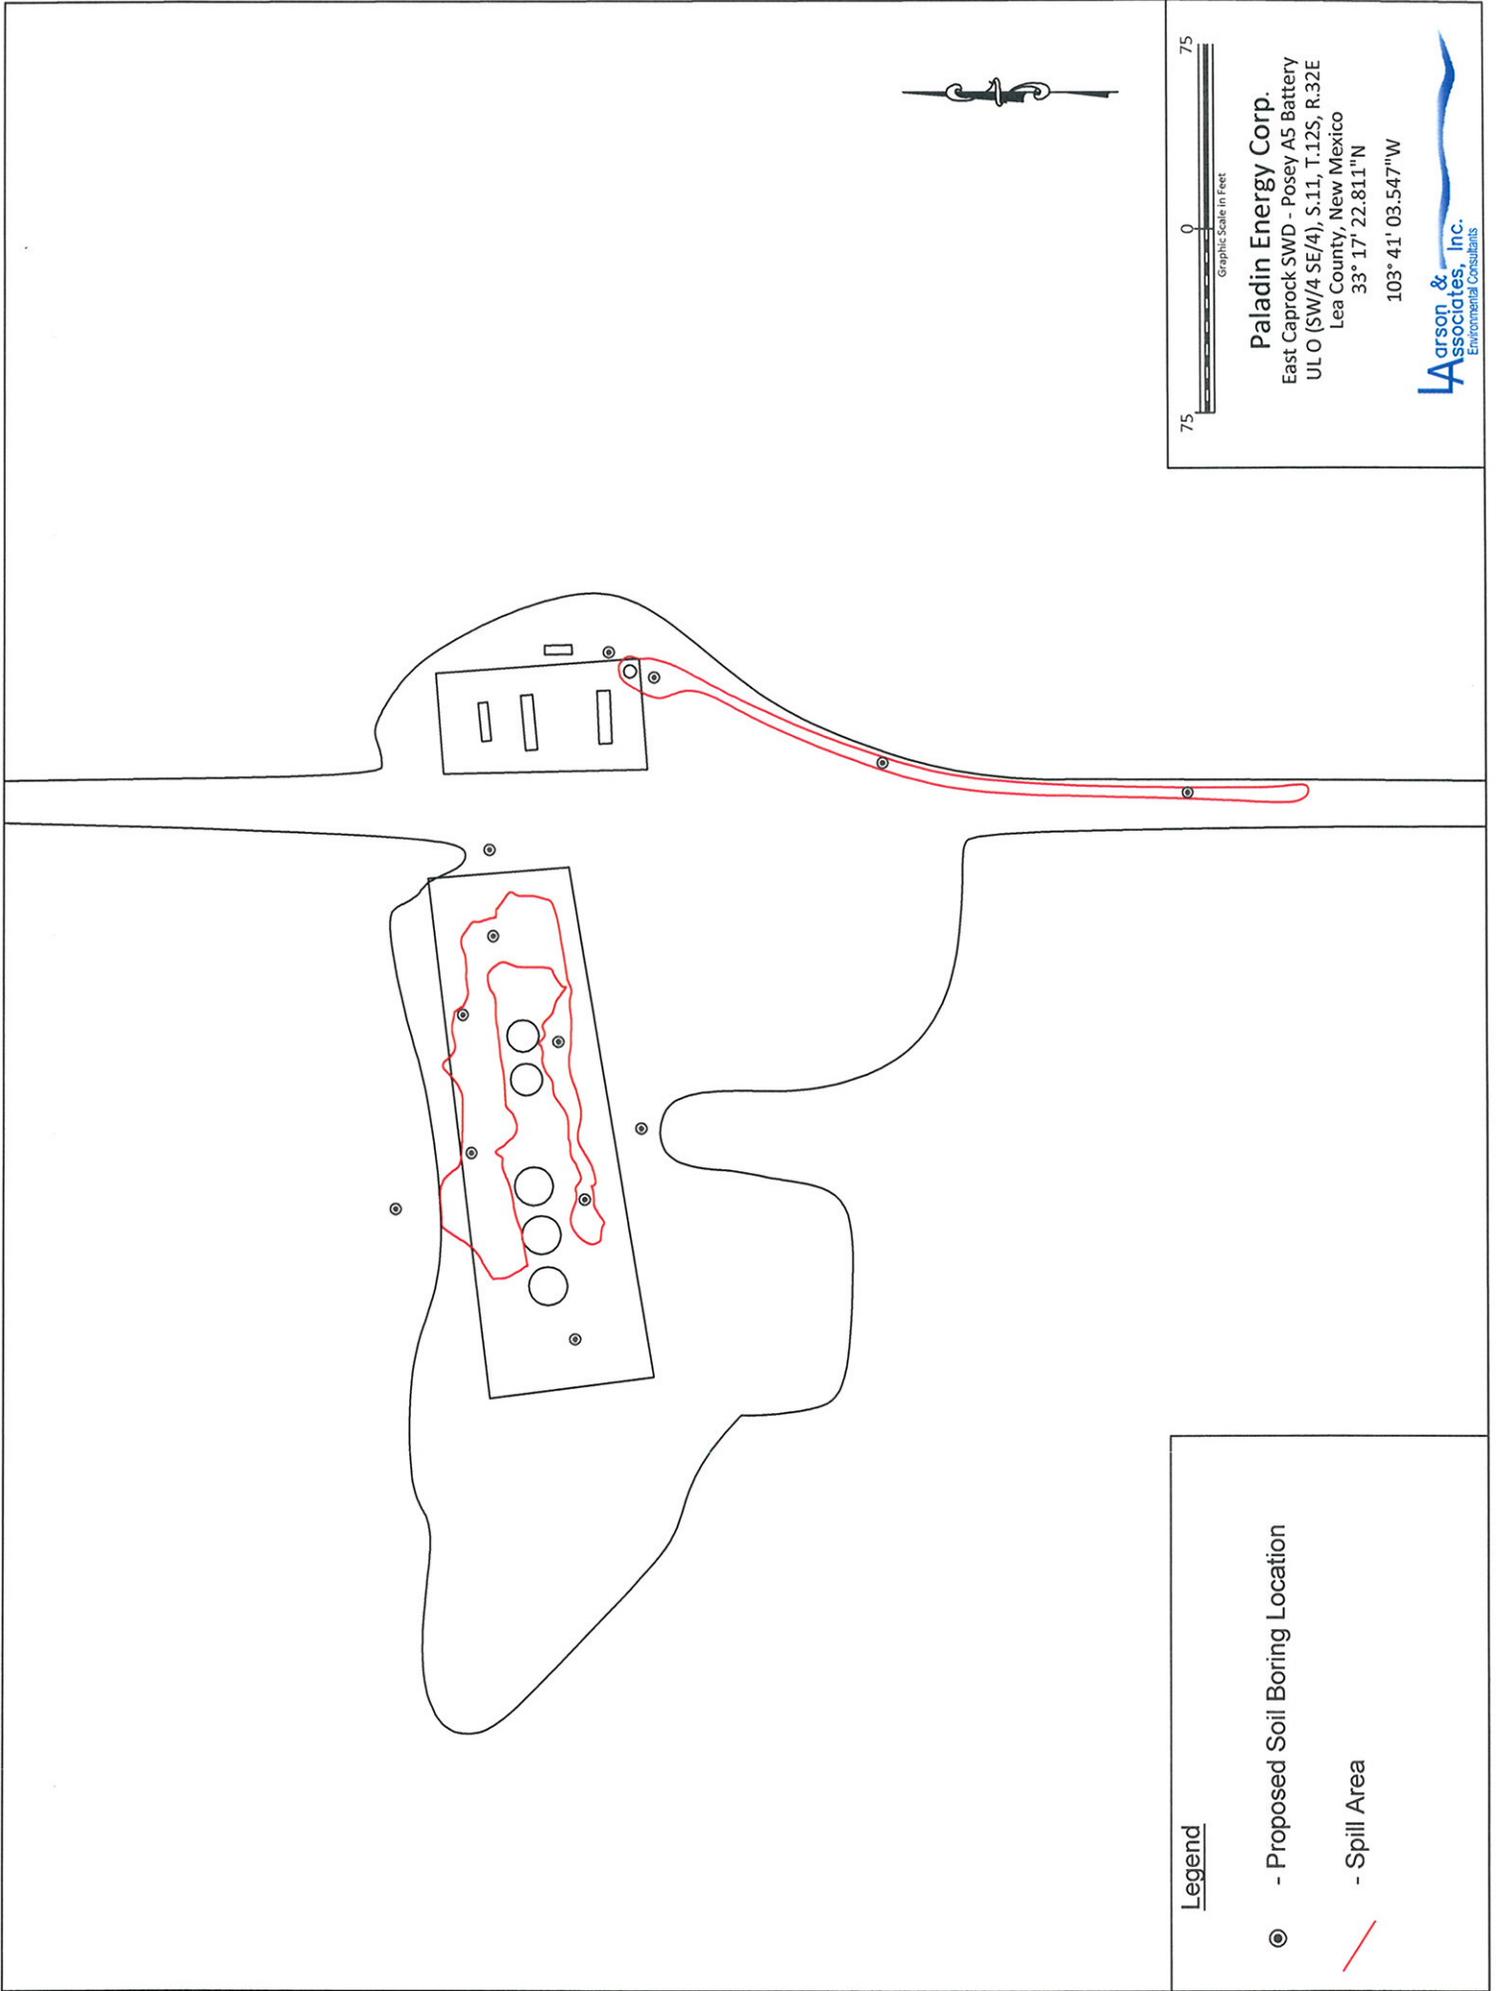
Figure 3 - Site Map and Proposed Soil Boring Locations

- - Proposed Soil Boring Location
- - Spill Area

Paladin proposes to delineate the horizontal and vertical extent of the spills by collecting and analyzing soil samples from approximately 13 locations. An air rotary rig will be used to drill soil borings with discrete soil samples collected with a jam tube sampler every 5 feet (i.e., 0, 5, 10, 15, etc.) between about 15 and 25 feet below ground surface (bgs) depending on subsurface conditions. The soil samples will be submitted under preservation and chain of custody to qualified laboratory and analyzed for benzene, toluene, ethylbenzene and xylenes (BTEX) by EPA SW-846 Method 8021B, total petroleum hydrocarbons (TPH) by EPA SW-846 Method 8015 including gasoline range organics (GRO) and diesel range organics (DRO) and oil range organics (ORO) and chloride by EPA Method 300.1. The laboratory results will be compared to the recommended remediation action levels (RRAL) calculated from OCD guidance and compiled into a report for submittal to the OCD. The report will include scaled drawings showing the Site layout, spill areas and sample locations, boring logs, laboratory analysis and remediation plan. Figure 3 presents a Site drawing and proposed sample locations.
