# Pit, Below-Grade Tank, or
12348 Proposed Alternative Method Permit or Closure Plan Application

1.
Operator: BP America Production Company OGRID #: 778
Address: 200 Energy Court, Farmington, NM 87401
Facility or well name: Cornell B 1
API Number: 3004508414 OCD Permit Number:
U/L or Qtr/Qtr D Section 14 Township 29N Range 12W County: San Juan
Center of Proposed Design: Latitude 36.73141 Longitude -108.07341 NAD: ☐ 1927 ☒ 1983
Surface Owner: ☐ Federal ☐ State ☒ Private ☐ Tribal Trust or Indian Allotment

# CORNELL B # 1

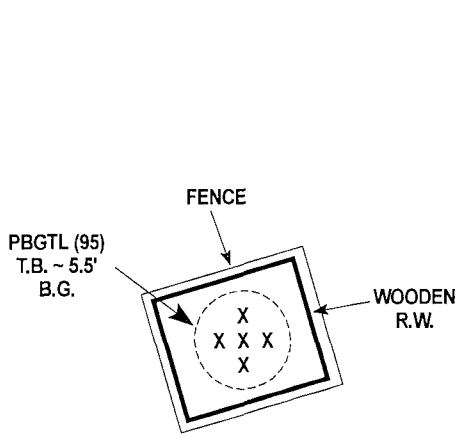
## SITE SKETCH

DISCOLORATION/STAINING OBSERVED: [YES] / NO EXPLANATION - MEDIUM LIGHT TO MEDIUM DARK GRAY WITHIN BEDROCK SURFACE ONLY.
