Pit, Below-Grade Tank, or
12345 Proposed Alternative Method Permit or Closure Plan Application

Facility or well name: Lobato Gas Com A 1A

BELOW-GRADE TANK CLOSURE PLAN

Lobato Gas Com A 1A
API No. 3004522280
Unit Letter D, Section 3, T29N, R9W

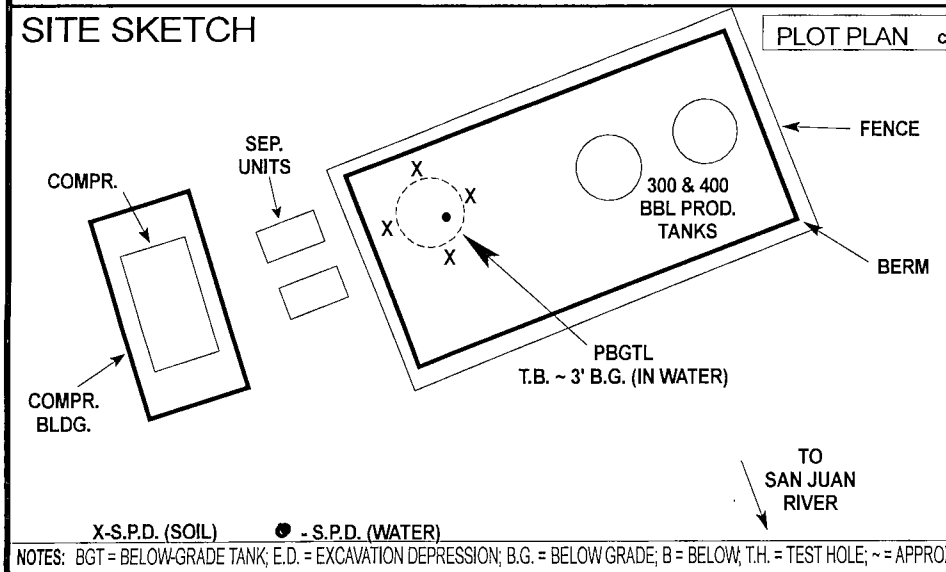
SITE SKETCH

DISCOLORATION/STAINING OBSERVED: YES / NO EXPLANATION - MED. GRAY BETWEEN 1.5' - 3' BELOW GRADE @ WEST SIEDWALL & BETWEEN. 2' - 3' @ SOUTH SIDEWALL.

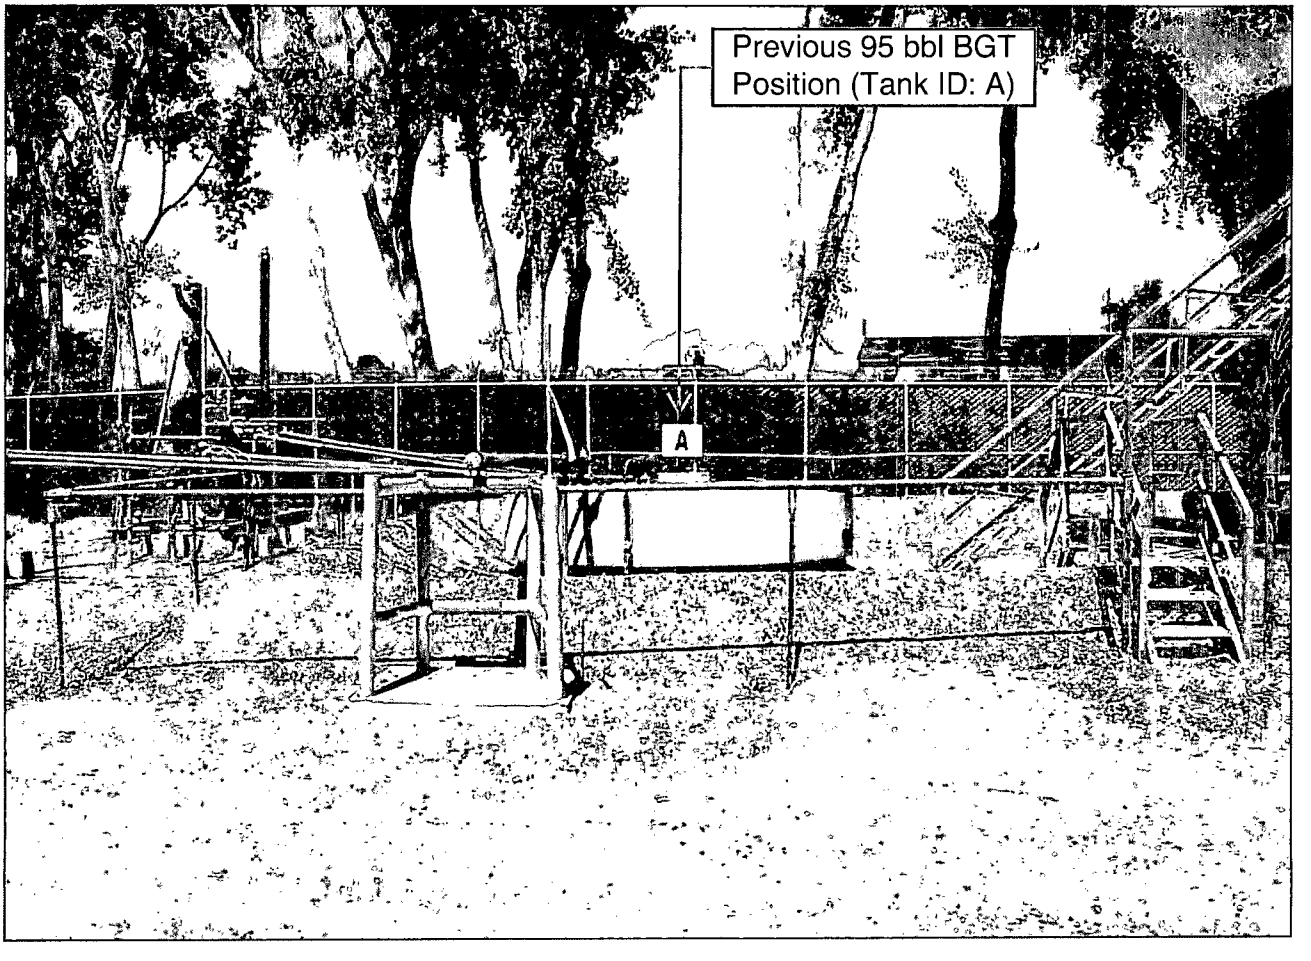
Previous 95 bbl BGT
Position (Tank ID: A)
A
