| | Confirmation "Sidewall" Sample Location | <br>Site & Sample Location Map<br>Plain's Pipeline, L.P.<br>Alpha Crude Lynch Station<br>Lea County, NM | Drafted By: JL | | Checked By: CS | |

TABLE 1  
CONCENTRATIONS OF BENZENE, BTEX, TPH, AND CHLORIDE IN SOIL  
ALPHA CRUDE LYNCH STATION  
PLAINS PIPELINE, L.P.  
LEA COUNTY, NM  
PLAINS SRS NUMBER 2017-102

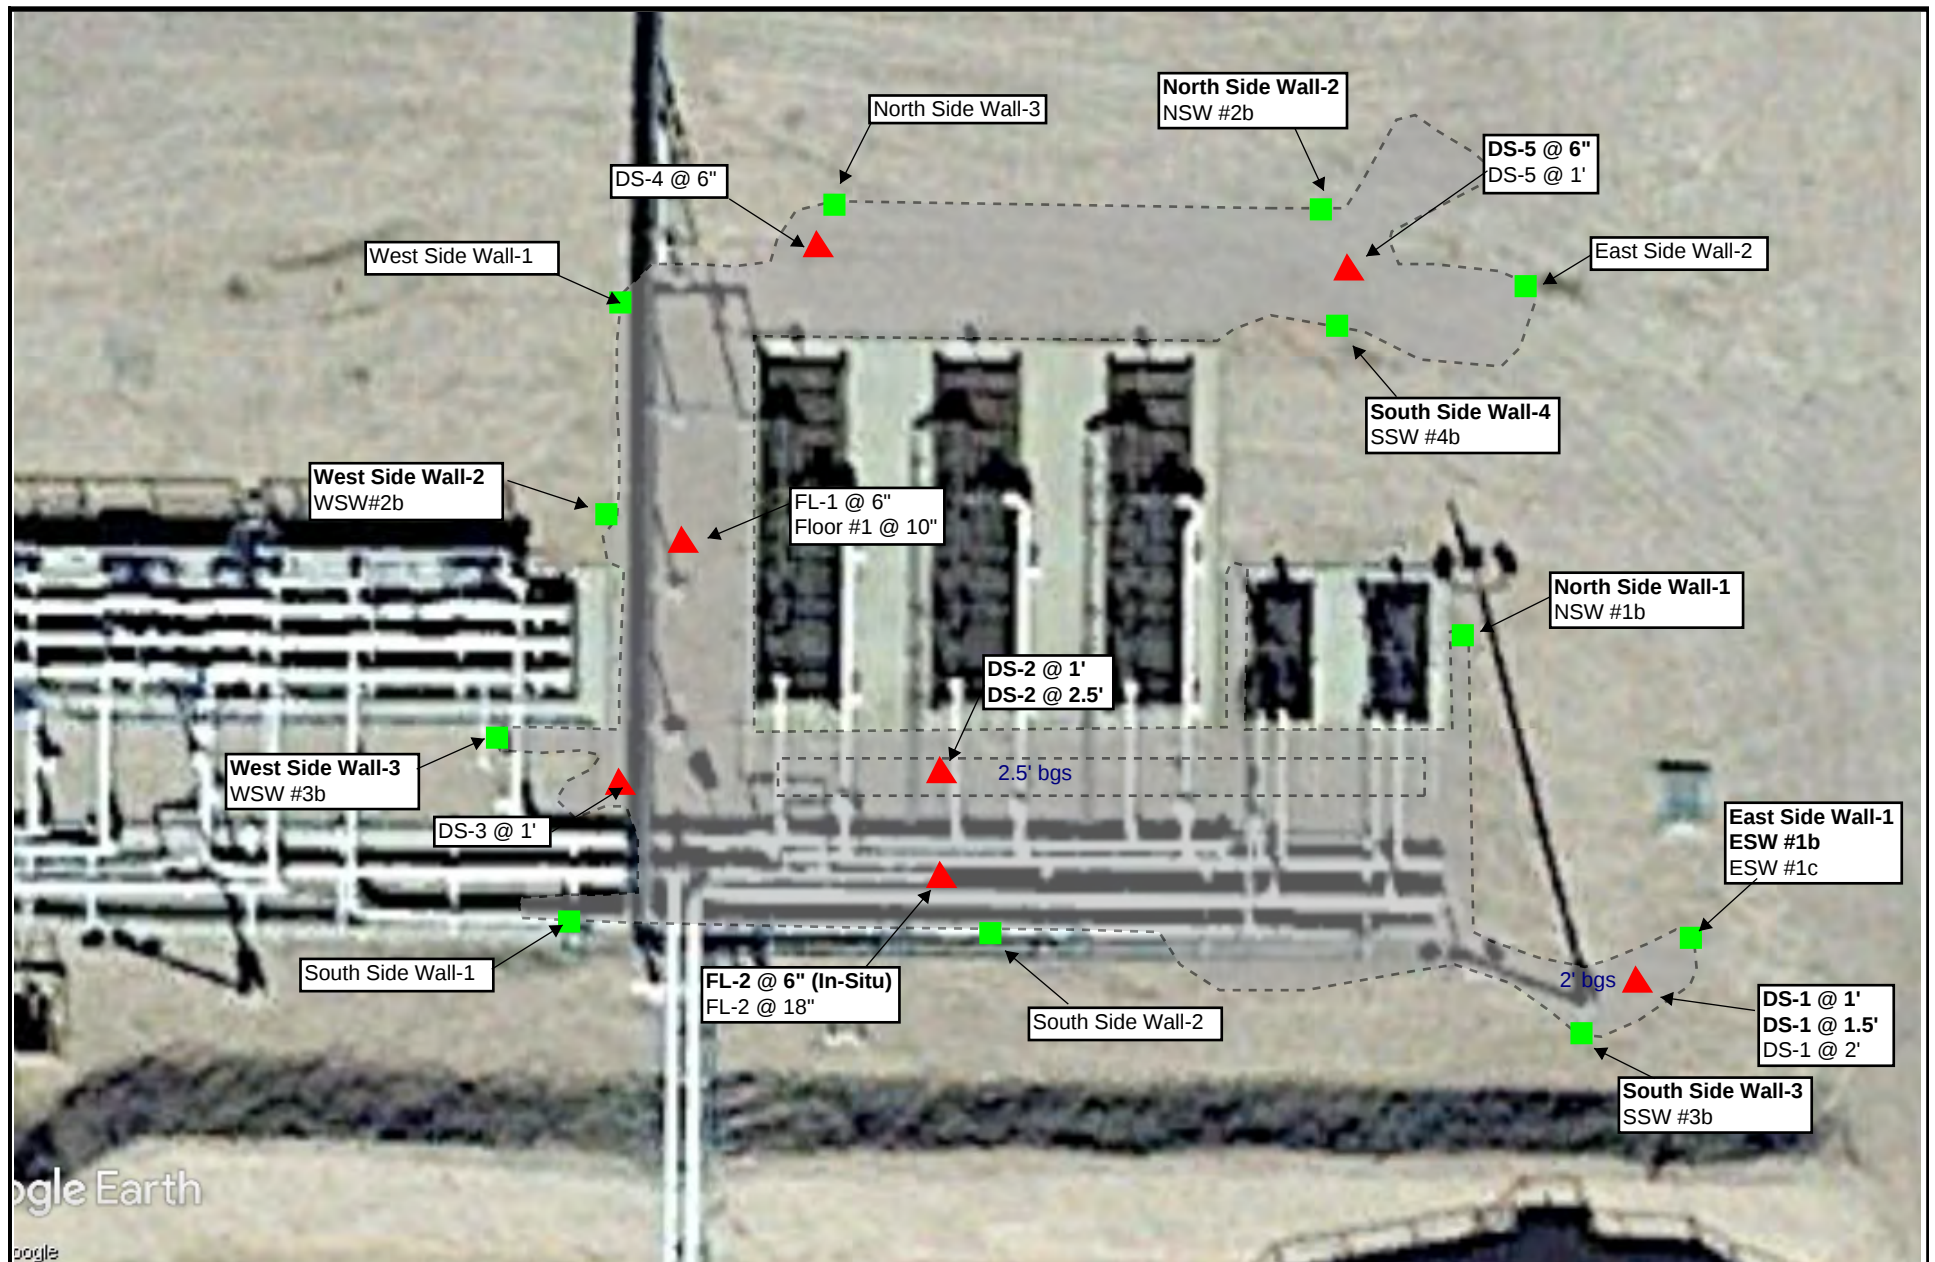
| | Confirmation "Floor" Sample Location | | Draft: July 24, 2017 | | | |
| | Excavated Area | | Lat. N 32.521555 Long. W103.524896 | | | |
