Pit, Below-Grade Tank, or
Proposed Alternative Method Permit or Closure Plan Application

1.
Operator: BP America Production Company OGRID #: 778
Address: 200 Energy Court, Farmington, NM 87401
Facility or well name: Davis 1
API Number: 3004526798 OCD Permit Number:
U/L or Qtr/Qtr E Section 23 Township 32N Range 11W County: San Juan
Center of Proposed Design: Latitude 36.973378 Longitude -107.964051 NAD: ☐ 1927 ☒ 1983
Surface Owner: ☐ Federal ☐ State ☒ Private ☐ Tribal Trust or Indian Allotment

BELOW-GRADE TANK CLOSURE PLAN

Davis 1
API No. 3004526798
Unit Letter E, Section 23, T32N, R11W

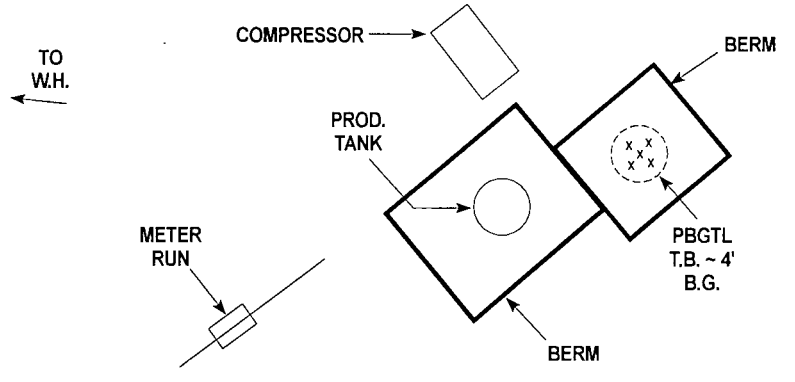
PLOT PLAN circle: attached

DISCOLORATION/STAINING OBSERVED: YES / NO EXPLANATION - STAINING @ BGT FOOT PRINT & 1' THICK BETWEEN 4.5' - 5.5 FT. B.G.

APPARENT EVIDENCE OF A RELEASE OBSERVED AND/OR OCCURRED : YES / NO EXPLANATION: MINOR STAINING @ BGT FOOT PRINT - 4' B.G.

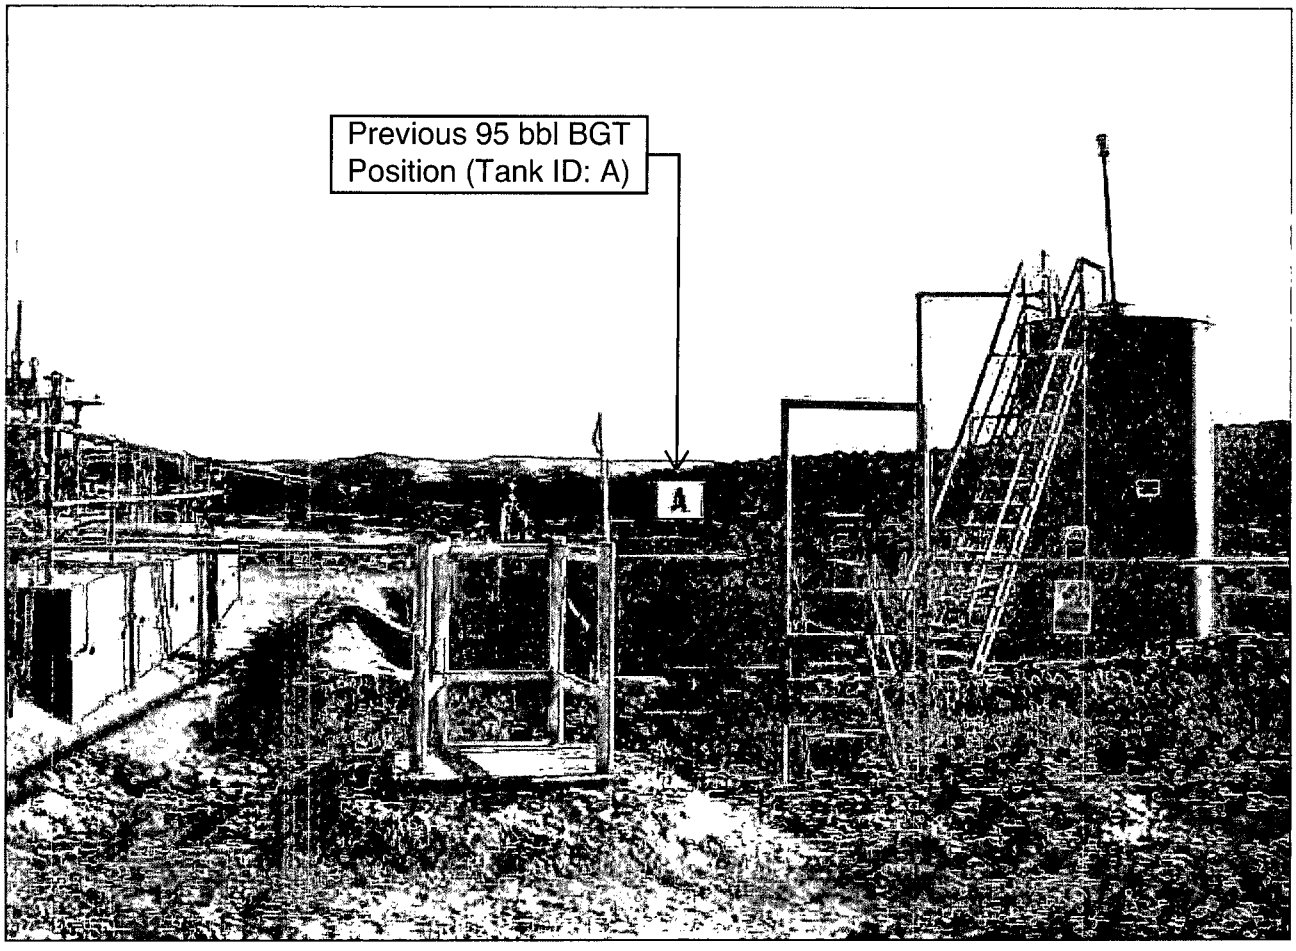
Previous 95 bbl BGT
Position (Tank ID: A)
A

8. If it is determined that a release has occurred, then BP will comply with 19.15.30 NMAC and 19.15.29 NMAC, as appropriate.
Sampling results indicate a minor release occurred. Impacted soil was excavated and removed.

9. If the sampling demonstrates that a release has not occurred or that any release does not exceed the concentrations specified above, then BP shall backfill the excavation, with compacted, non-waste containing, earthen material; construct a division-prescribed soil cover, re-contour and re-vegetate the location. The location will be reclaimed if it is not with in the active process area
The area under the BGT was backfilled with clean soil and is still within the active well area.
