# **APPENDIX E**

## **WELL BORE DIAGRAM**

**LINAM AGI #2 ASBUILT WELL SCHEMATIC**

**Location:** 2120 FSL & 2120' FWL  
**STR** S30-T18S-R37E  
**County, St.:** LEA COUNTY, NEW MEXICO

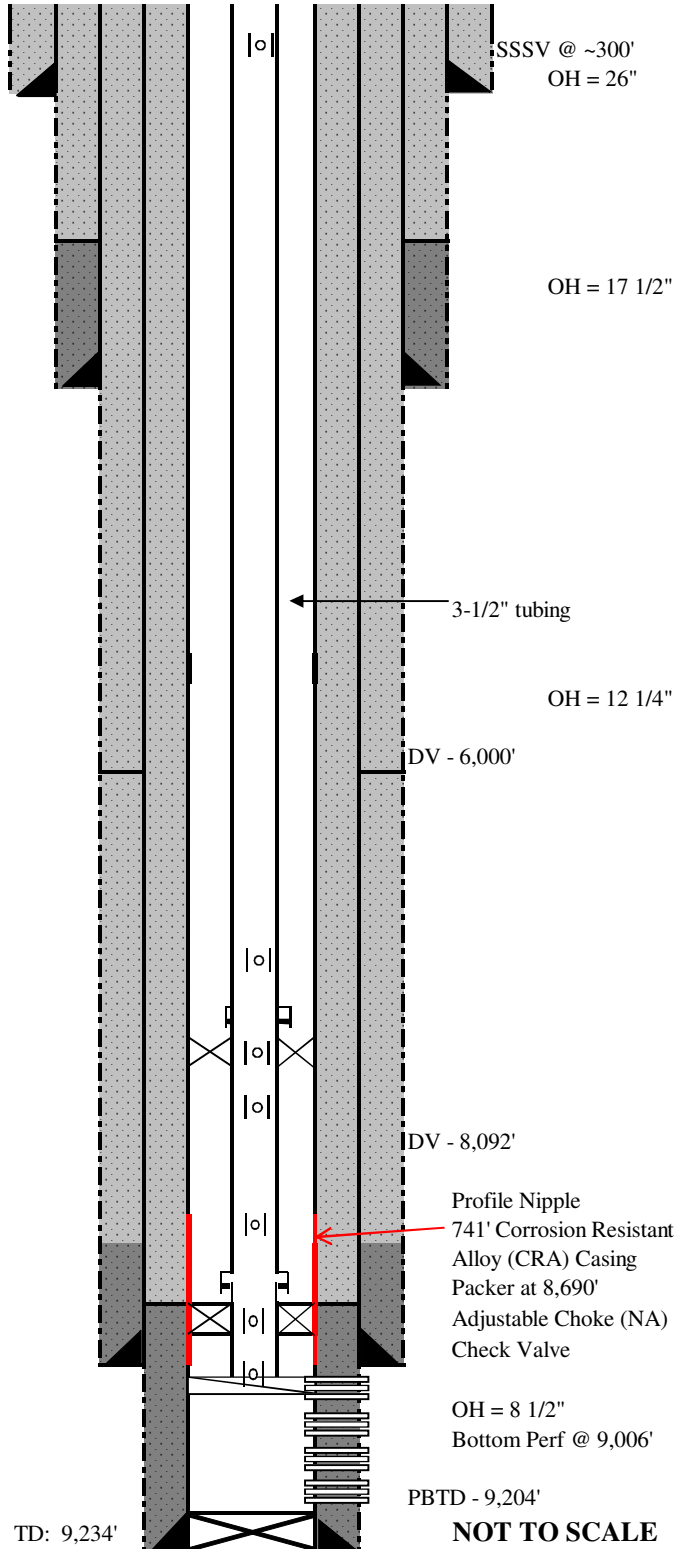
**CONDUCTOR CASING**

30" Conductor at 120'

**SURFACE CASING**

20", 106.5#, J55, BTC from surface to 1572'

Cement to surface

**UPPER INTERMEDIATE CASING:**

13 3/8", 68 #/ft, J55, STC at 3,219'

**LOWER INTERMEDIATE CASING:**

9 5/8", 47 #/ft, HCL-80, LTC at 8,604'

**PRODUCTION CASING:**

7", 26 #/ft, HCL-80, LTC to 8,414'

7", 26 #/ft, 28Cr, VAM TOP from 8,414' to 9,155'

7", 26 #/ft, HCL-80, LTC to 9,155' to 9,204'

**TUBING:**

Subsurface Safety Valve at 300'

3 1/2", 9.3#/ft, L80 from surface to 8,550'

3 1/2", 9.3#/ft, SM2550 from 8,550 to 8,683'

Premium thread utilizing metal to metal sealing in collars

**ANNULAR FLUID:**

Diesel Fuel w/ biocide from top of packer to surface

**BOTTOM HOLE PRESSURE/TEMPERATURE**

Monitoring equipment set immediately above packer

Permanent injection packer with Incoloy components set in Corrosion Resistant Alloy (CRA) csg at 8,690'
