Pit, Below-Grade Tank, or
12472 Proposed Alternative Method Permit or Closure Plan Application

BELOW-GRADE TANK CLOSURE PLAN

Atlantic A LS 17
API No. 3004523280
Unit Letter J, Section 27, T31N, R10W

FIELD REPORT:

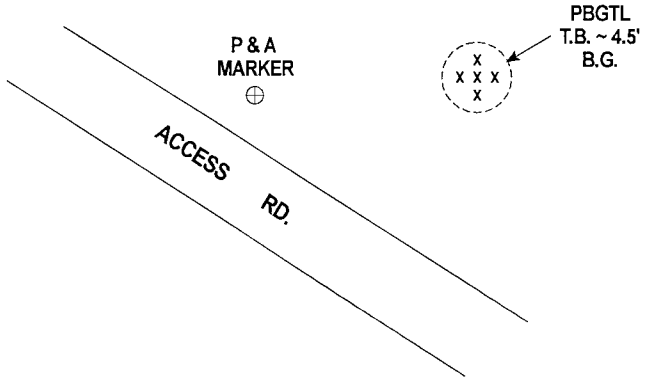
SITE SKETCH

ADDITIONAL COMMENTS: APPROVED PERMIT INDICATED 45 BBL BGT. NO APPARENT EVIDENCE OF A RELEASE OBSERVED FROM BGT. GAS WELL WELL RECENTLY PLUGGED & ABANDONED (P & A).
