SUNDRY NOTICES AND REPORTS ON WELLS (DO NOT USE THIS FORM FOR PROPOSALS TO DRILL OR TO DEEPEN OR PLUG BACK TO A DIFFERENT RESERVOIR. USE "APPLICATION FOR PERMIT" (FORM C-101) FOR SUCH PROPOSALS.)		WELL API NO. 30-025-38576

2. Name of Operator DCP Midstream LP		6. State Oil & Gas Lease No. V07530-0001
3. Address of Operator 370 17 th Street, Suite 2500, Denver, CO 80202		7. Lease Name or Unit Agreement Name Linam AGI

Proposed Workover, Well Repair and Operating Procedure

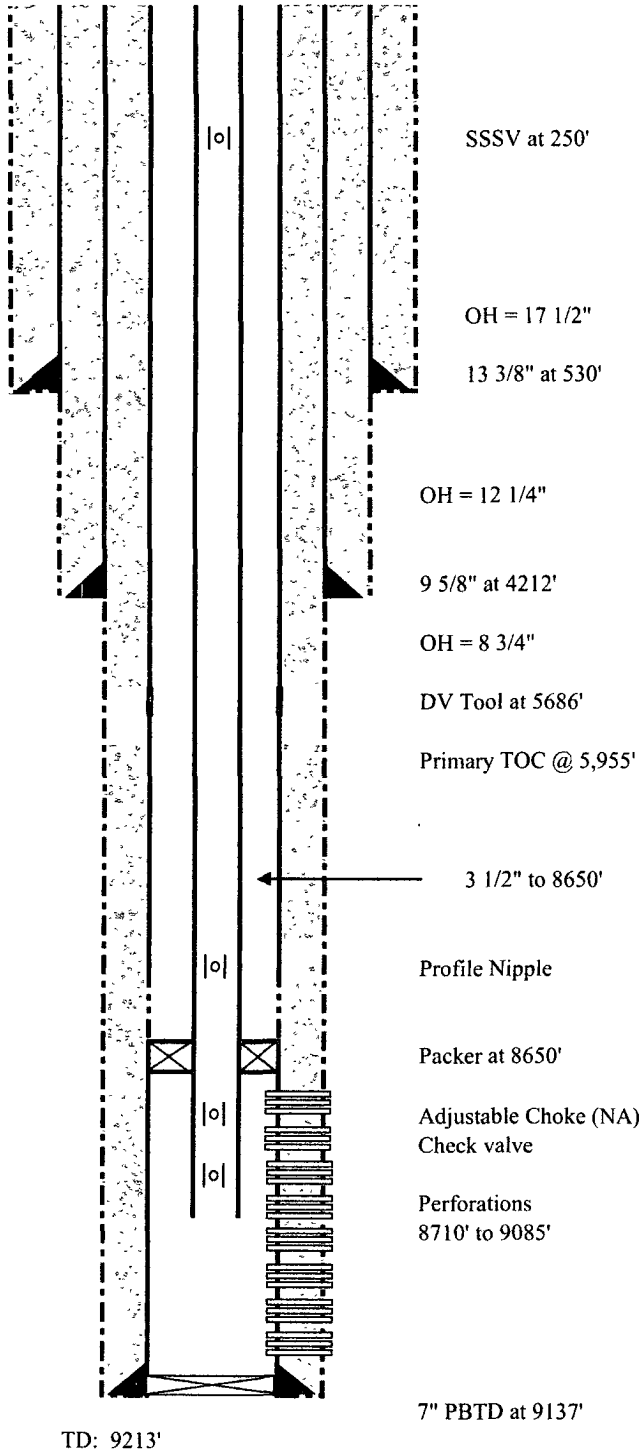
PACKER FLUID (CORROSION INHIBITED):
 Diesel w/ Cortron R-2525 (Corrosion inhibitor and oxygen scavenger)

Primary Target	Secondary Target
Lower Bone Springs	Brushy Canyon
8710' - 8730'	5000' to 5300'
8755' - 8765'	(Not perforated)
8780' - 8795'	
8780' - 8890'	
8925' - 8930'	
8945' - 8975'	
8985' - 9000'	
9045' - 9085'

1. Make a mechanical repair of the well that replaces all tubulars in the well with the exception of the SSSV which is fully functional and whose integrity has not been affected (see attached well bore diagram).
2. Implement a well annulus treatment and packer fluid introduction method and composition that addresses the potential multiple causes of the observed damage to the well tubulars over the entire string but especially in the areas where problems have been encountered in the well. (see attached MSDS for treatments and additives)
3. Conduct continued pressure, annular pressure, temperature and flow rate monitoring and monthly reporting to NMOCD of this monitoring data
4. Conduct ~~annual~~ MITs under NMOCD supervision until future turnaround allows for developing the stacked packer system *every 6 months*
