# Pit, Below-Grade Tank, or
12641 Proposed Alternative Method Permit or Closure Plan Application

# BP AMERICA PRODUCTION COMPANY
SAN JUAN BASIN, NORTHWEST NEW MEXICO

BELOW-GRADE TANK CLOSURE PLAN

**Florance 24, Tank B (21 bbl)**
**API No. 3004508119**
**Unit Letter A, Section 23, T29N, R9W**

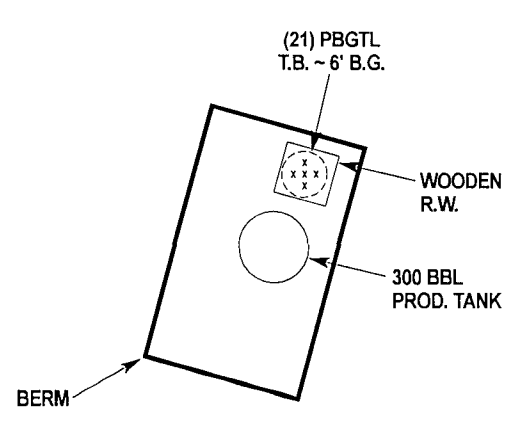
PLOT PLAN circle: attached

DISCOLORATION/STAINING OBSERVED: [YES] NO EXPLANATION - @ 21 BGT BETWEEN 4' - 6' BELOW GRADE ONLY.

APPARENT EVIDENCE OF A RELEASE OBSERVED AND/OR OCCURRED: [YES] NO EXPLANATION: @ 21 BGT ONLY AROUND SIDEWALLS.

OTHER: SOIL IMPACTS @ 21 BGT, VERY MINIMAL IN QUANTITY (<1 CUBIC YARD). 21 BGT SIDEWALLS COVERED WITH SEDIMENT PROBABLY CAUSED BY WIND BLOWN DEPOSITION OR BY GRAVITATIONAL PROCESS AIDED BY PRECIPITATION [E.G. - SLUFFING FROM RAIN EVENT(S)].
