Pit, Below-Grade Tank, or
12644 Proposed Alternative Method Permit or Closure Plan Application

BELOW-GRADE TANK CLOSURE PLAN

Florance Gas Com J 16 Tank B (21 bbl)
API No. 3004509800
Unit Letter A, Section 6, T30N, R9W

Release Notification and Corrective Action

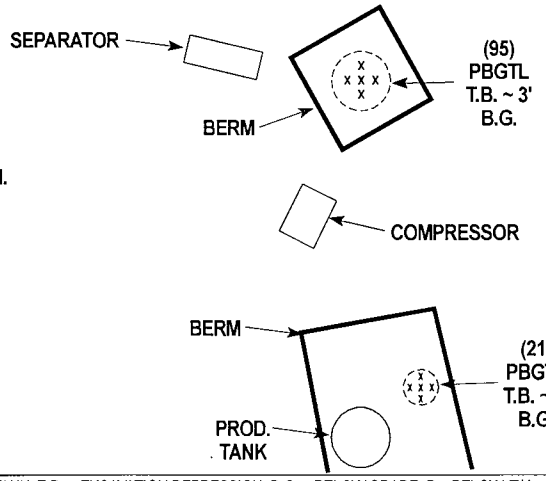
PLOT PLAN circle: attached

DISCOLORATION/STAINING OBSERVED: YES / NO EXPLANATION - BLACK BENEATH 21 BGT

APPARENT EVIDENCE OF A RELEASE OBSERVED AND/OR OCCURRED: YES / NO EXPLANATION: AT 21 BGT

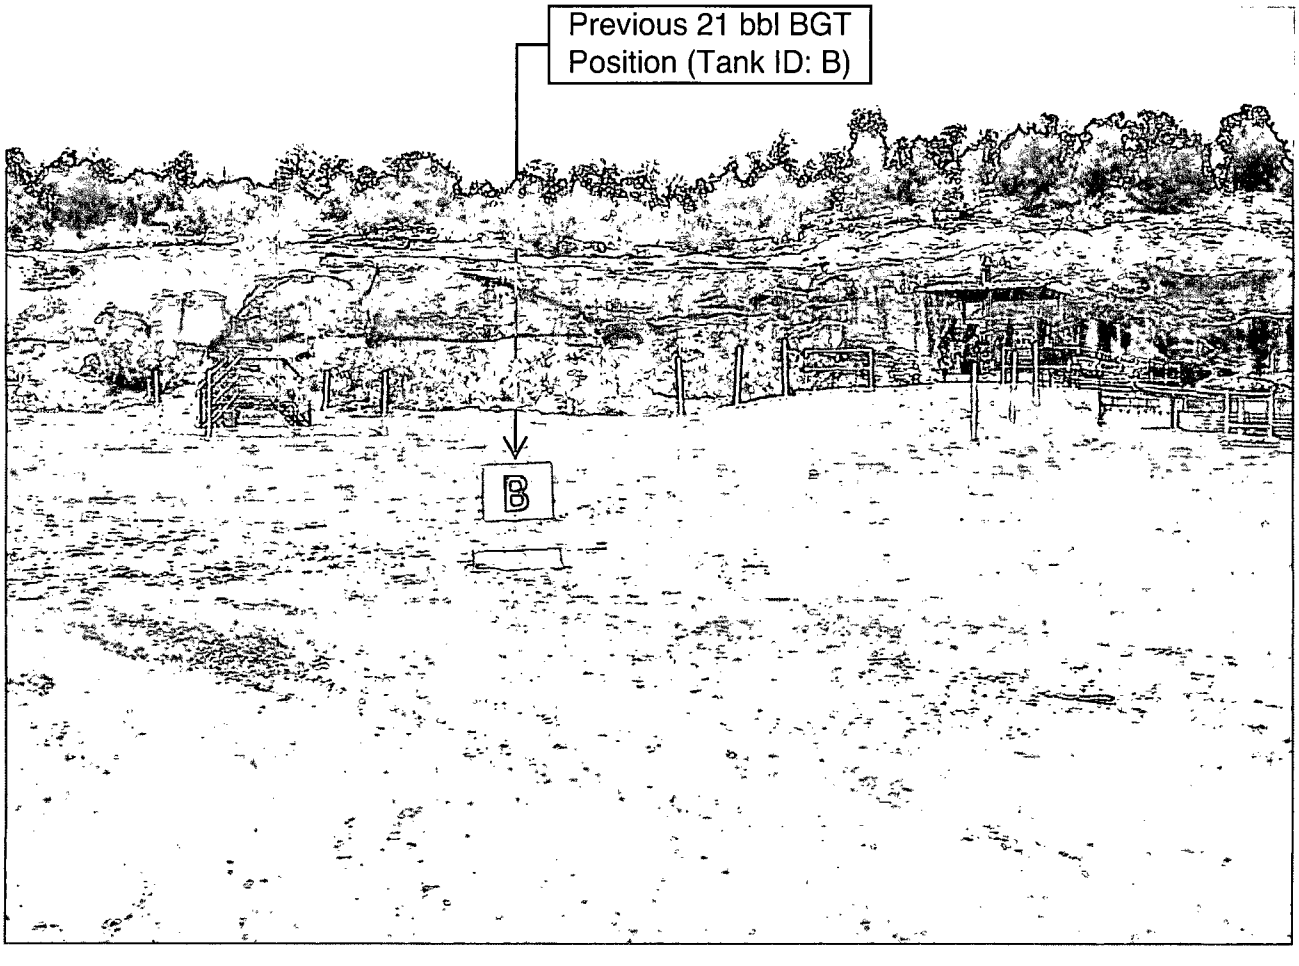
Previous 21 bbl BGT
Position (Tank ID: B)
B

Soil under the BGT was sampled and Benzene and chloride levels were below the stated limits. TPH was 3,000 ppm by Method 418.1 and 5,300 ppm by Method 8015D, and total BTEX was 150 ppm. Sampling data is attached.

9. If the sampling demonstrates that a release has not occurred or that any release does not exceed the concentrations specified above, then BP shall backfill the excavation, with compacted, non-waste containing, earthen material; construct a division-prescribed soil cover, re-contour and re-vegetate the location. The location will be reclaimed if it is not with in the active process area
The area under the BGT was backfilled with clean soil and is still within the active well area.
