Pit, Below-Grade Tank, or Proposed Alternative Method Permit or Closure Plan Application

Facility or well name: Gallegos Canyon Unit 204E

BELOW-GRADE TANK CLOSURE PLAN

Gallegos Canyon Unit 204E, BGT Tank B (95 bbl)
API No. 3004525262
Unit Letter I, Section 34, T28N, R12W

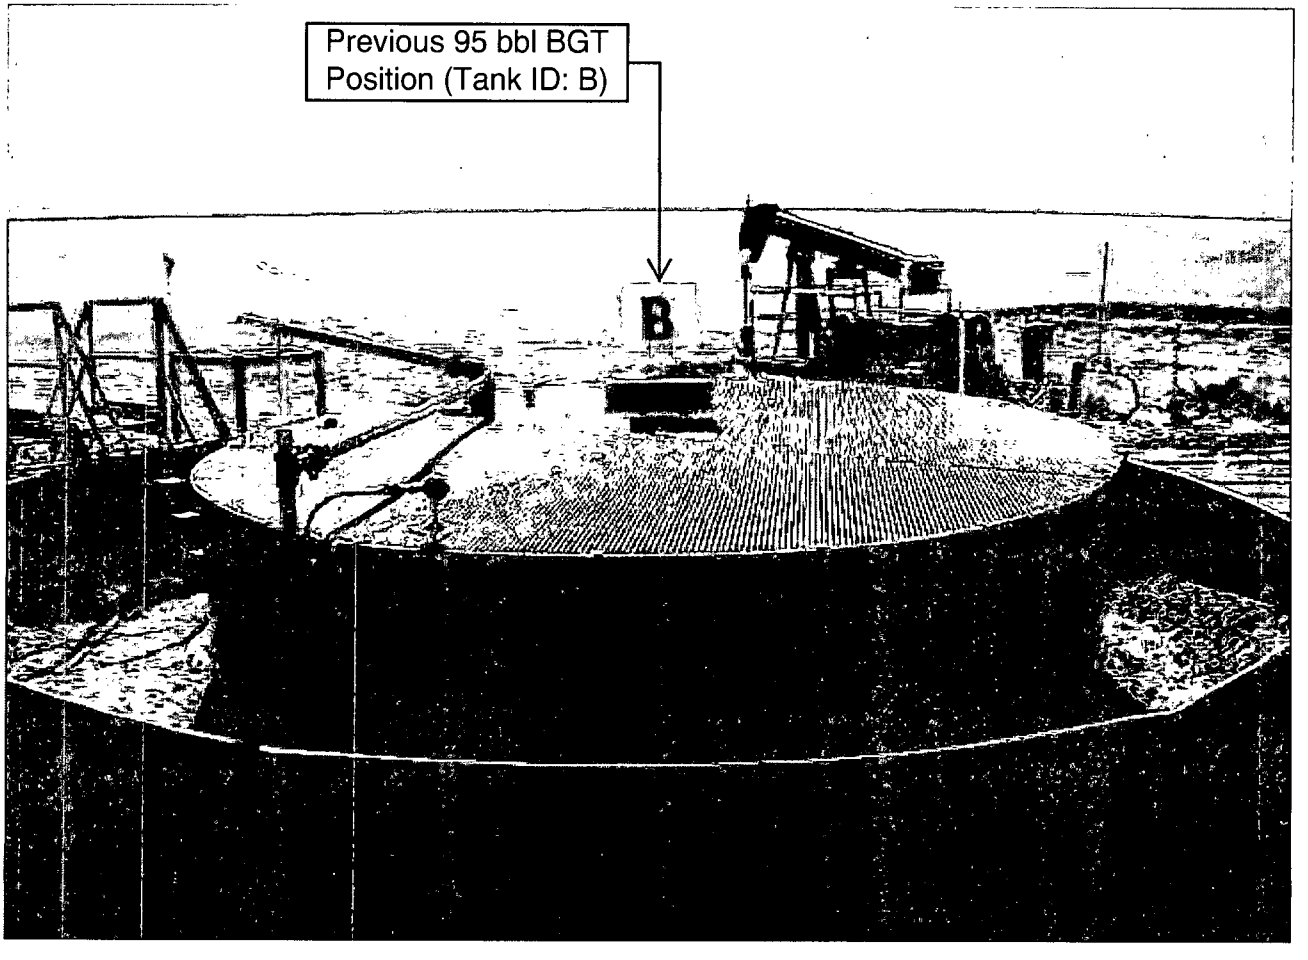
Previous 95 bbl BGT
Position (Tank ID: B)
B

9. If the sampling demonstrates that a release has not occurred or that any release does not exceed the concentrations specified above, then BP shall backfill the excavation, with compacted, non-waste containing, earthen material; construct a division-prescribed soil cover, re-contour and re-vegetate the location. The location will be reclaimed if it is not with in the active process area
The area under the BGT was backfilled with clean soil and is still within the active well area.
