Pit, Below-Grade Tank, or Proposed Alternative Method Permit or Closure Plan Application

Facility or well name: Ridenour Gas Com 1

BELOW-GRADE TANK CLOSURE PLAN

Ridenour Gas Com 1 Tank B (21 bbl)
API No. 3004510750
Unit Letter H, Section 13, T31N, R11W

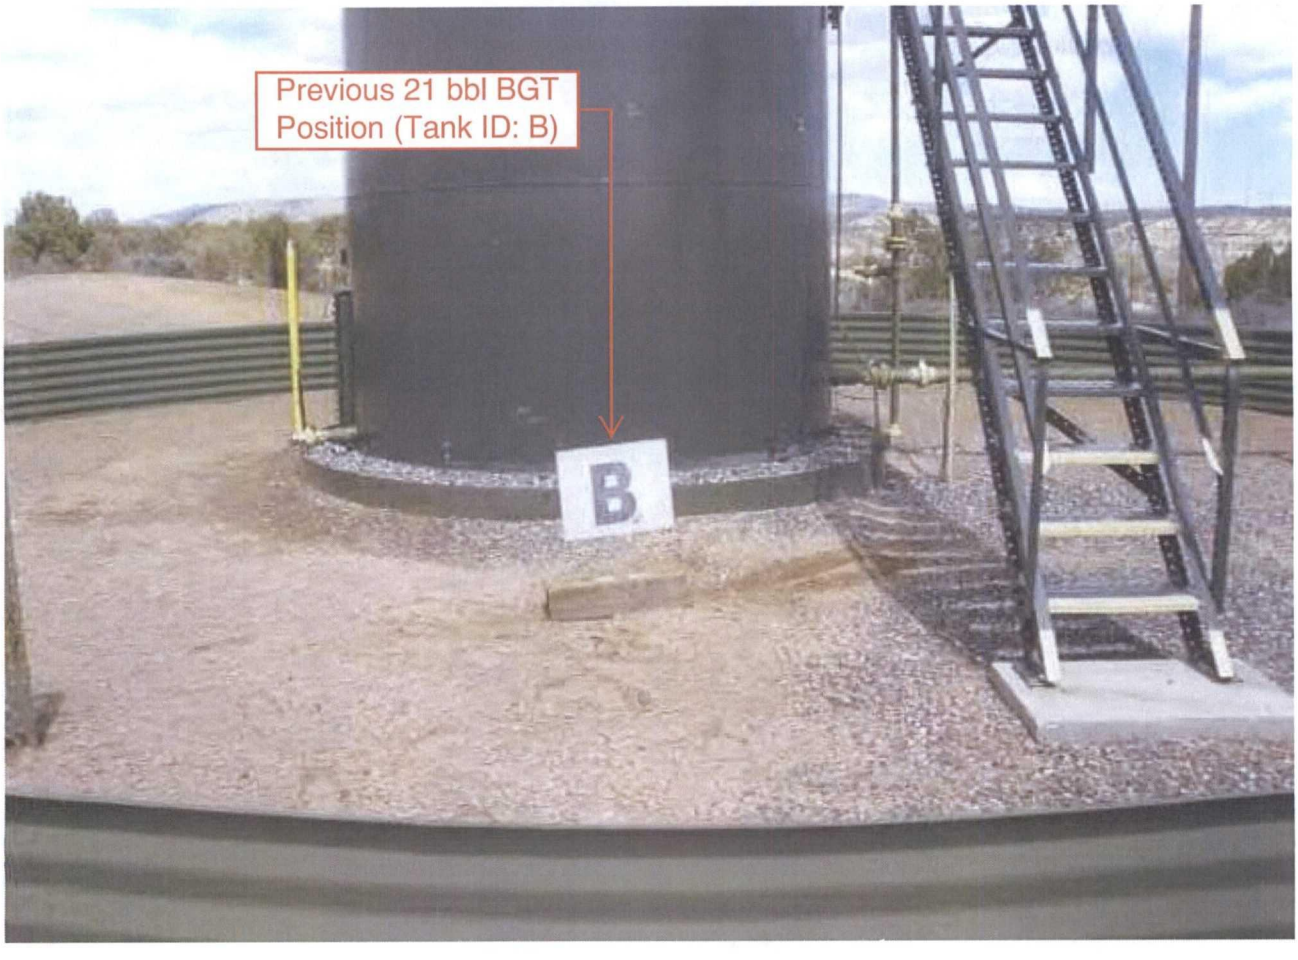
Previous 21 bbl BGT
Position (Tank ID: B)
B
