Pit, Below-Grade Tank, or
Proposed Alternative Method Permit or Closure Plan Application

Facility or well name: Ridenour Gas Com 1

BELOW-GRADE TANK CLOSURE PLAN

Ridenour Gas Com 1 Tank A (95 bbl)
API No. 3004510750
Unit Letter H, Section 13, T31N, R11W

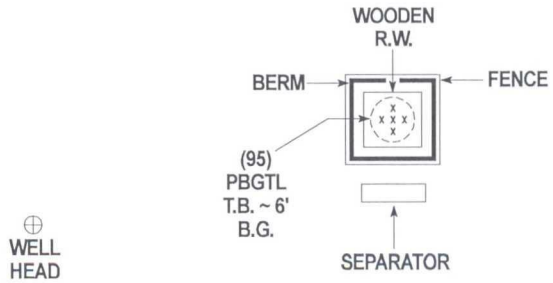
PLOT PLAN circle: attached

ADDITIONAL COMMENTS: NO APPARENT EVIDENCE OF A RELEASE OBSERVED FROM BGT.

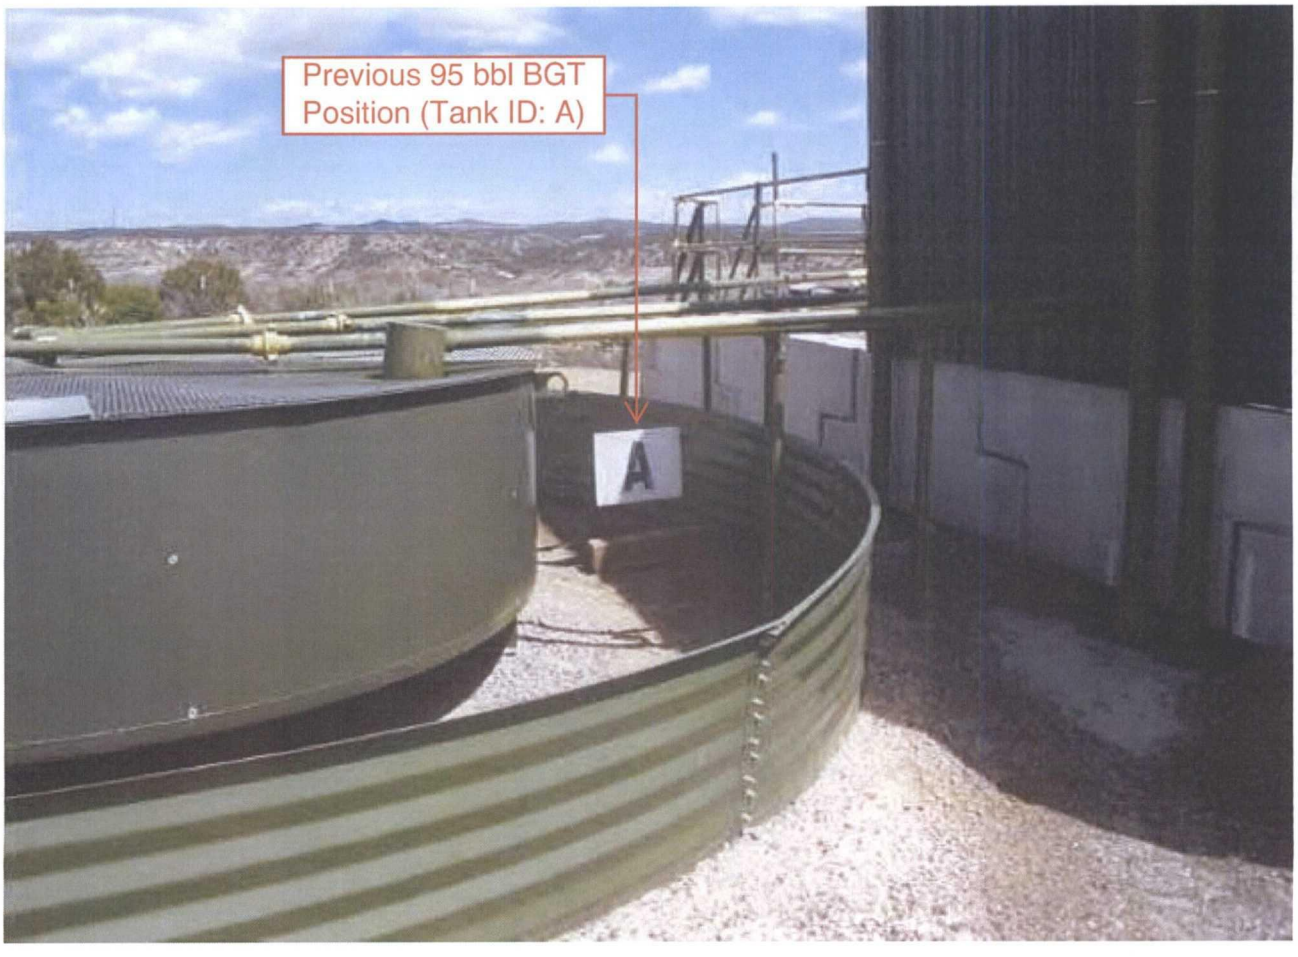
Previous 95 bbl BGT
Position (Tank ID: A)
A

9. If the sampling demonstrates that a release has not occurred or that any release does not exceed the concentrations specified above, then BP shall backfill the excavation, with compacted, non-waste containing, earthen material; construct a division-prescribed soil cover, re-contour and re-vegetate the location. The location will be reclaimed if it is not with in the active process area
The area under the BGT was backfilled with clean soil and is still within the active well area.
