Pit, Below-Grade Tank, or
Proposed Alternative Method Permit or Closure Plan Application

Burlington Resources Oil Gas Company, LP
San Juan Basin
Below Grade Tank Closure Report

Lease Name: Culpepper Martin 95E
API No.: 30-039-23802

BGT Summary
Site Name – Canyon Largo Unit 95E
Location – Unit Letter O, Section 36, Township 25N, Range 6W
API Number – 30-039-23802
Monument Latitude/Longitude – N36.35283 and W107.41610
BGT Latitude/Longitude – N36.35295 and W107.41620
Land Jurisdiction – State of New Mexico
Size of BGT – 120 barrels
Site Ranking – 10 New Mexico Oil Conservation Division (NMOCD) Guidelines for Remediation of Leaks, Spills, and Releases (August 1993) see Table 1
Date of BGT Closure Soil Sampling – April 14, 2015

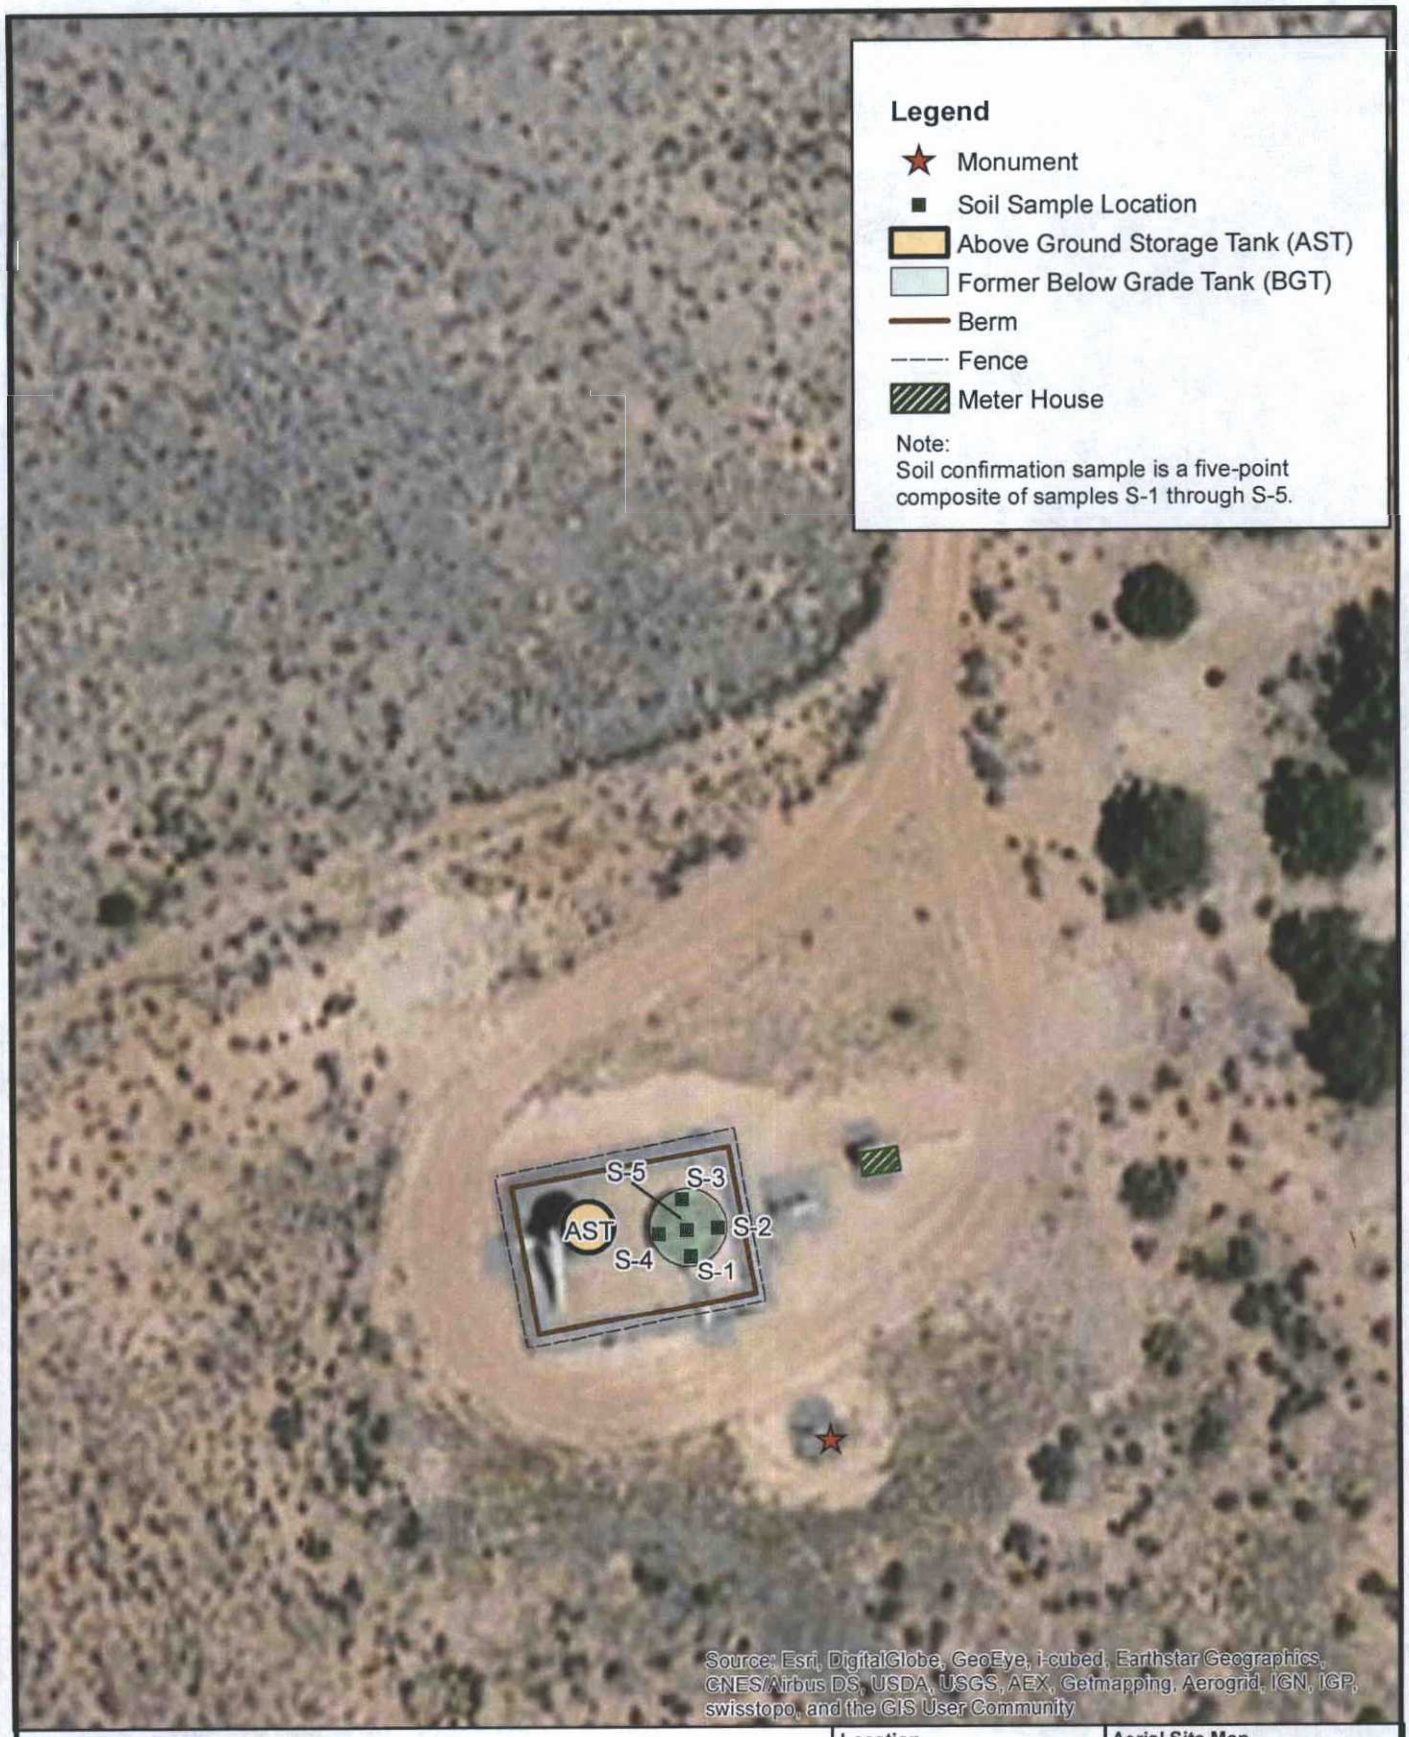
Field Activities
On April 14, 2015, following removal of the BGT tank and liner, Rule personnel conducted a visual inspection for surface/subsurface indications of a release. Minor staining was observed beneath the liner in an area located along the southern edge of the BGT. Rule personnel then collected five soil samples (S-1

through S-5) from 0.25 feet beneath the BGT liner. Stained soils were included as sample S-1. Figure 2 provides the location of the soil samples collected from below the BGT. The field work summary sheet is attached.

Objective:	Closure sampling for BGT
Tank Size:	120 bbls (removed prior to arrival)
Liner:	Yes, removed while onsite
Observations:	Staining observed near S-1. Included in SC-1-per Cory Smith (NMOCD) onsite during sampling.
Notes:	Heavy liner and cribbing in place. Sandstone bedrock at 3-4" below BGT.
