Pit, Below-Grade Tank, or Proposed Alternative Method Permit or Closure Plan Application

BP AMERICA PRODUCTION COMPANY
SAN JUAN BASIN, NORTHWEST NEW MEXICO

BELOW-GRADE TANK CLOSURE PLAN

Wilcch A 003
API No. 3004523342
Unit Letter B, Section 23, T29N, R8W

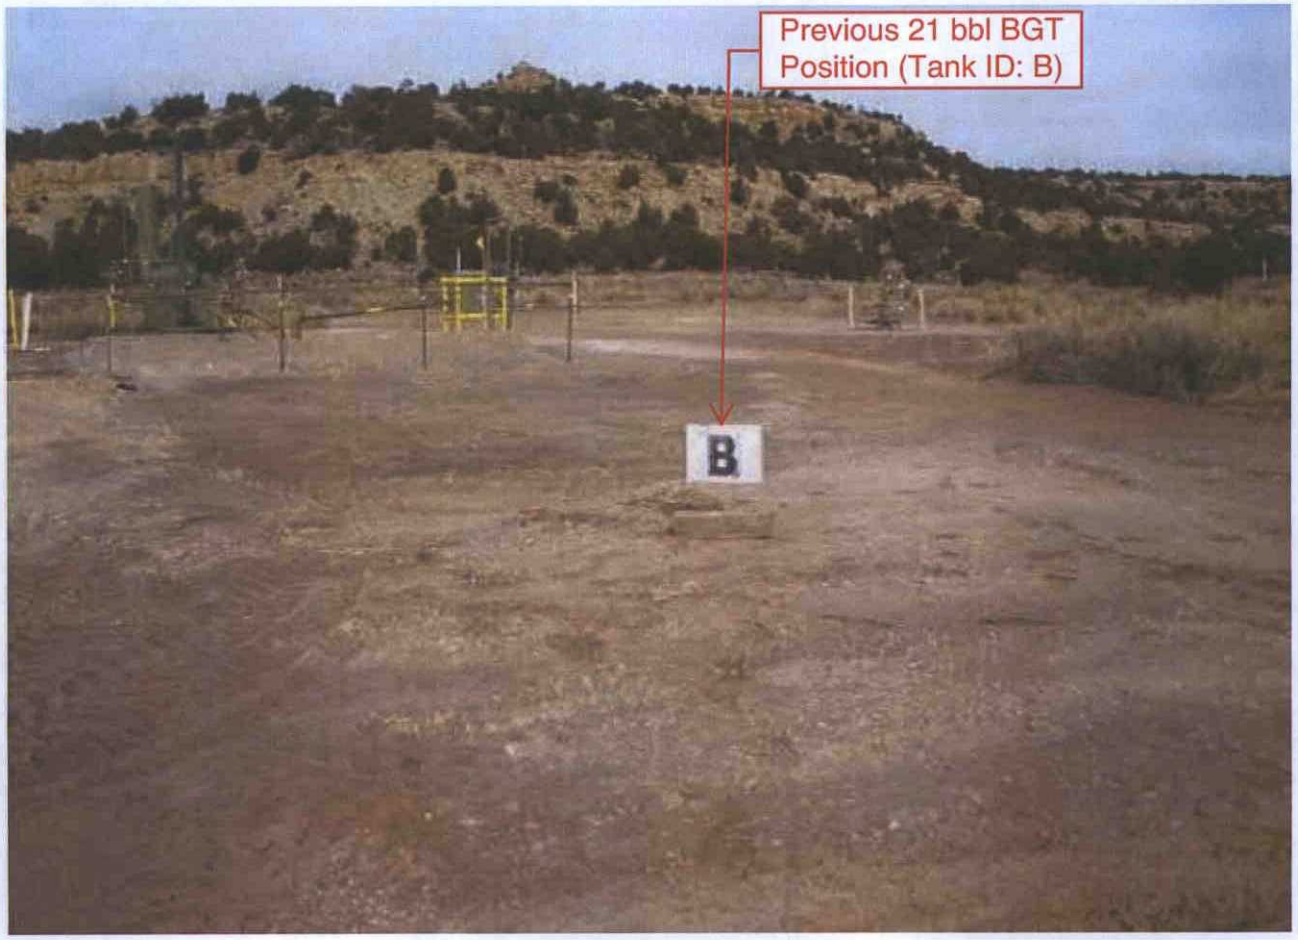
Previous 21 bbl BGT
Position (Tank ID: B)
B

9. If the sampling demonstrates that a release has not occurred or that any release does not exceed the concentrations specified above, then BP shall backfill the excavation, with compacted, non-waste containing, earthen material; construct a division-prescribed soil cover, re-contour and re-vegetate the location. The location will be reclaimed if it is not with in the active process area
Sampling demonstrates a release has not occurred. The BGT was backfilled and remains within the active well pad.
