Pit, Below-Grade Tank, or
14194 Proposed Alternative Method Permit or Closure Plan Application

BELOW-GRADE TANK CLOSURE PLAN

Mudge LS 022M
API No. 3004530757
Unit Letter P, Section 4, T31N, R11W

FIELD REPORT:

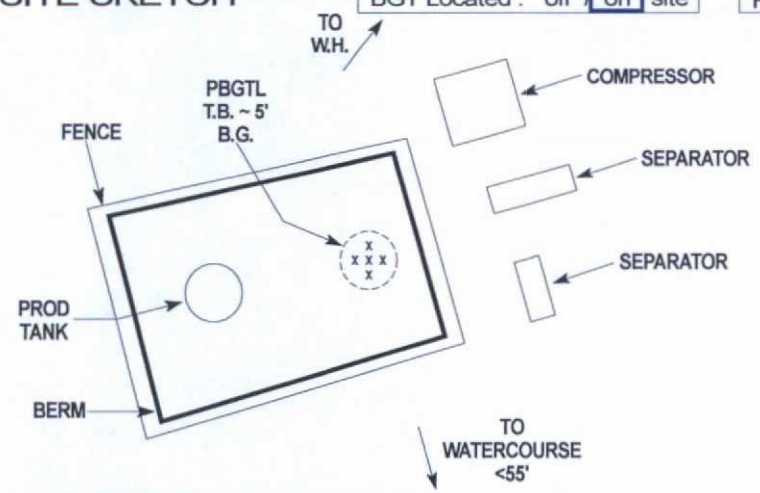
PLOT PLAN circle: attached

BGT Located : off / on site
