Pit, Below-Grade Tank, or
14448 Proposed Alternative Method Permit or Closure Plan Application

1.
Operator: BP America Production Company OGRID #: 778
Address: 200 Energy Court, Farmington, NM 87401
Facility or well name: Gallegos Canyon Unit 184E
API Number: 3004524427 OCD Permit Number:
U/L or Qtr/Qtr J Section 28 Township 28N Range 12W County: San Juan
Center of Proposed Design: Latitude 36.62982 Longitude -108.11292 NAD: ☐1927 ☒1983
Surface Owner: ☒ Federal ☐ State ☐ Private ☐ Tribal Trust or Indian Allotment

BELOW-GRADE TANK CLOSURE PLAN

Gallegos Canyon Unit #184E
API No. 3004524427
Unit Letter J, Section 28, 28N, R12W

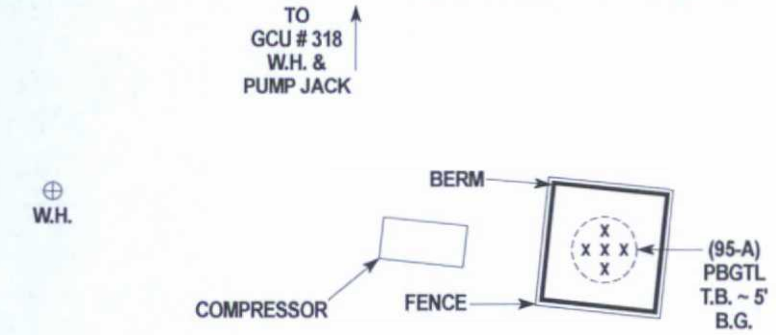
PLOT PLAN circle: attached

DISCOLORATION/STAINING OBSERVED: YES / [NO] EXPLANATION -

APPARENT EVIDENCE OF A RELEASE OBSERVED AND/OR OCCURRED : YES / [NO] EXPLANATION:
