Pit, Below-Grade Tank, or Proposed Alternative Method Permit or Closure Plan Application

Burlington Resources Oil & Gas Company, LP
San Juan Basin
Below Grade Tank Closure Report

Lease Name: SAN JUAN 30-6 UNIT 123
API No.: 30-039-26002

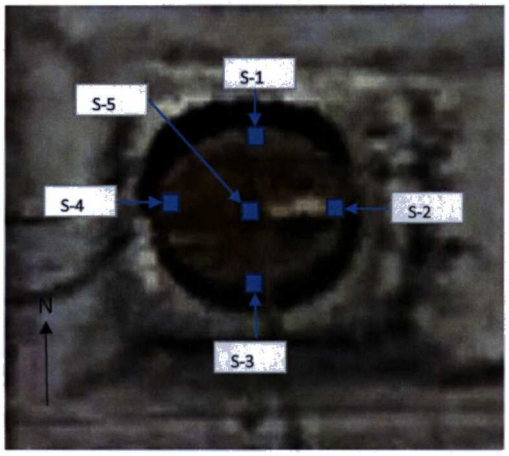
Objective:	Closure sampling for BGT
Tank Size:	120 barrels, removed during closure activities
Liner:	No liner was observed during closure activities
Observations:	No staining or excess moisture was observed below the tank.
Notes:	A NMOCD representative was onsite during collection of the confirmation sample.

SC-1 is a 5-point composite of S-1 through S-5, collected 0.5 ft below BGT.
Sample SC-1 was laboratory analyzed for TPH (8015 and 418.1), BTEX (8021) and chlorides (300.0).

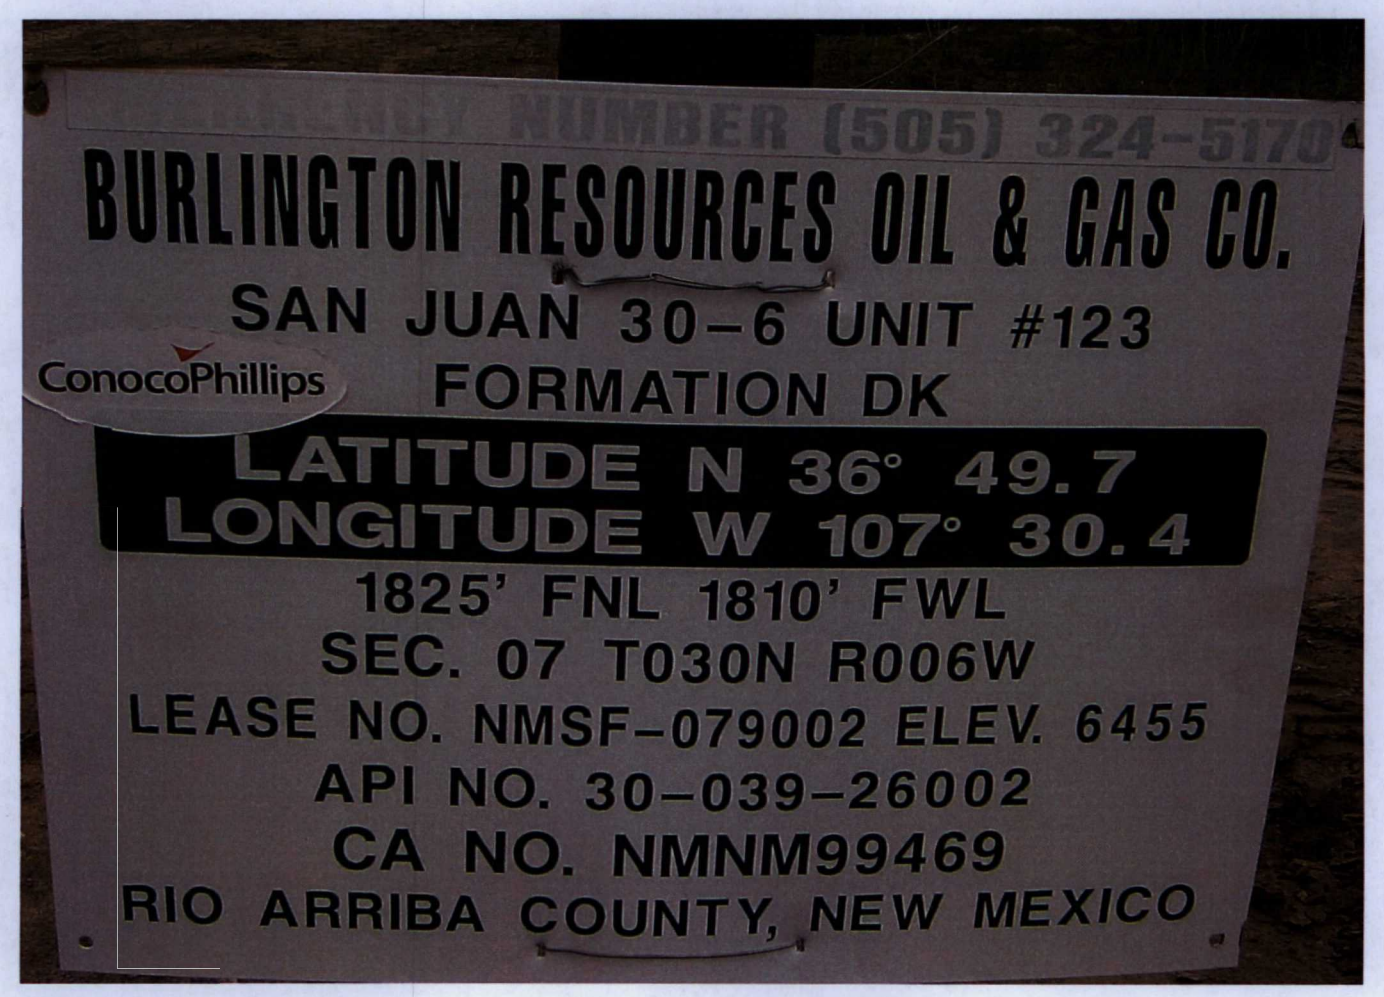
NUMBER (505) 324-5170
BURLINGTON RESOURCES OIL & GAS CO.
SAN JUAN 30-6 UNIT #123
ConocoPhillips
FORMATION DK
LATITUDE N 36° 49.7
LONGITUDE W 107° 30.4
1825' FNL 1810' FWL
SEC. 07 T030N R006W
LEASE NO. NMSF-079002 ELEV. 6455
API NO. 30-039-26002
CA NO. NMNM99469
RIO ARRIBA COUNTY, NEW MEXICO
