Pit, Below-Grade Tank, or Proposed Alternative Method Permit or Closure Plan Application

1.
Operator: BP America Production Company OGRID #: 778
Address: 200 Energy Court, Farmington, NM 87401
Facility or well name: Florance 002
API Number: 3004509372 OCD Permit Number:
U/L or Qtr/Qtr A Section 20 Township 30N Range 09W County: San Juan
Center of Proposed Design: Latitude 36.801083 Longitude -107.79862 NAD: ☐1927 ☒ 1983
Surface Owner: ☒ Federal ☐ State ☐ Private ☐ Tribal Trust or Indian Allotment

BELOW-GRADE TANK CLOSURE PLAN

Florance 002
API No. 3004509372
Unit Letter A, Section 20, T30N, R09W

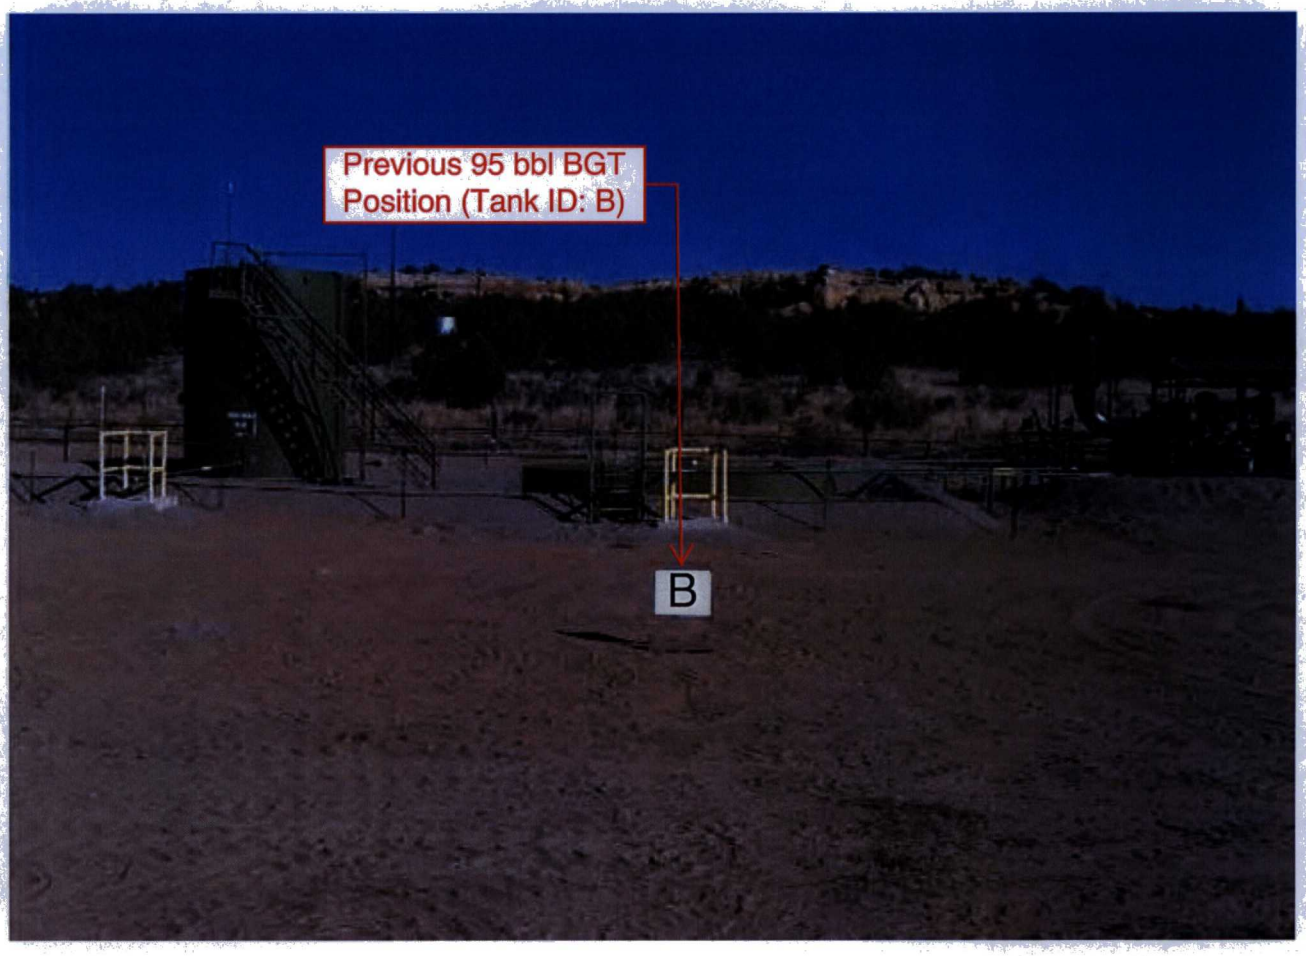
Previous 95 bbl BGT
Position (Tank ID: B)
B

Soil under the BGT was sampled for TPH, BTEX and chloride with all concentrations below the stated limits. The field report and laboratory reports are attached.

10. BP shall reclaim the BGT location and all areas associated with the BGT including associated access roads to a safe and stable condition that blends with the surrounding undisturbed area. BP shall substantially restore the impacted surface area to the condition that existed prior to oil and gas operations by placement of the soil cover as provided in Subsection H of 19.15.17.13 NMAC, re-contour the location and associated areas to a contour that approximates the original contour and blends with the surrounding topography and re-vegetate according to Subsection I of 19.15.17.13 NMAC.
The area has been backfilled and will be reclaimed once the well has been plugged and abandoned.
