Pit, Below-Grade Tank, or Proposed Alternative Method Permit or Closure Plan Application

1.
Operator: Burlington Resources Oil & Gas Company, LP OGRID #: 14538
Address: PO BOX 4289, Farmington, NM 87499
Facility or well name: MURPHY A COM B #3
API Number: 30-045-08790 OCD Permit Number: _____
U/L or Qtr/Qtr G Section 2 Township 29N Range 11W County: San Juan
Center of Proposed Design: Latitude 36.75723 °N Longitude -107.95806 °W NAD: ☐1927 ☒ 1983
Surface Owner: ☒ Federal ☐ State ☐ Private ☐ Tribal Trust or Indian Allotment

Burlington Resources Oil & Gas Company, LP
San Juan Basin
Below Grade Tank Closure Report

Lease Name: Murphy A Com B #3
API No.: 30-045-08790

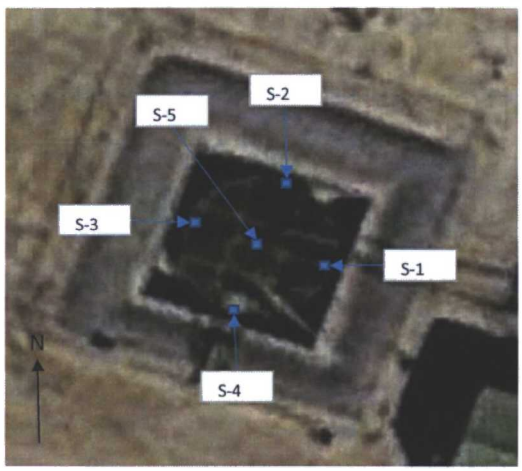
Objective:	Closure sampling for BGT
Tank Size:	120 barrels, removed during closure activities
Liner:	Liner present, removed during closure activities
Observations:	No staining or excess moisture was observed below the tank.
Notes:	Ms. Vanessa Fields, NMOCD representative, was on site during soil sampling activies.

SC-1 is a 5-point composite of S-1 through S-5, collected 0.5 ft below BGT.
Sample SC-1 was laboratory analyzed for TPH (8015), BTEX (8021) and chlorides (300.0).
