Pit, Below-Grade Tank, or Proposed Alternative Method Permit or Closure Plan Application

Address: 200 Energy Court, Farmington, NM 87401
Facility or well name: JOHNSTON COM B 002
API Number: 3004523989 OCD Permit Number:
U/L or Qtr/Qtr P Section 11 Township 28N Range 09W County: San Juan
Center of Proposed Design: Latitude 36.67134 Longitude -107.75196 NAD: ☐1927 ☒1983
Surface Owner: ☒ Federal ☐ State ☐ Private ☐ Tribal Trust or Indian Allotment

BELOW-GRADE TANK CLOSURE PLAN

Johnston Com B 002
API No. 3004523989
Unit Letter P, Section 11, T28N, R09W

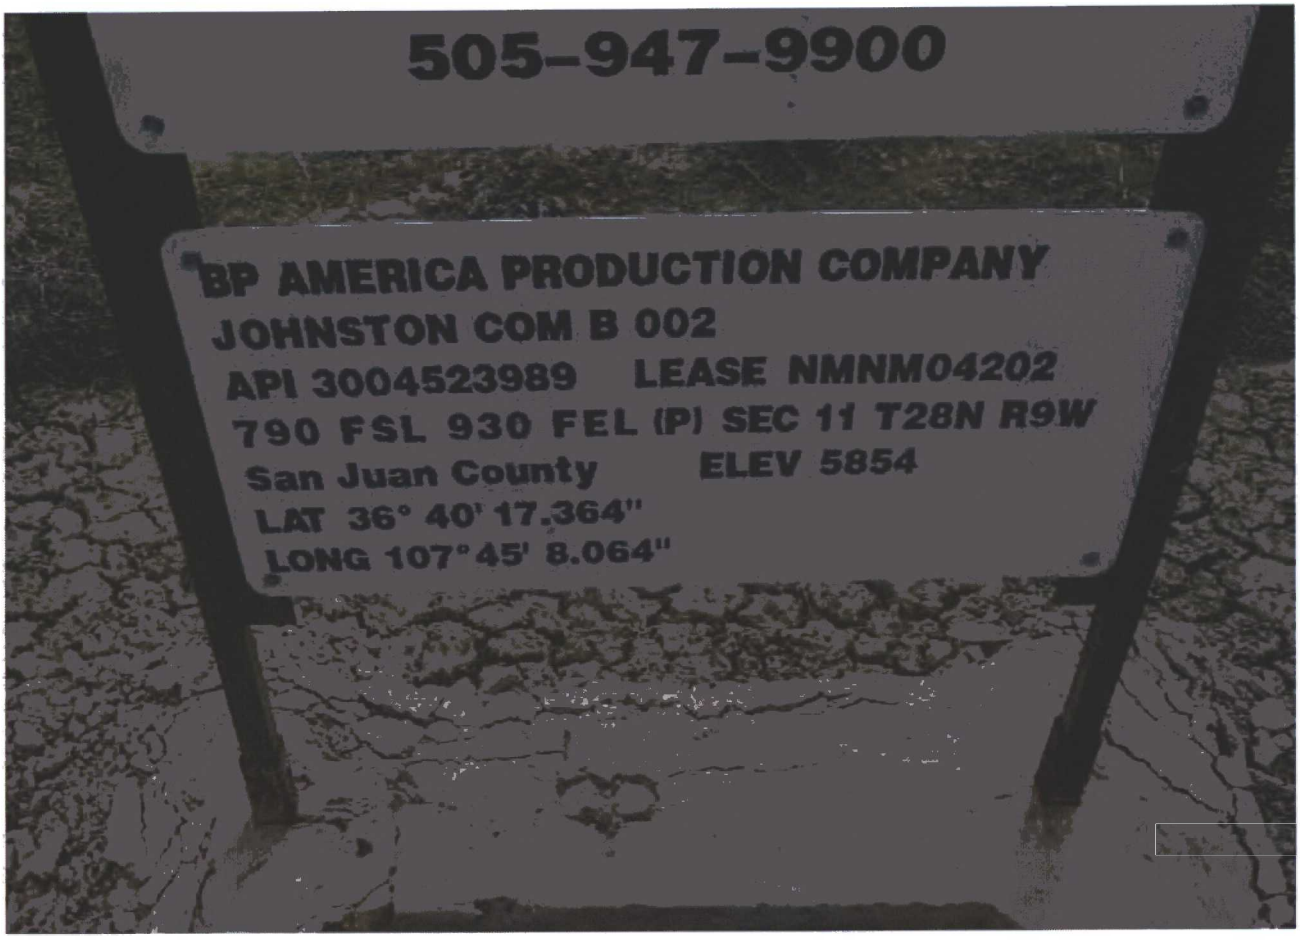
505-947-9900
BP AMERICA PRODUCTION COMPANY
JOHNSTON COM B 002
API 3004523989 LEASE NMNM04202
790 FSL 930 FEL (P) SEC 11 T28N R9W
San Juan County ELEV 5854
LAT 36° 40' 17.364"
LONG 107° 45' 8.064"

Closure report on C-144 form is included including photos of reclamation completion.

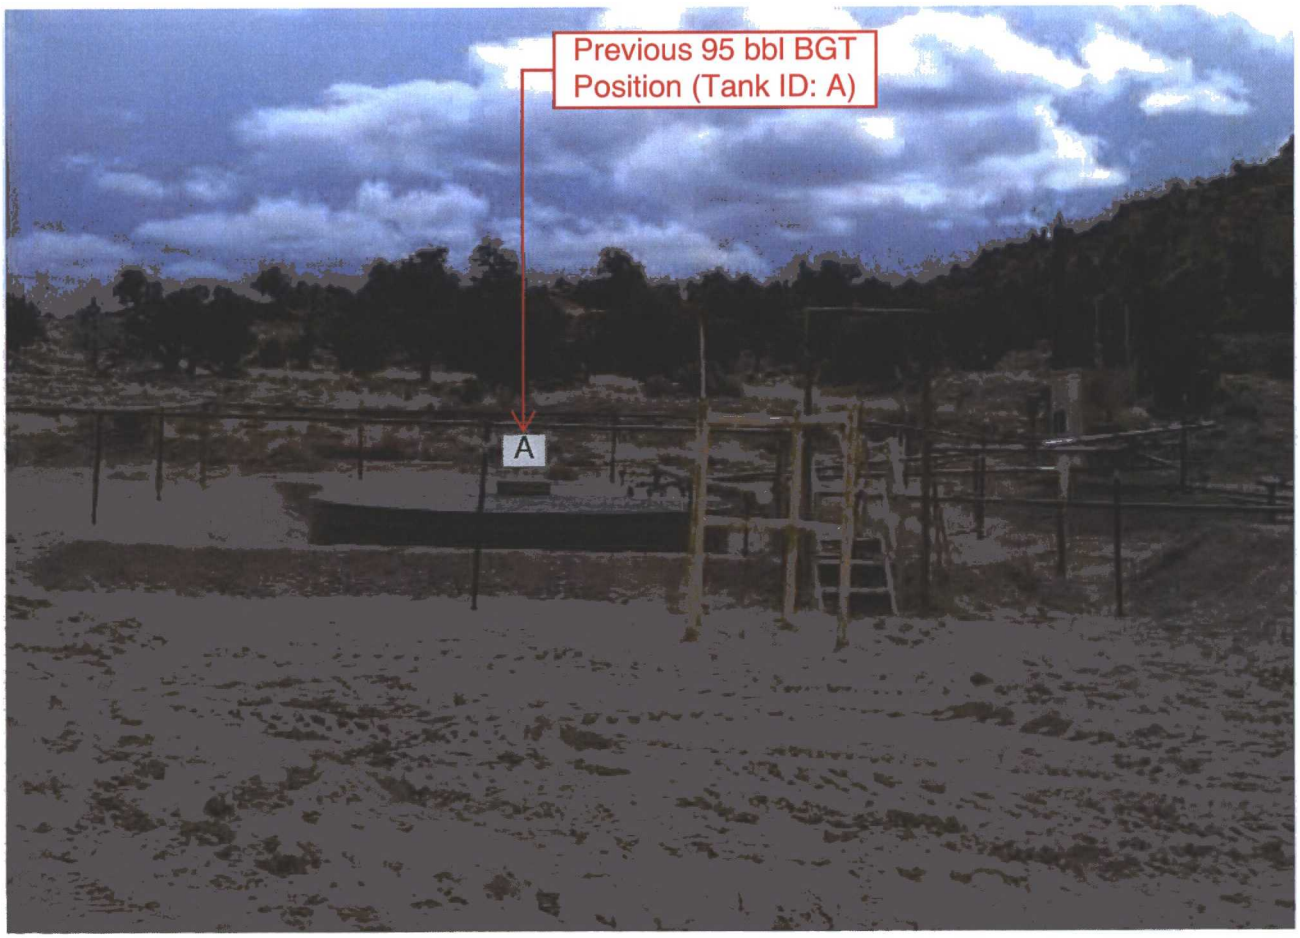
Previous 95 bbl BGT
Position (Tank ID: A)
A

10. BP shall reclaim the BGT location and all areas associated with the BGT including associated access roads to a safe and stable condition that blends with the surrounding undisturbed area. BP shall substantially restore the impacted surface area to the condition that existed prior to oil and gas operations by placement of the soil cover as provided in Subsection H of 19.15.17.13 NMAC, re-contour the location and associated areas to a contour that approximates the original contour and blends with the surrounding topography and re-vegetate according to Subsection I of 19.15.17.13 NMAC.
The area has been backfilled. The location will be reclaimed when the well is plugged and abandoned.
