Pit, Below-Grade Tank, or Proposed Alternative Method Permit or Closure Plan Application

1.
Operator: BP America Production Company OGRID #: 778
Address: 200 Energy Court, Farmington, NM 87401
Facility or well name: Florance 011R
API Number: 3004527890 OCD Permit Number:
U/L or Qtr/Qtr B Section 30 Township 30N Range 08W County: San Juan
Center of Proposed Design: Latitude 36.78521 Longitude -107.71114 NAD: ☐1927 ☒1983
Surface Owner: ☐ Federal ☐ State ☒ Private ☐ Tribal Trust or Indian Allotment

BELOW-GRADE TANK CLOSURE PLAN

Florance 011R
API No. 3004527890
Unit Letter B, Section 30, T30N, R08W

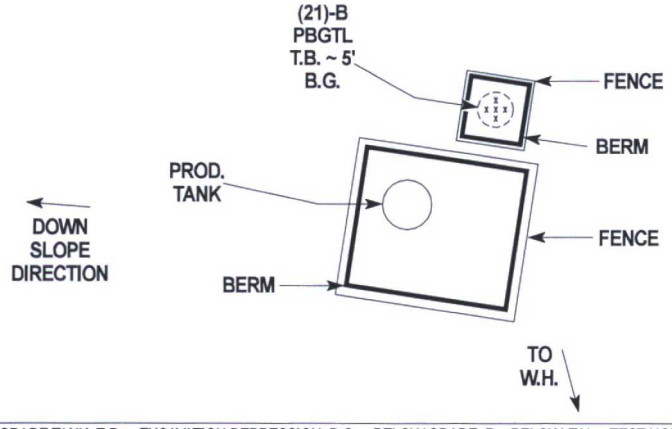
PLOT PLAN circle: attached

DISCOLORATION/STAINING OBSERVED: YES / [NO] EXPLANATION -

APPARENT EVIDENCE OF A RELEASE OBSERVED AND/OR OCCURRED : YES / [NO] EXPLANATION:

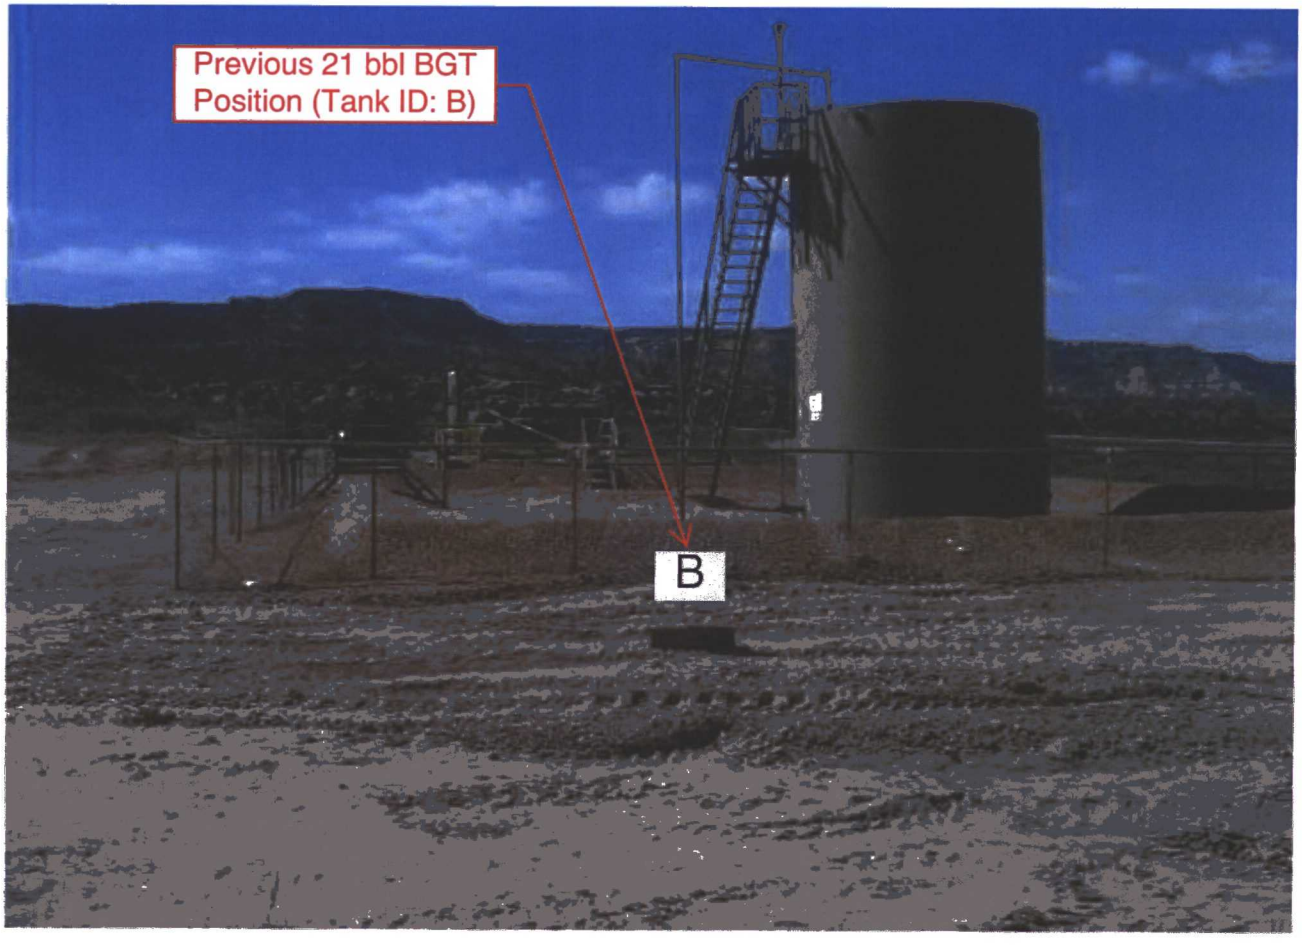
Previous 21 bbl BGT
Position (Tank ID: B)
B

10. BP shall reclaim the BGT location and all areas associated with the BGT including associated access roads to a safe and stable condition that blends with the surrounding undisturbed area. BP shall substantially restore the impacted surface area to the condition that existed prior to oil and gas operations by placement of the soil cover as provided in Subsection H of 19.15.17.13 NMAC, re-contour the location and associated areas to a contour that approximates the original contour and blends with the surrounding topography and re-vegetate according to Subsection I of 19.15.17.13 NMAC.
The area has been backfilled. The location will be reclaimed when the well is plugged and abandoned.
