# Pit, Below-Grade Tank, or Proposed Alternative Method Permit or Closure Plan Application

# BP AMERICA PRODUCTION COMPANY
SAN JUAN BASIN, NORTHWEST NEW MEXICO

BELOW-GRADE TANK CLOSURE PLAN

**Case B #6**
**API No. 30045011074**
**Unit Letter A, Section 5, T31N, R11W**

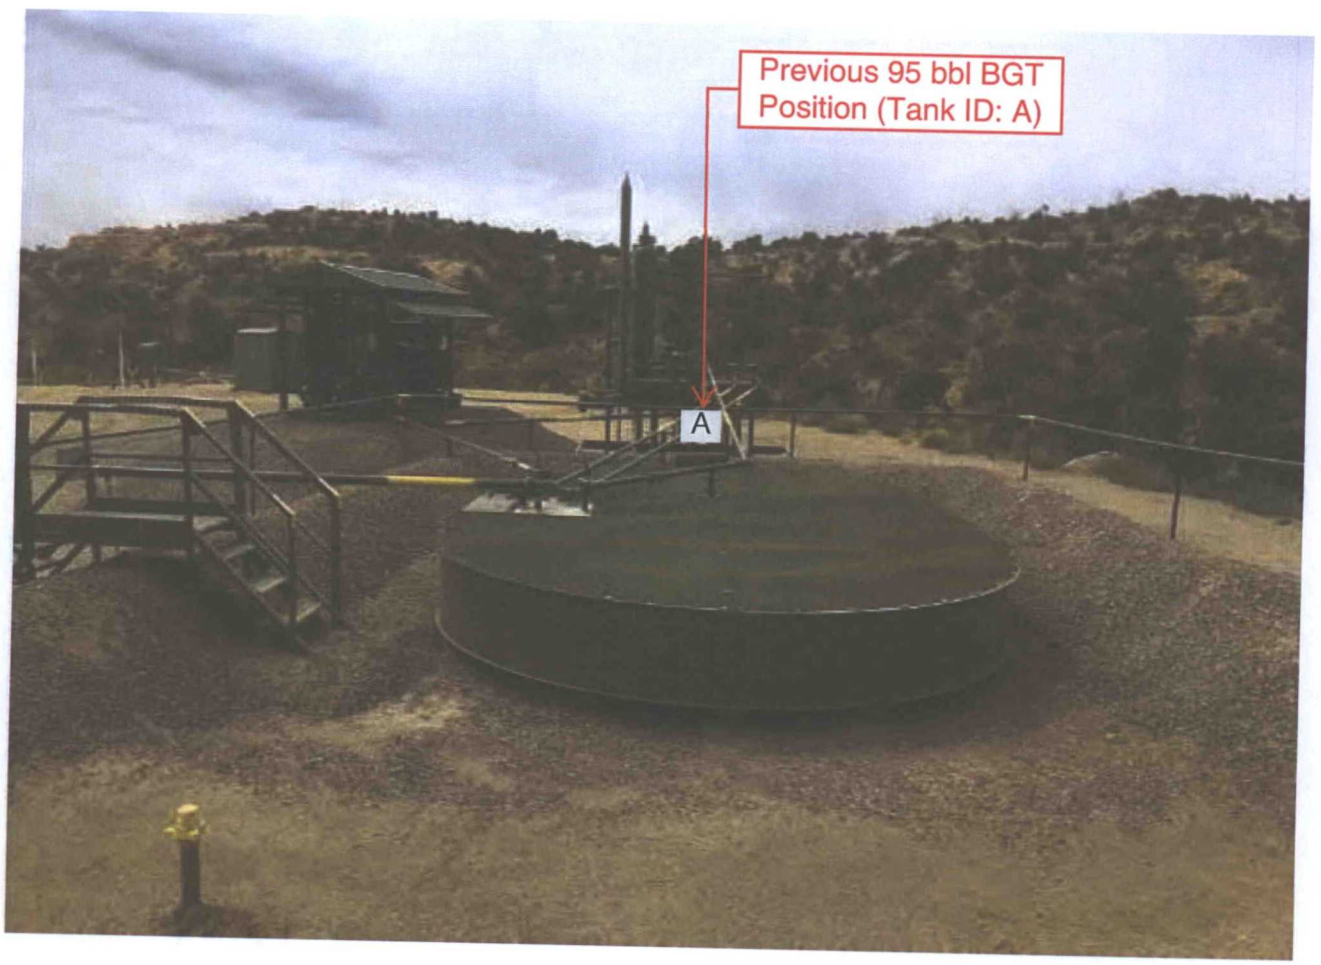
Previous 95 bbl BGT
Position (Tank ID: A)
A

10. BP shall reclaim the BGT location and all areas associated with the BGT including associated access roads to a safe and stable condition that blends with the surrounding undisturbed area. BP shall substantially restore the impacted surface area to the condition that existed prior to oil and gas operations by placement of the soil cover as provided in Subsection H of 19.15.17.13 NMAC, re-contour the location and associated areas to a contour that approximates the original contour and blends with the surrounding topography and re-vegetate according to Subsection I of 19.15.17.13 NMAC.
**The area has been backfilled and a 105 BBL shallow low profile above-ground tank set on top. The location will be reclaimed once the well is plugged and abandoned.**
