Pit, Below-Grade Tank, or Proposed Alternative Method Permit or Closure Plan Application

BELOW-GRADE TANK CLOSURE PLAN

Koch LS 001

API No. 3004509915

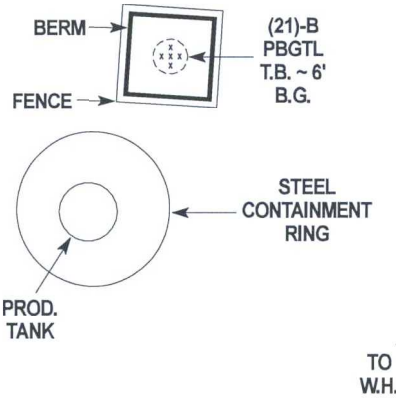
PLOT PLAN circle: attached

DISCOLORATION/STAINING OBSERVED: YES / [NO] EXPLANATION -

APPARENT EVIDENCE OF A RELEASE OBSERVED AND/OR OCCURRED : YES / [NO] EXPLANATION:

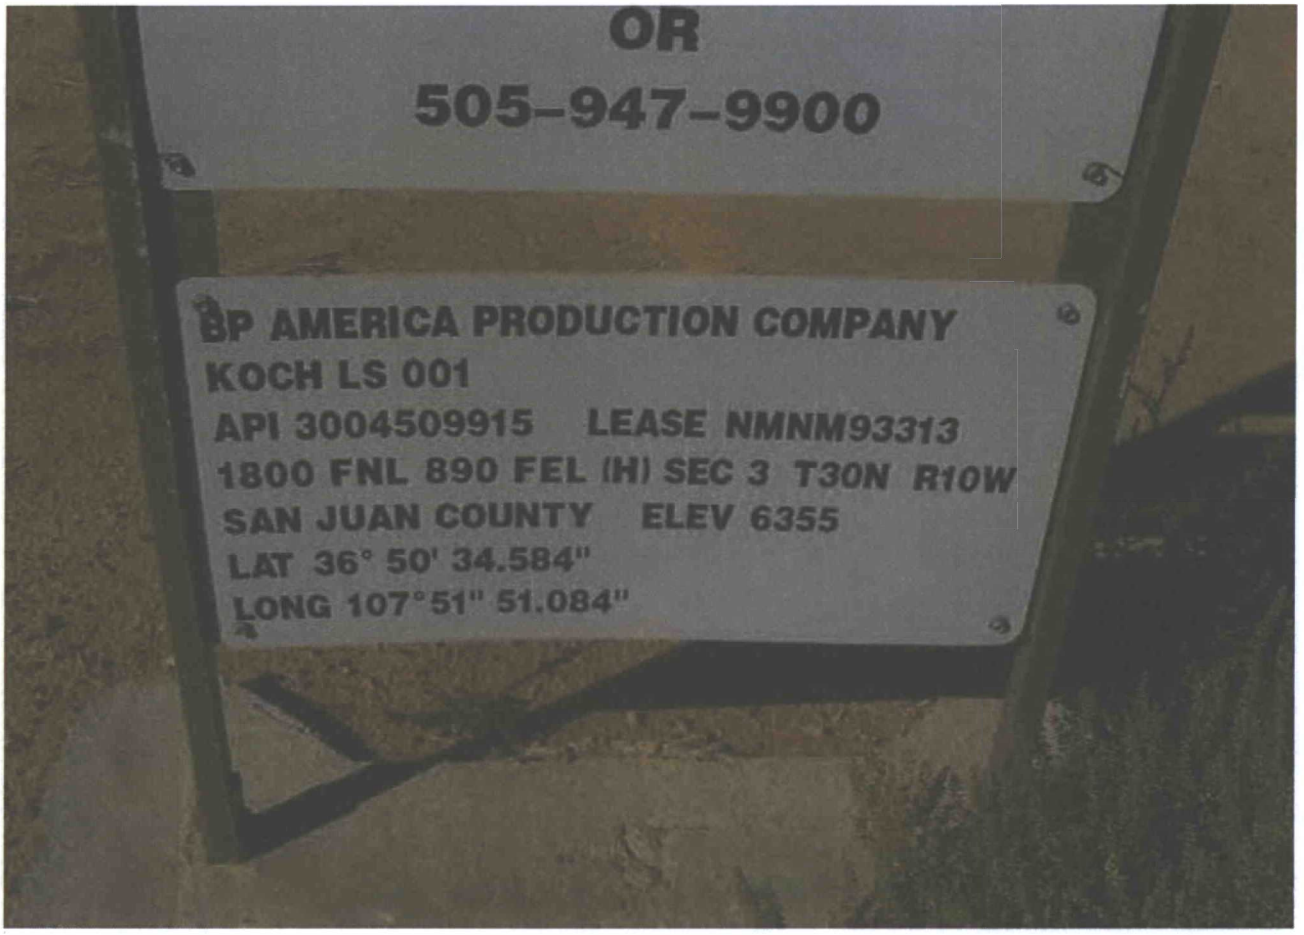
OR
505-947-9900
BP AMERICA PRODUCTION COMPANY
KOCH LS 001
API 3004509915 LEASE NMNM93313
1800 FNL 890 FEL (H) SEC 3 T30N R10W
SAN JUAN COUNTY ELEV 6355
LAT 36° 50' 34.584"
LONG 107°51" 51.084"

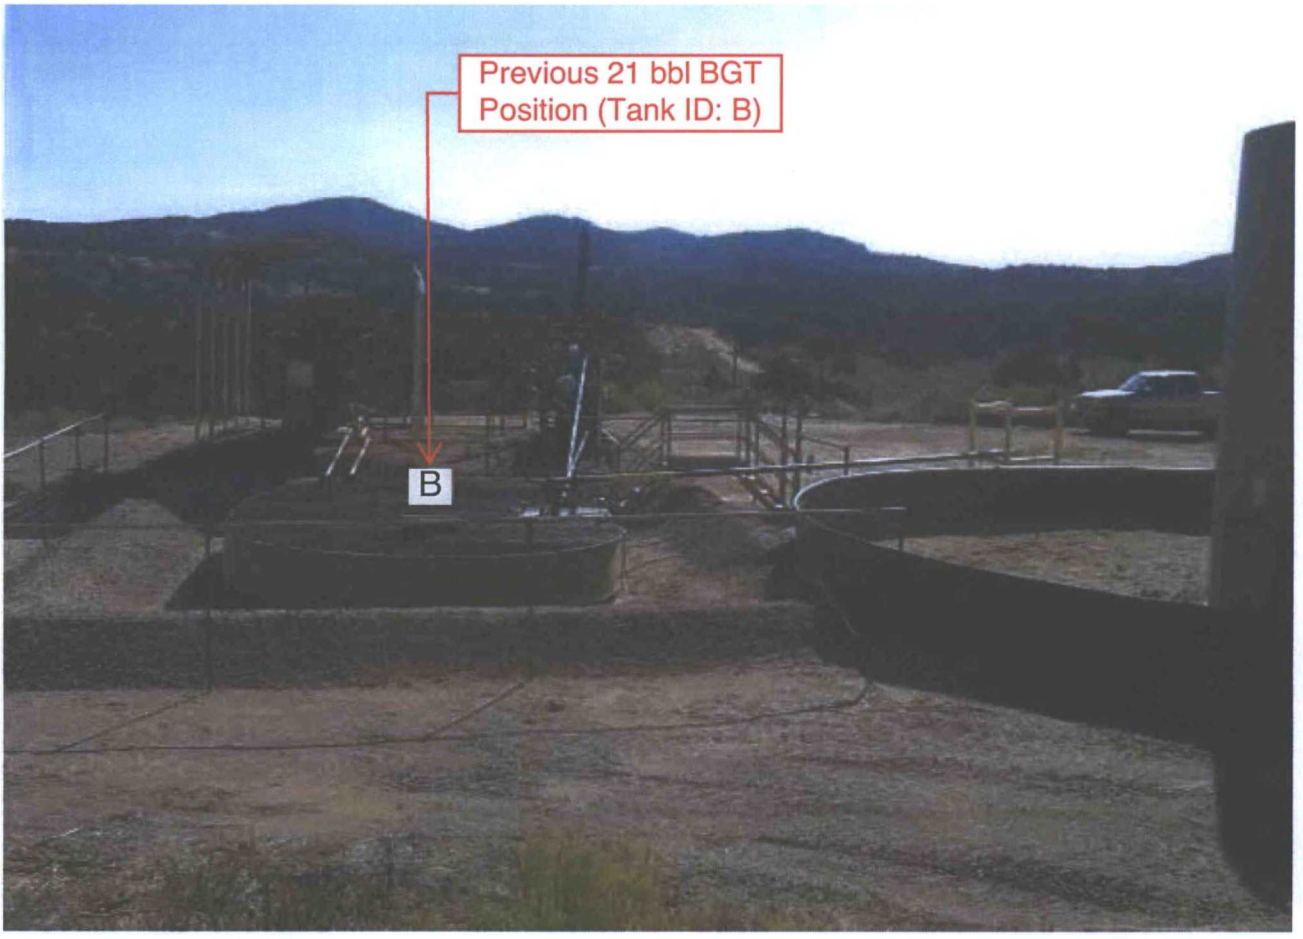
The area has been backfilled and a 105 bbl shallow low profile above-grade tank set atop BGT location. The location will be reclaimed once the well is plugged and abandoned.

Previous 21 bbl BGT
Position (Tank ID: B)
B
