Pit, Below-Grade Tank, or Proposed Alternative Method Permit or Closure Plan Application

BP AMERICA PRODUCTION COMPANY
SAN JUAN BASIN, NORTHWEST NEW MEXICO

BELOW-GRADE TANK CLOSURE PLAN

ATLANTIC LS 004

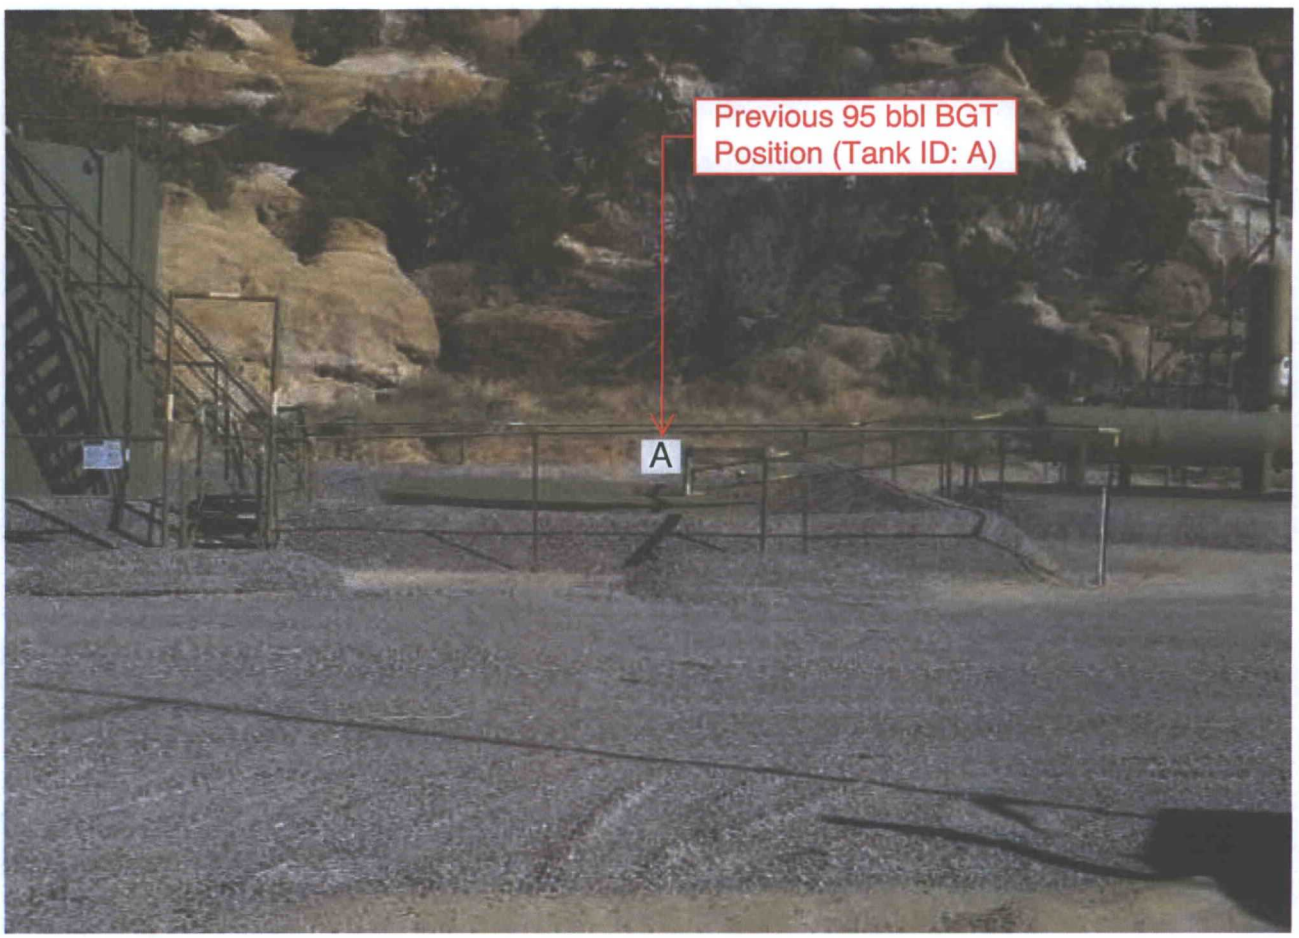
The area has been backfilled and a 105 BBL shallow low profile above-ground tank set atop BGT location. The location will be reclaimed once the well is plugged and abandoned.

Previous 95 bbl BGT
Position (Tank ID: A)
A
