Pit, Below-Grade Tank, or Proposed Alternative Method Permit or Closure Plan Application

BP AMERICA PRODUCTION COMPANY
SAN JUAN BASIN, NORTHWEST NEW MEXICO

BELOW-GRADE TANK CLOSURE PLAN

PRITCHARD 003

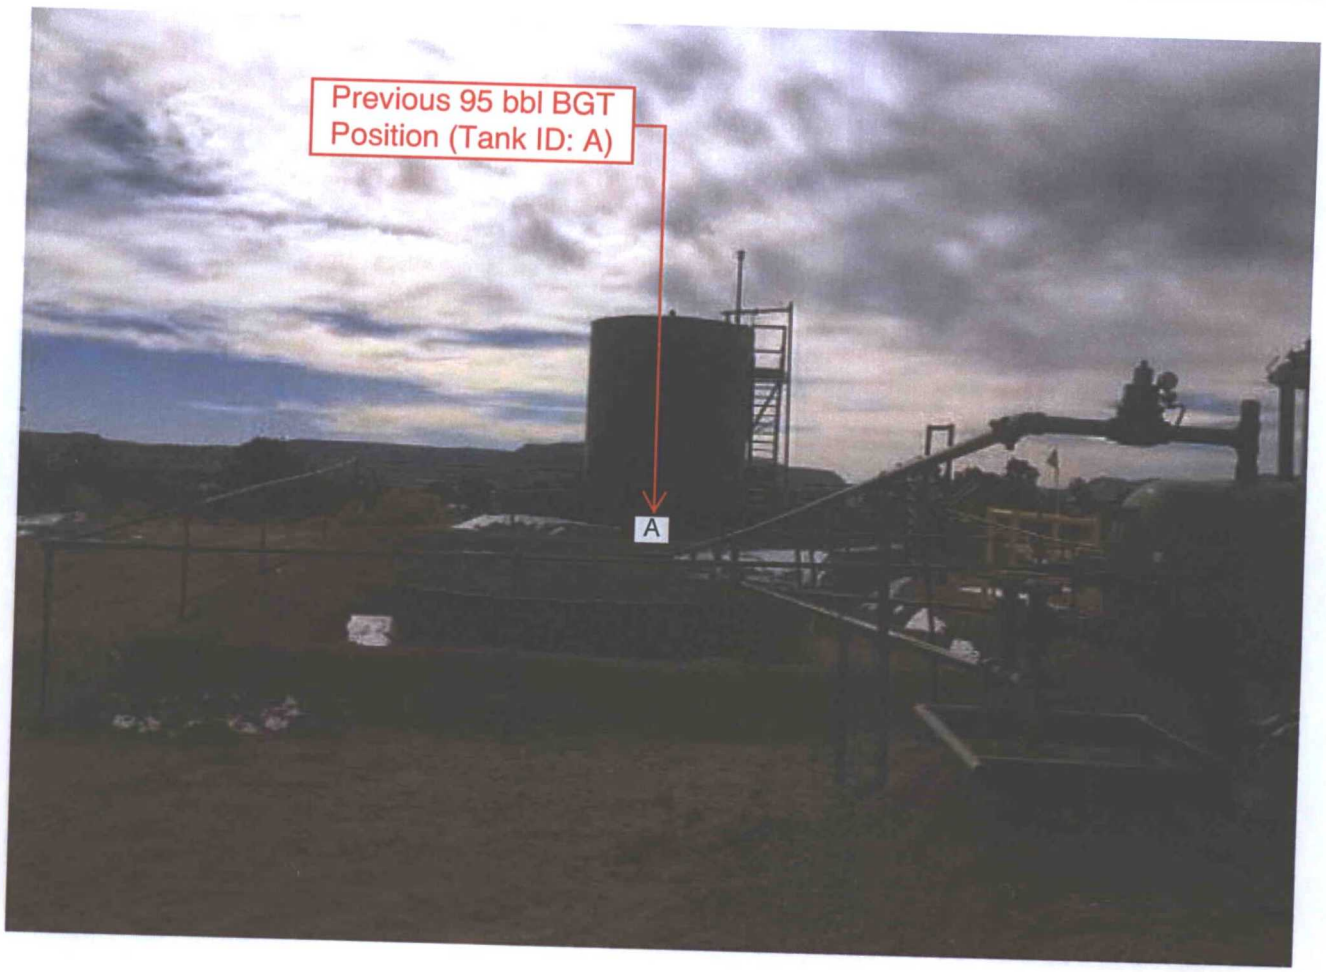
Previous 95 bbl BGT
Position (Tank ID: A)
A

The area has been backfilled and a 105 BBL shallow low profile above-grade tank set atop BGT location. The location will be reclaimed once the well is plugged and abandoned.
