Pit, Below-Grade Tank, or Proposed Alternative Method Permit or Closure Plan Application

BP AMERICA PRODUCTION COMPANY
SAN JUAN BASIN, NORTHWEST NEW MEXICO

BELOW-GRADE TANK CLOSURE PLAN

GCU 090

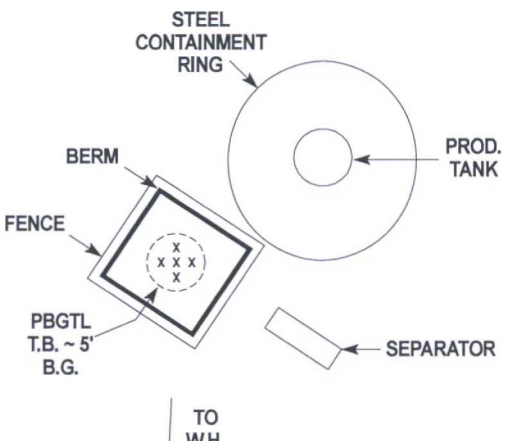
PLOT PLAN circle: attached

DISCOLORATION/STAINING OBSERVED: YES / [NO] EXPLANATION -

APPARENT EVIDENCE OF A RELEASE OBSERVED AND/OR OCCURRED : YES [NO] EXPLANATION:
