Pit, Below-Grade Tank, or Proposed Alternative Method Permit or Closure Plan Application

BELOW-GRADE TANK CLOSURE PLAN

GCU 090E

API No. 3004526193

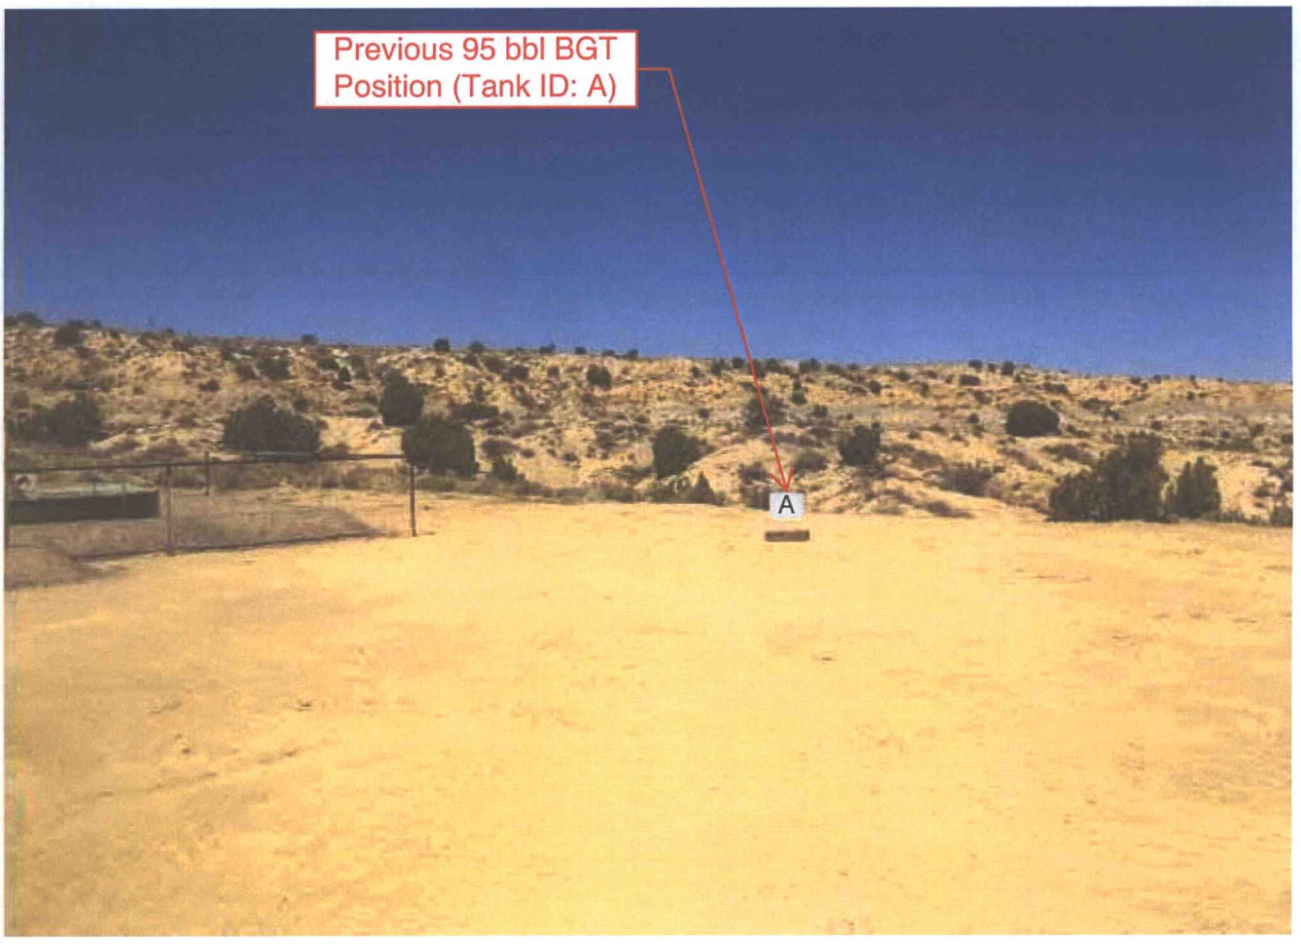
Previous 95 bbl BGT
Position (Tank ID: A)
A

The area has been backfilled and BGT location's surface is clear but within the site's operational area. The location will be reclaimed once the well is plugged and abandoned.
