Pit, Below-Grade Tank, or Proposed Alternative Method Permit or Closure Plan Application

BELOW-GRADE TANK CLOSURE PLAN

GCU 053

API No. 3004506979

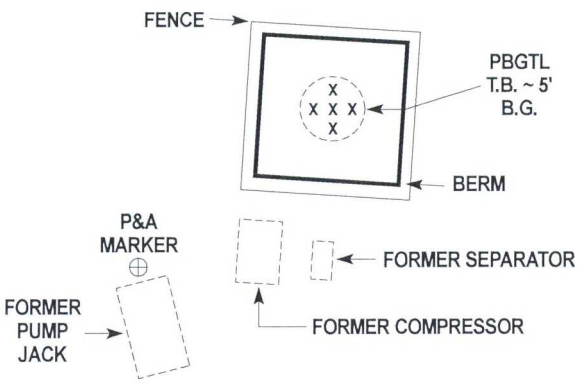
PLOT PLAN circle: attached

BGT Located : off / [on] site

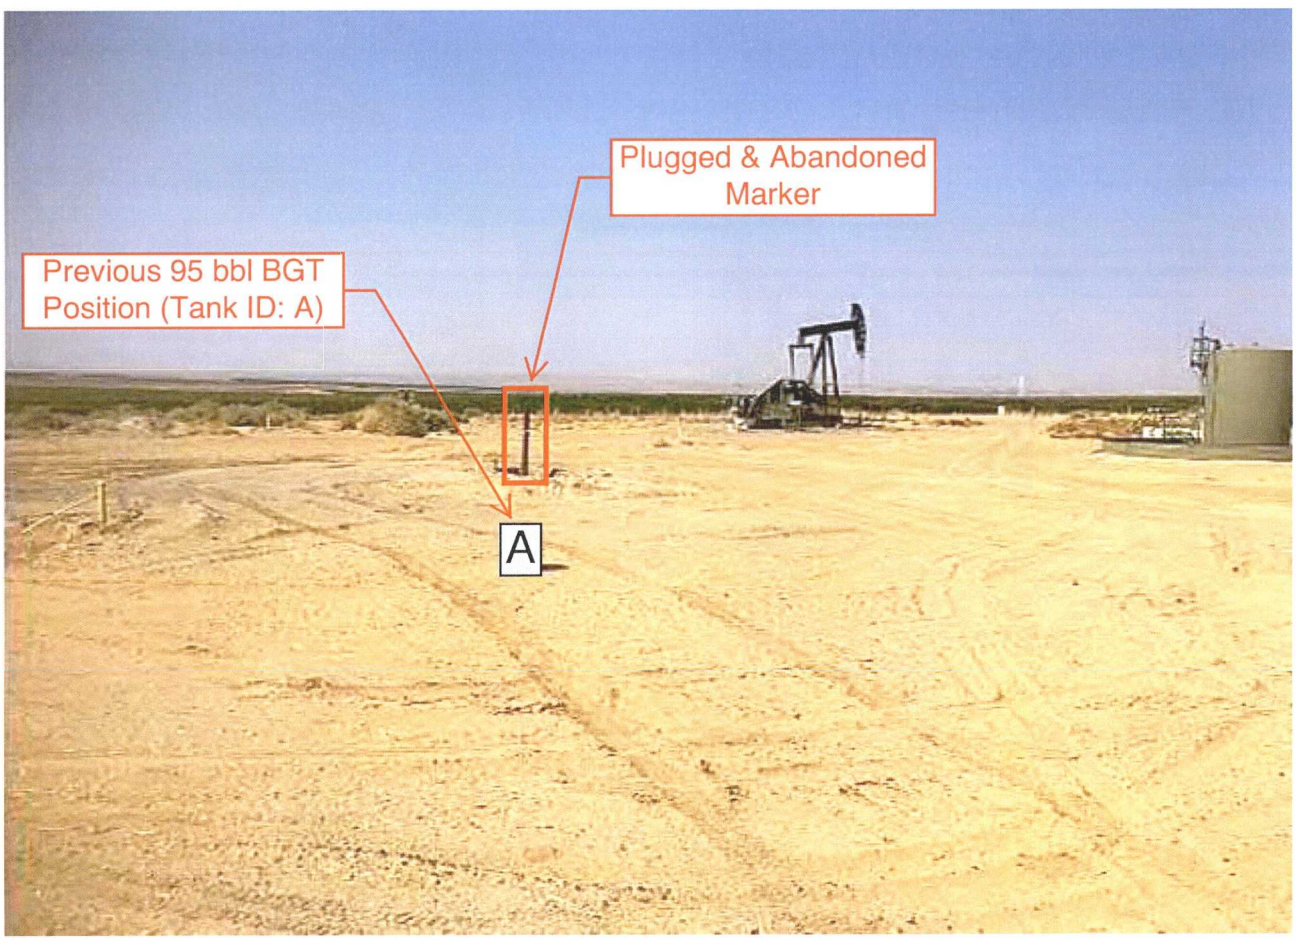
The area has been backfilled and BGT location's surface condition is clear, but within the site's operational area. The location will be reclaimed once the well is plugged and abandoned.

Plugged & Abandoned Marker
Previous 95 bbl BGT Position (Tank ID: A)
A
