Pit, Below-Grade Tank, or Proposed Alternative Method Permit or Closure Plan Application

BP AMERICA PRODUCTION COMPANY
SAN JUAN BASIN, NORTHWEST NEW MEXICO

BELOW-GRADE TANK CLOSURE PLAN

GCU 232

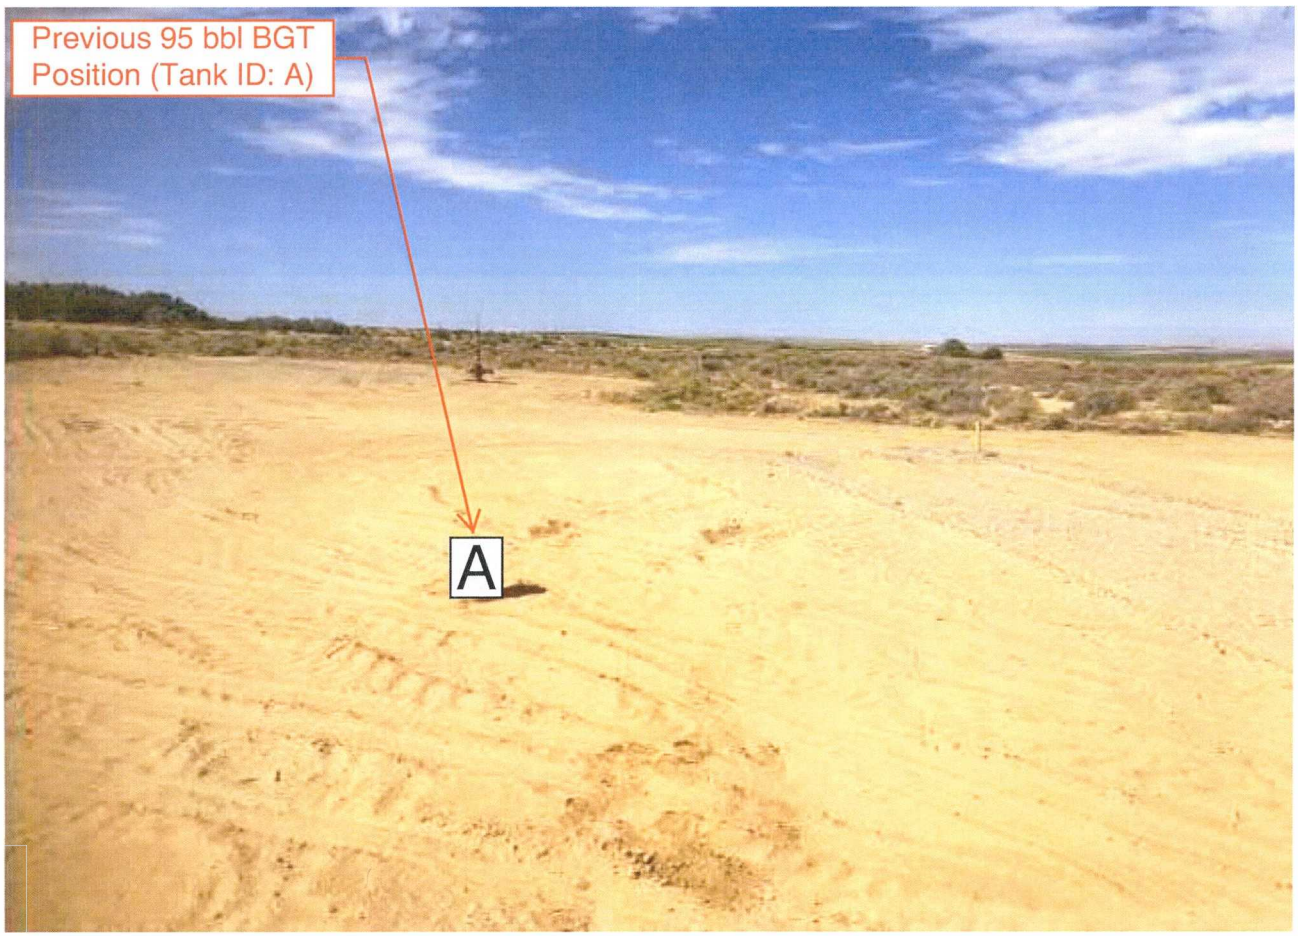
The area has been backfilled and BGT location's surface condition is clear, but within the site's operational area. The location will be reclaimed once the well is plugged and abandoned.

Previous 95 bbl BGT
Position (Tank ID: A)
A
