Pit, Below-Grade Tank, or Proposed Alternative Method Permit or Closure Plan Application

BP AMERICA PRODUCTION COMPANY
SAN JUAN BASIN, NORTHWEST NEW MEXICO

BELOW-GRADE TANK CLOSURE PLAN

Northeast Blanoc Unit 032A

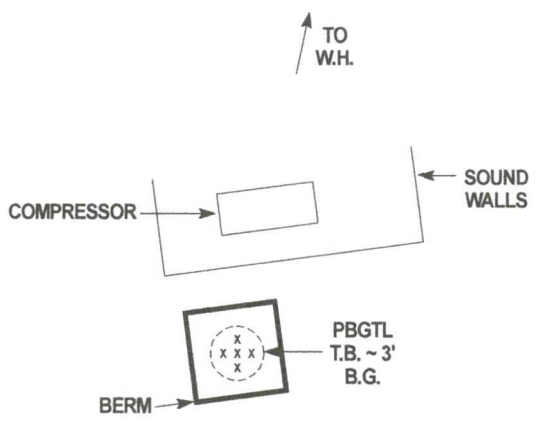
PLOT PLAN circle: attached

DISCOLORATION/STAINING OBSERVED: YES / NO EXPLANATION - MEDIUM GRAY DIRECTLY BENEATH BGT AT 3 FT. B.G. (FOOTPRINT AREA ONLY)

APPARENT EVIDENCE OF A RELEASE OBSERVED AND/OR OCCURRED : YES / NO EXPLANATION: VISUALLY BENEATH BGT & PHYSICAL HYDROCARBON ODOR

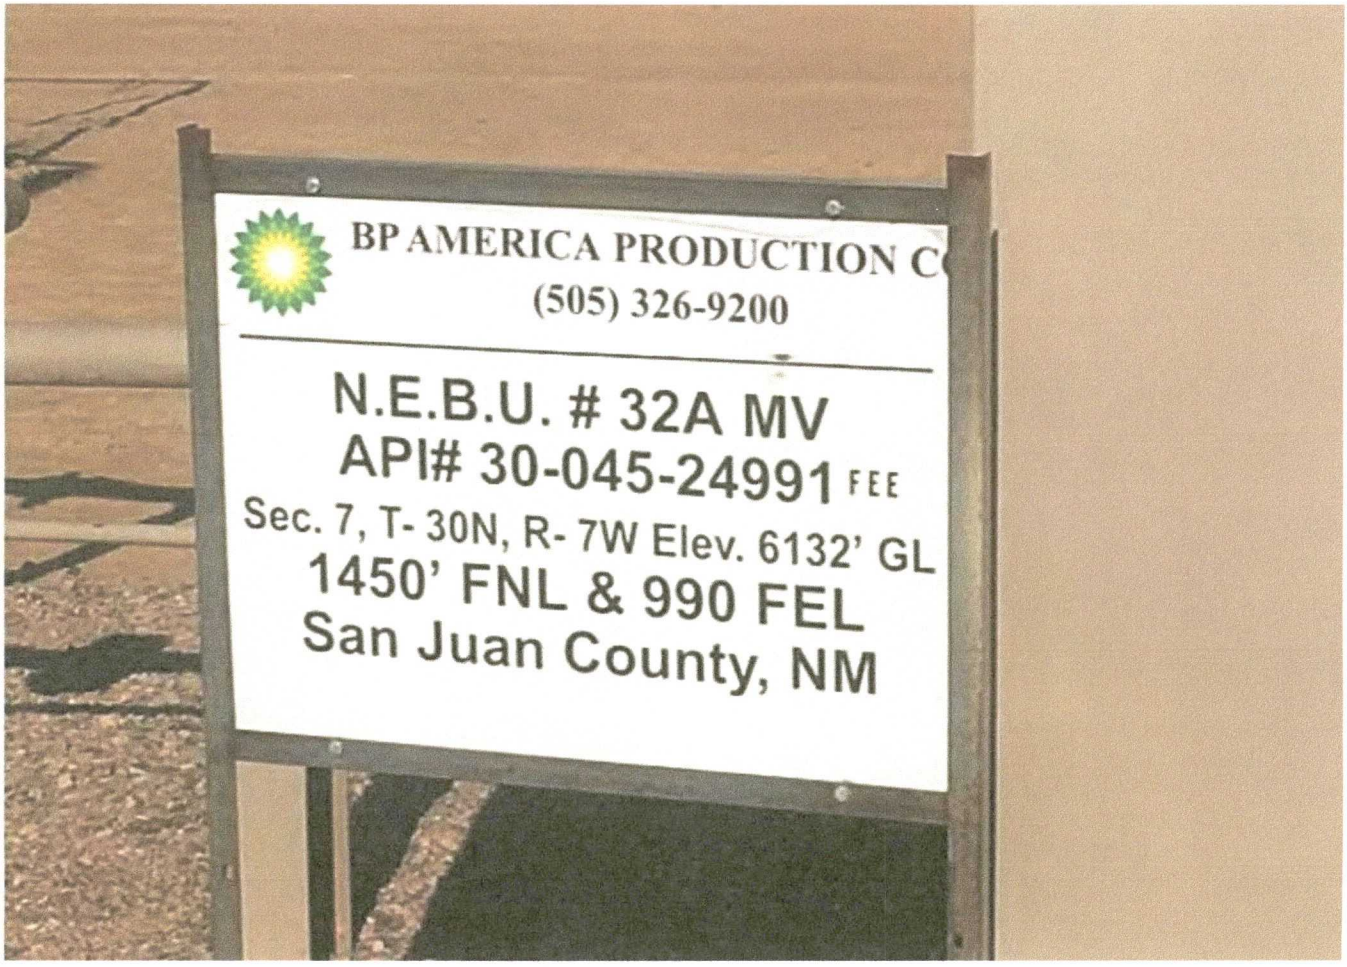
BP AMERICA PRODUCTION C
(505) 326-9200
N.E.B.U. # 32A MV
API# 30-045-24991 FEE
Sec. 7, T- 30N, R- 7W Elev. 6132' GL
1450' FNL & 990 FEL
San Juan County, NM

Previous 45 bbl BGT
Position (Tank ID: A)
A
