Pit, Closed-Loop System, Below-Grade Tank, or Proposed Alternative Method Permit or Closure Plan Application

1.
Operator: BP AMERICA PRODUCTION COMPANY OGRID #: 778
Address: 200 Energy Court, Farmington, NM 87401
Facility or well name: W D HEATH A 007
API Number: 3004508498 OCD Permit Number:
U/L or Qtr/Qtr J Section 8.0 Township 29.0N Range 09W County: San Juan County
Center of Proposed Design: Latitude 36.73697 Longitude -107.79852 NAD: ☐ 1927 ☒ 1983
Surface Owner: ☒ Federal ☐ State ☐ Private ☐ Tribal Trust or Indian Allotment

BELOW-GRADE TANK CLOSURE PLAN

W D Heath A G # 7 – Tank ID: A
API #: 3004508498
Unit Letter J, Section 8, T29N, R09W

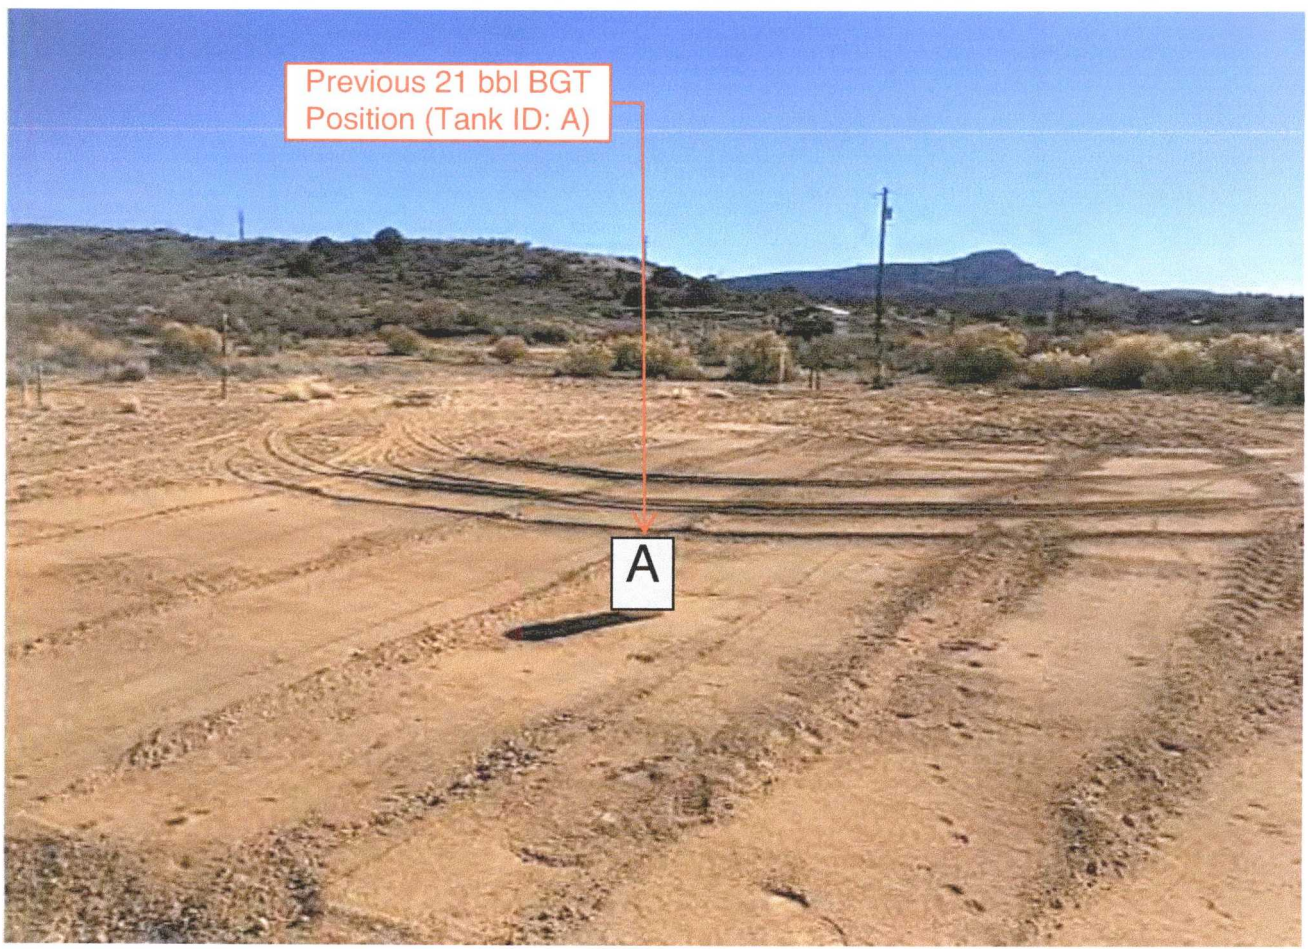
Previous 21 bbl BGT
Position (Tank ID: A)
A
