Pit, Closed-Loop System, Below-Grade Tank, or Proposed Alternative Method Permit or Closure Plan Application

1.
Operator: BP AMERICA PRODUCTION COMPANY OGRID #: 778
Address: 380 North Airport Road, Durango, CO 81303
Facility or well name: RIDDLE 002
API Number: 300459457 OCD Permit Number:
U/L or Qtr/Qtr N Section 17.0 Township 30.0N Range 09W County: San Juan County
Center of Proposed Design: Latitude 36.80690 Longitude -107.80632 NAD: ☐1927 ☒ 1983
Surface Owner: ☒ Federal ☐ State ☐ Private ☐ Tribal Trust or Indian Allotment

BELOW-GRADE TANK CLOSURE PLAN

Riddle # 2 – Tank ID: A
API #: 3004509457
Unit Letter N, Section 17, T30N, R09W

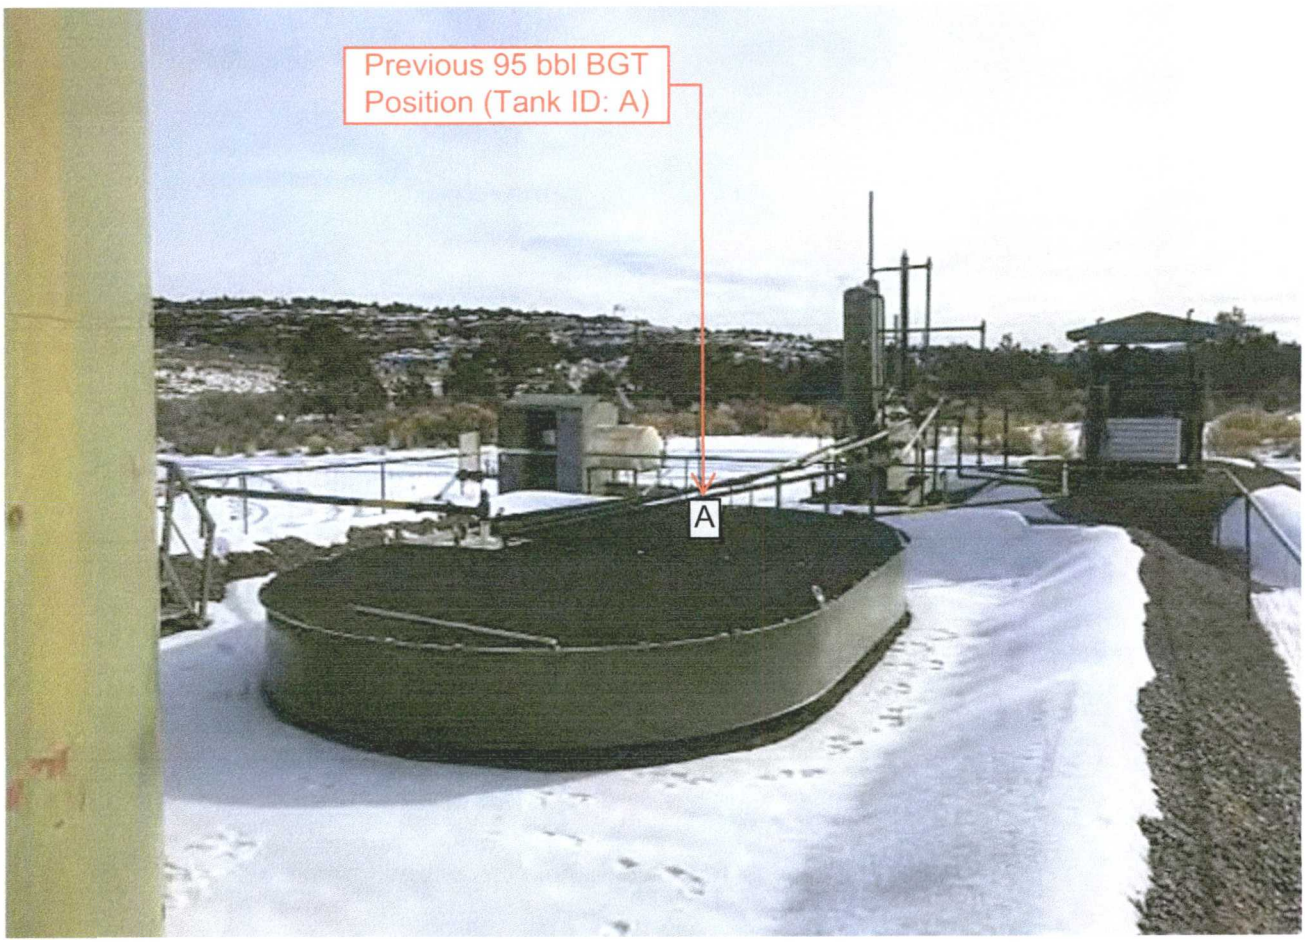
Previous 95 bbl BGT
Position (Tank ID: A)
A

10. BP shall reclaim the BGT location and all areas associated with the BGT including associated access roads to a safe and stable condition that blends with the surrounding undisturbed area. BP shall substantially restore the impacted surface area to the condition that existed prior to oil and gas operations by placement of the soil cover as provided in Subsection H of 19.15.17.13 NMAC, re-contour the location and associated areas to a contour that approximates the original contour and blends with the surrounding topography and re-vegetate according to Subsection I of 19.15.17.13 NMAC.
The BGT area has been backfilled and will be reclaimed once the well has been plugged & abandoned.
