Pit, Closed-Loop System, Below-Grade Tank, or Proposed Alternative Method Permit or Closure Plan Application

1.
Operator: BP AMERICA PROD. CO. OGRID #: 778
Address: 1199 Main Ave., Suite 101, Durango, CO 81301
Facility or well name: FLORANCE 124E
API Number: 3004524688 OCD Permit Number:
U/L or Qtr/Qtr M Section 27.0 Township 29.0N Range 09W County: San Juan County
Center of Proposed Design: Latitude 36.692317 Longitude -107.772744 NAD: ☐ 1927 ☒ 1983
Surface Owner: ☒ Federal ☐ State ☐ Private ☐ Tribal Trust or Indian Allotment

BELOW-GRADE TANK CLOSURE PLAN

Florance # 124E – Tank ID: B
API #: 3004524688
Unit Letter M, Section 27, T29N, R9W

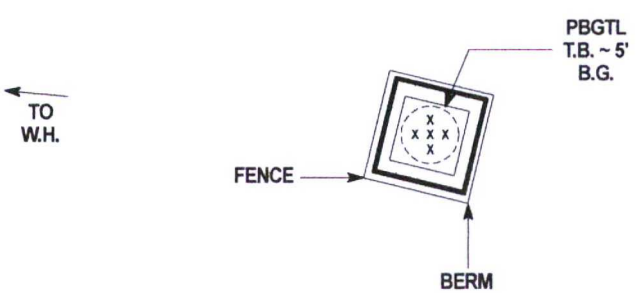
PLOT PLAN circle: attached

APPARENT EVIDENCE OF A RELEASE OBSERVED AND/OR OCCURRED : YES [NO] EXPLANATION:

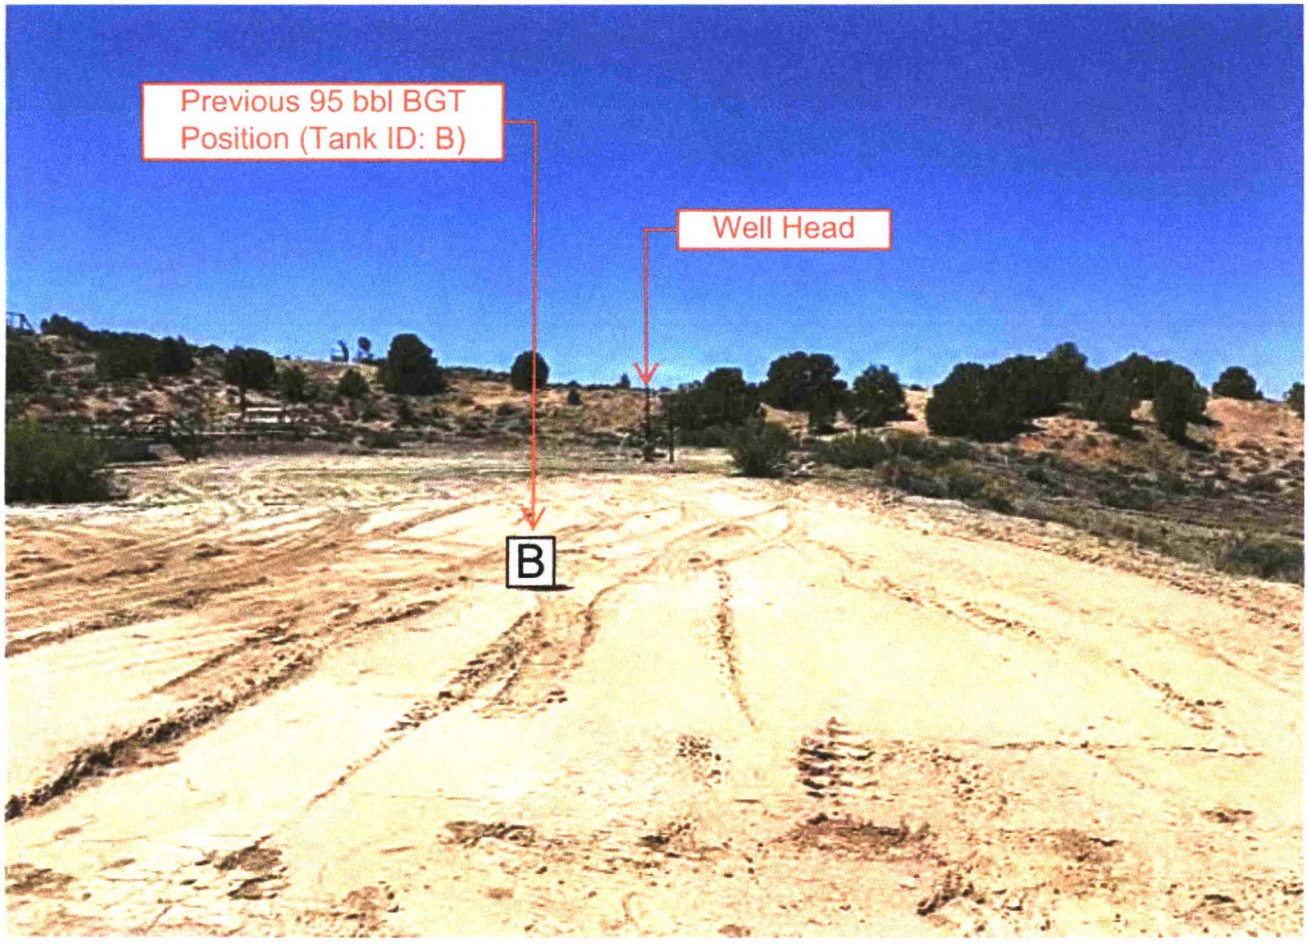
Previous 95 bbl BGT
Position (Tank ID: B)
Well Head
B

Closure report on C-144 form is included & contains a photo of the reclamation completion.

10. BP shall reclaim the BGT location and all areas associated with the BGT including associated access roads to a safe and stable condition that blends with the surrounding undisturbed area. BP shall substantially restore the impacted surface area to the condition that existed prior to oil and gas operations by placement of the soil cover as provided in Subsection H of 19.15.17.13 NMAC, re-contour the location and associated areas to a contour that approximates the original contour and blends with the surrounding topography and re-vegetate according to Subsection I of 19.15.17.13 NMAC.
The BGT area has been backfilled and will be reclaimed once the well has been plugged & abandoned.
