ENSOLUM

January 16, 2026

Re: Closure Request
Golden 8 Federal #001
Incident Numbers nKMW1035646177, nKMW1106629393, nJMW1333053660, nAB1422637219, nAB1607837012, nAB1633656856, nAB1803638613, and nAB1929041495
Eddy County, New Mexico

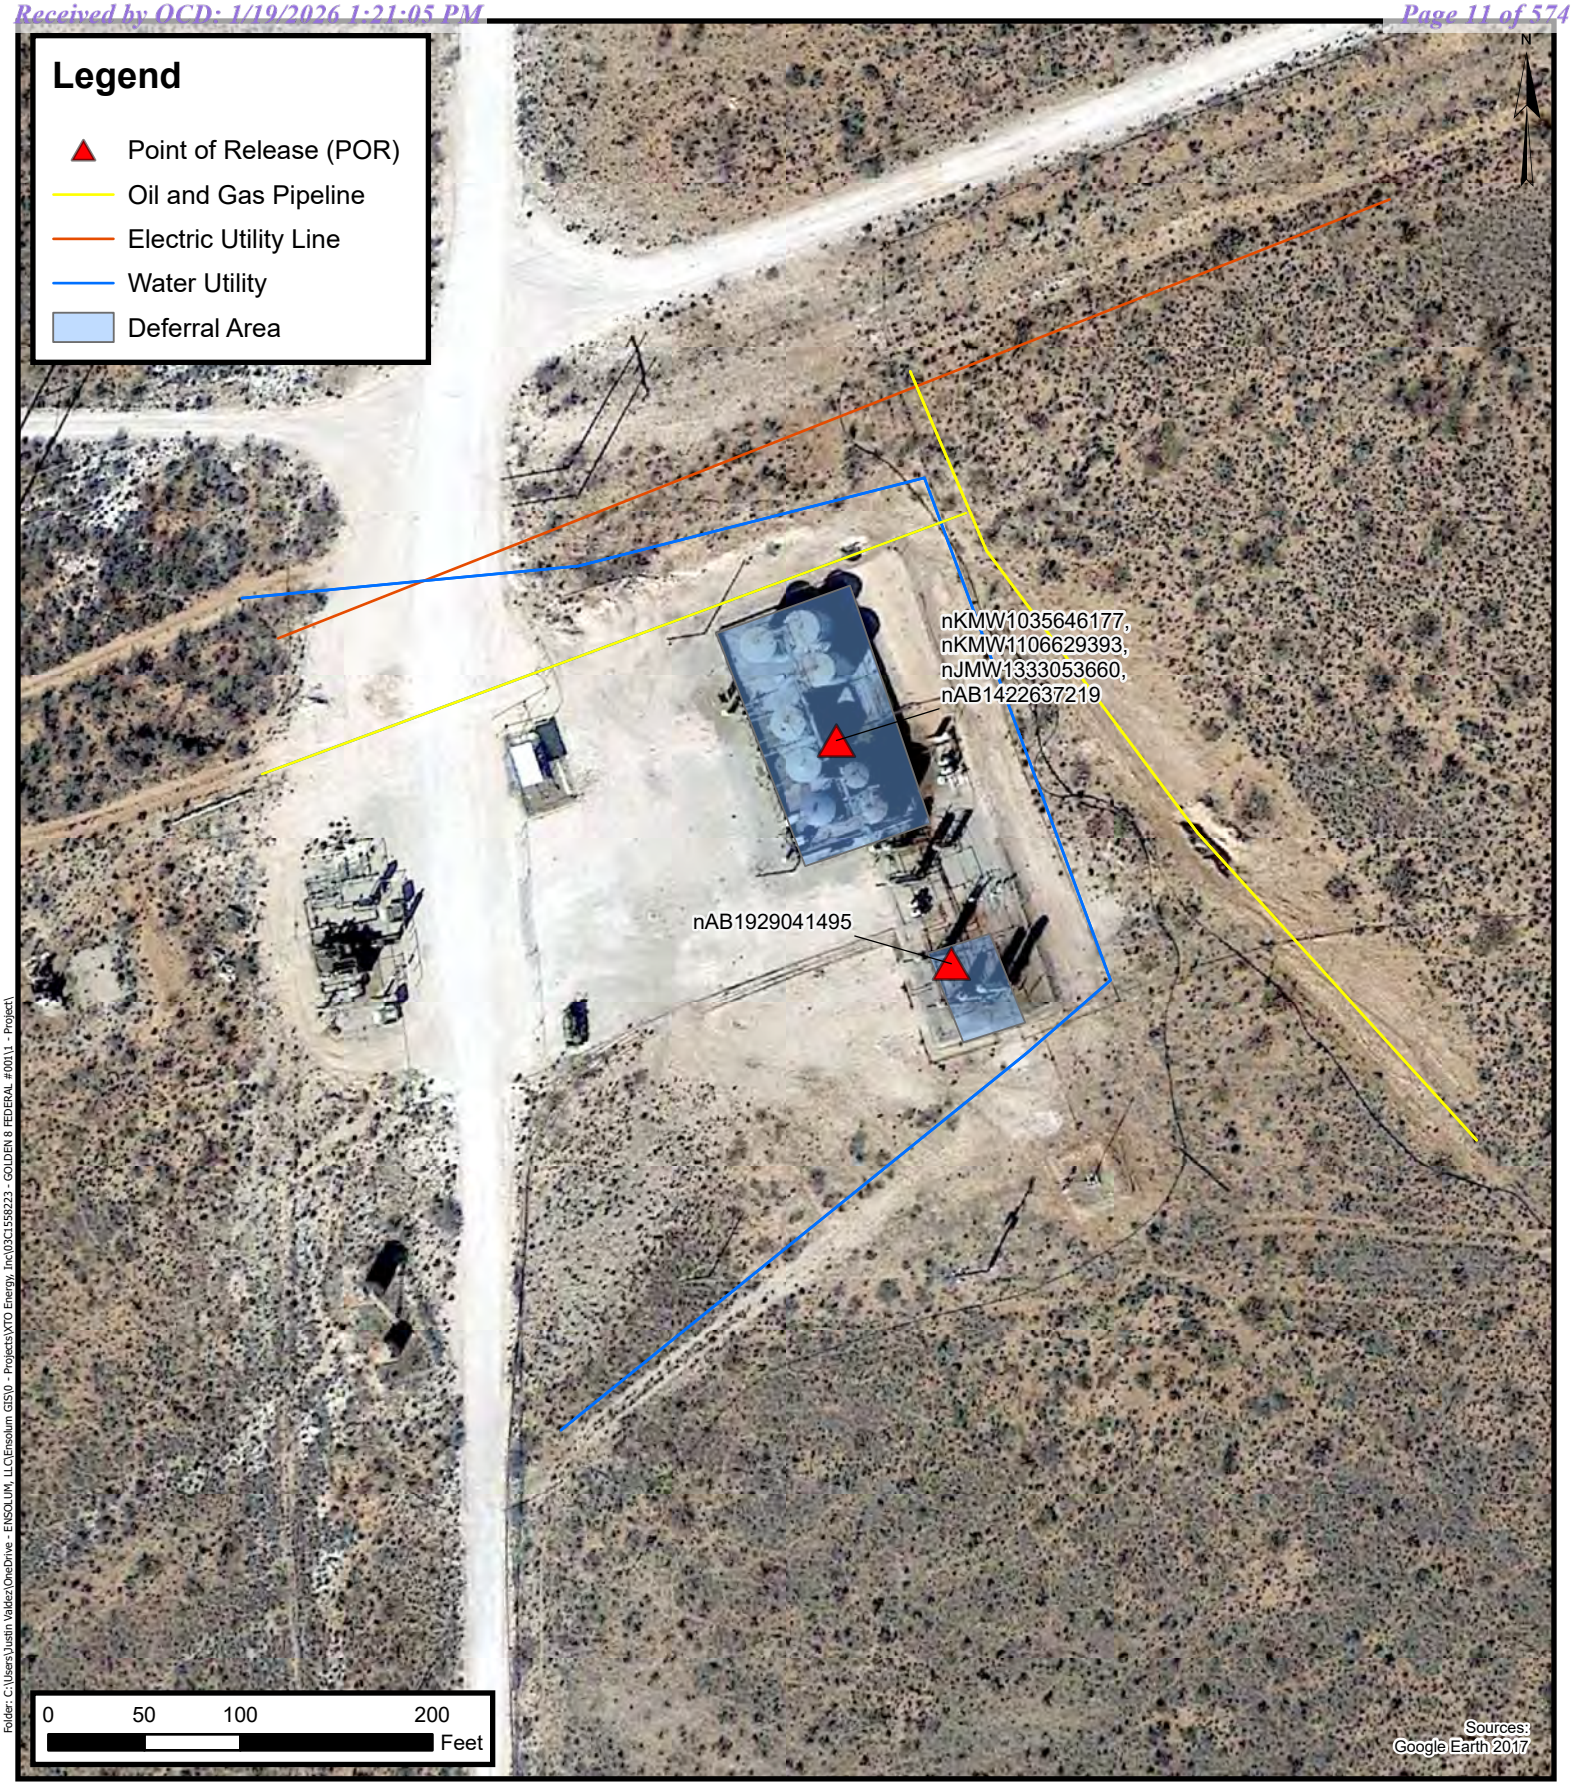
FIGURE 1

Site Receptor Map

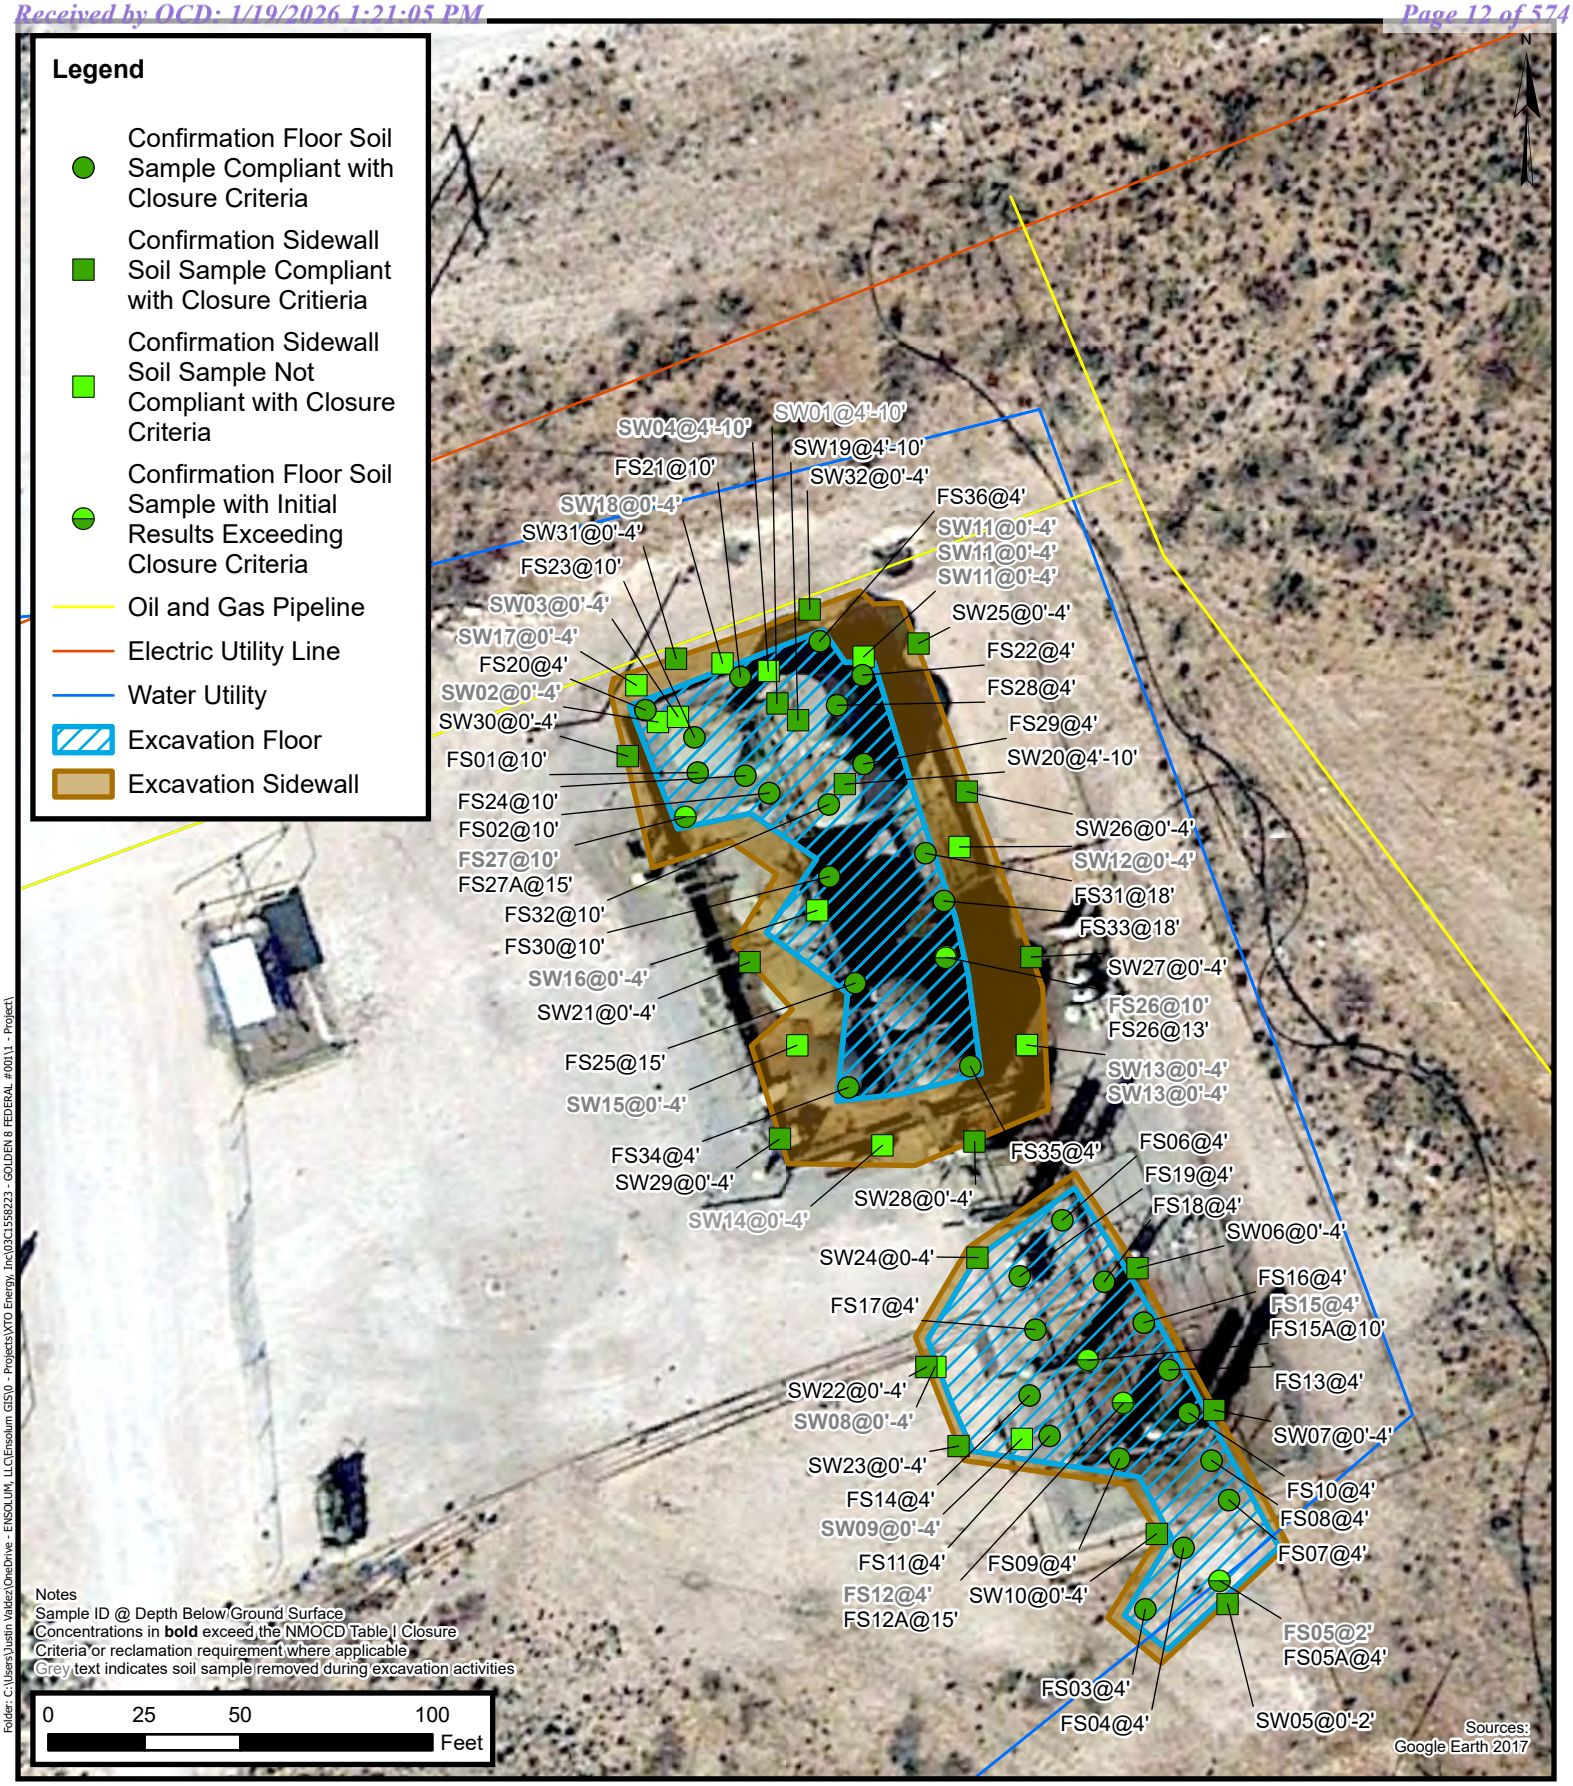
FIGURE 2

Deferral Locations
