Pit, Below-Grade Tank, or Proposed Alternative Method Permit or Closure Plan Application

Facility or well name: QUINE GAS COM 3

Hilcorp Energy Company
San Juan Basin: New Mexico Assets
Below Grade Tank Closure Report

Lease Name: Quine Gas Com 3
API No.: 30-045-31770

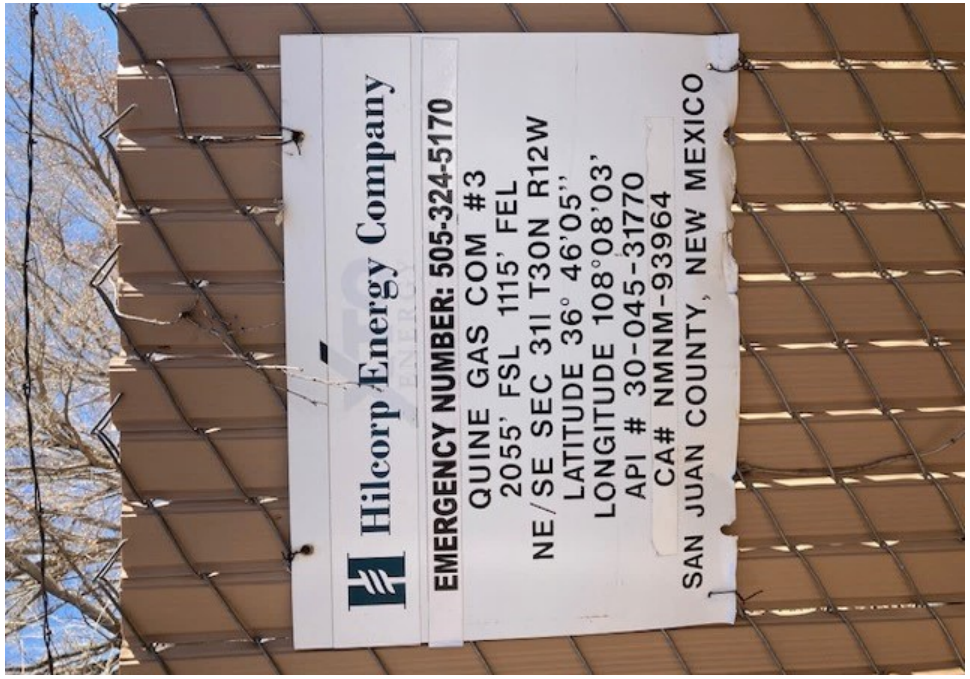
Hilcorp Energy Company
EMERGENCY NUMBER: 505-324-5170
QUINE GAS COM #3
2055' FSL 1115' FEL
NE/SE SEC 31 T30N R12W
LATITUDE 36° 46'05''
LONGITUDE 108°08'03'
API # 30-045-31770
CA# NMNM-93964
SAN JUAN COUNTY, NEW MEXICO
