Pit, Below-Grade Tank, or Proposed Alternative Method Permit or Closure Plan Application

Hilcorp Energy Company
San Juan Basin
Below Grade Tank Closure Report

Lease Name: Lunt FC 6
API No.: 30-045-34033

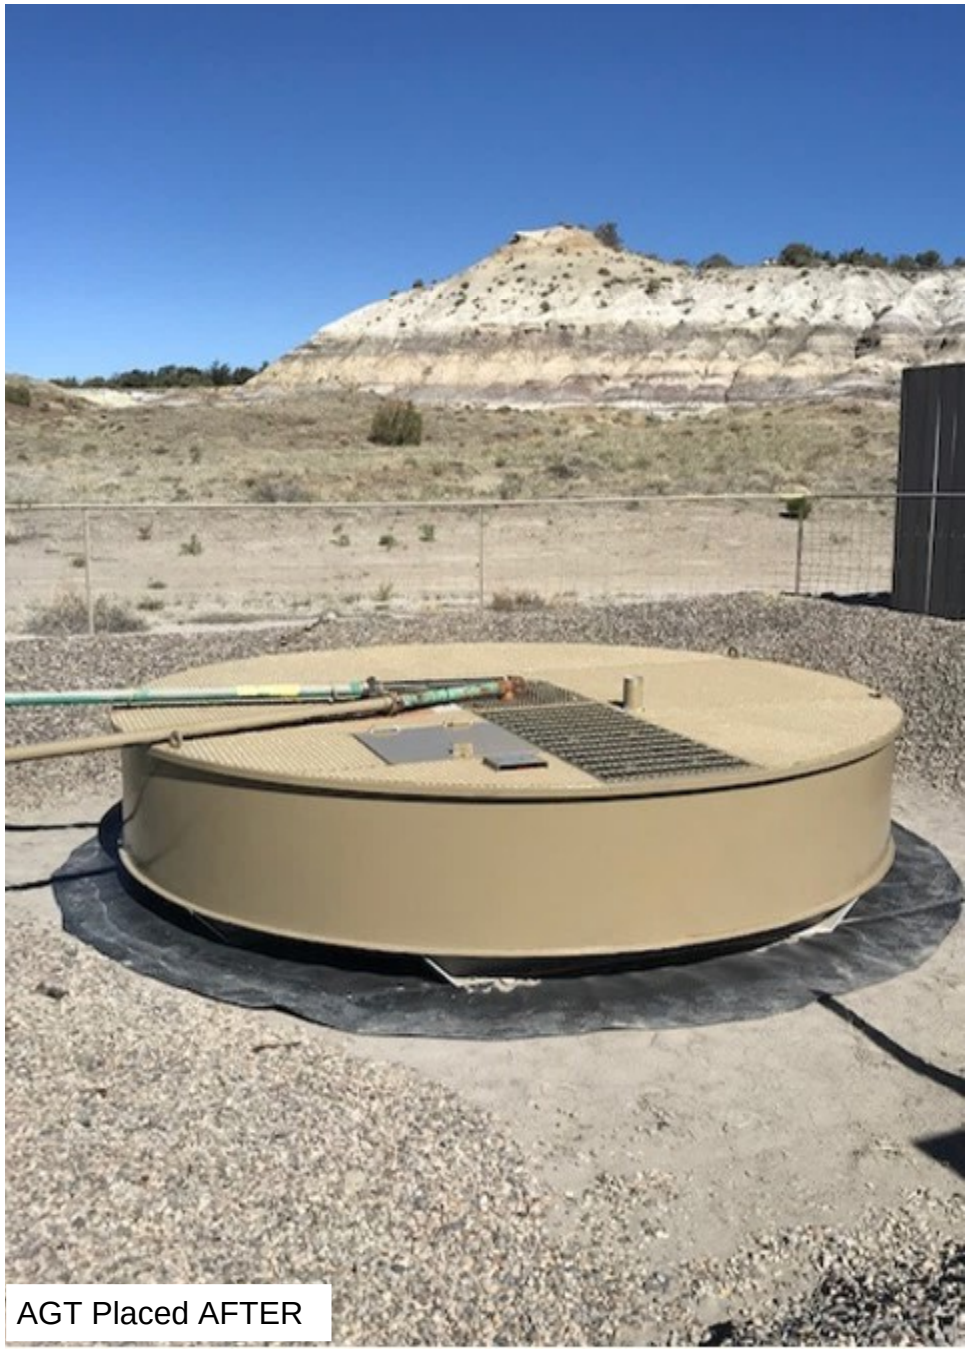
AGT Placed AFTER
