# Pit, Closed-Loop System, Below-Grade Tank, or Proposed Alternative Method Permit or Closure Plan Application

BELOW-GRADE TANK CLOSURE PLAN

**Northeast Blanco Unit # 16A – Tank ID: B**
**API #: 3003921722**
**Unit Letter J, Section 3, T30N, R07W**

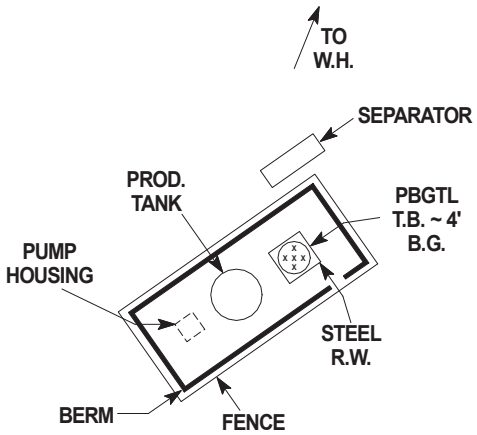
PLOT PLAN circle: attached

APPARENT EVIDENCE OF A RELEASE OBSERVED AND/OR OCCURRED : YES / NO EXPLANATION:
