BGT1 Closure Report

SIMCOE, LLC
SAN JUAN BASIN, NORTHWEST NEW MEXICO

Well Name: NEBU #047M
Well API# 30-045-34296
Unit Letter C, Section 32, T31N, R7W

BELOW-GRADE TANK CLOSURE PLAN

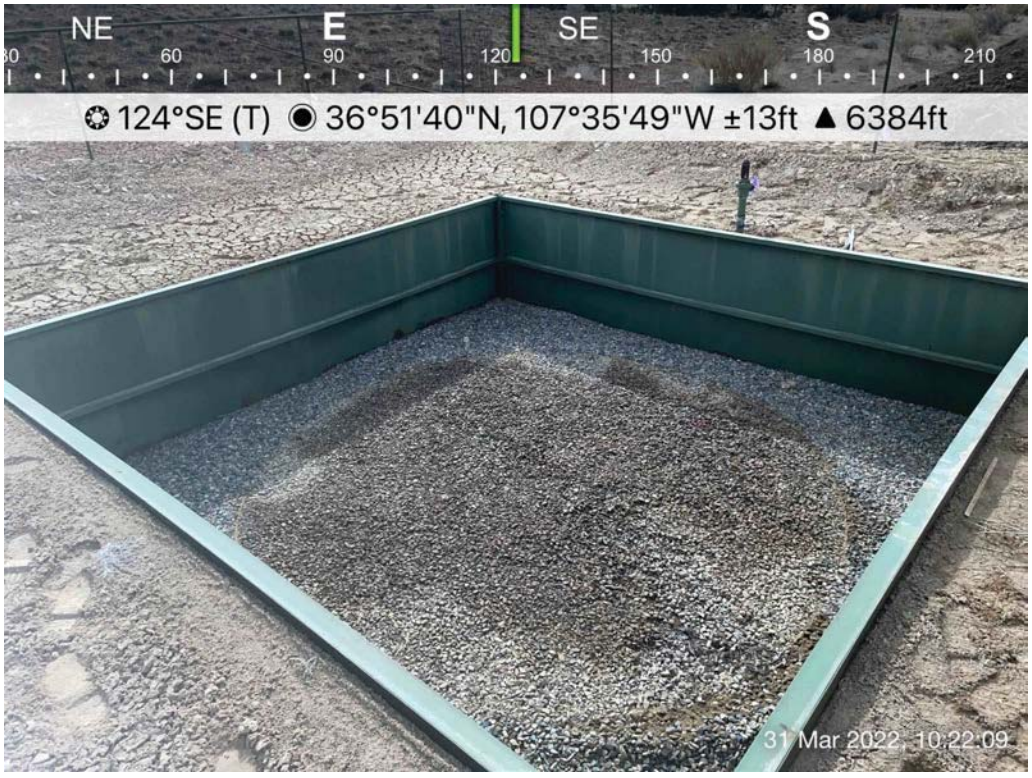
Photo 3: Former location of BGT following removal, 3/31/2022.
