BGT1 Closure Report

Well Name: Vandewart #002
Well API# 30-045-24031
Unit Letter M, Section 13, T29N, R8W

BELOW-GRADE TANK CLOSURE PLAN

Vandewart #002
Photographic Log
Simcoe LLC

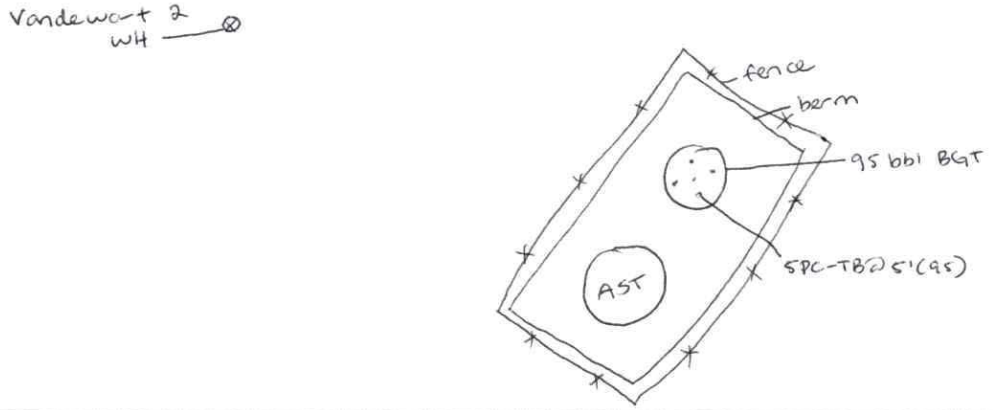
SITE SKETCH

DISCOLORATION/STAINING OBSERVED: YES / (NO) EXPLANATION -

APPARENT EVIDENCE OF A RELEASE OBSERVED AND/OR OCCURRED : YES / (NO) EXPLANATION:
