Pit, Below-Grade Tank, or Proposed Alternative Method Permit or Closure Plan Application

Hilcorp Energy Company
San Juan Basin
Below Grade Tank Closure Report

Lease Name: Whitley 3
API No.: 30-045-06715

Whitley 3
30-045-06715
BGT Closure Pictures

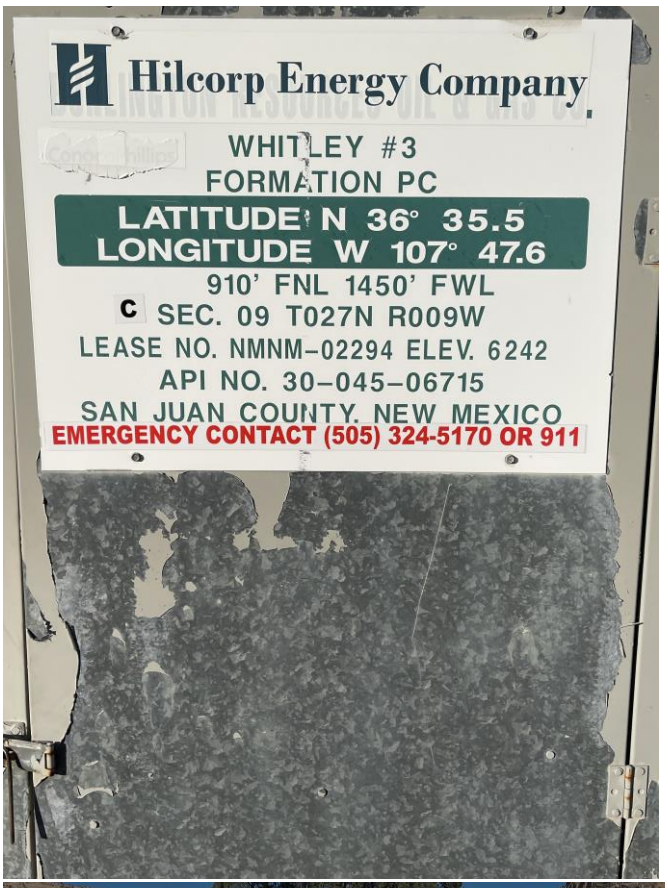
Back-fill photo facing NE of P&A Marker. 10/27/22 @ 10:24 am.

The below-grade tank area passed all requirements of Paragraph (4) of Subsection E of 19.15.17.13 NMAC and was backfilled with compacted, non-waste containing, earthen material.

The below-grade tank area was backfilled and more than four feet of cover was achieved and the cover included one foot of suitable material to establish vegetation at the site.
